Uffizi Gallery monitoring for IAQ assessment

Cristina Carletti^{1,*}, *Gianfranco Cellai*¹, *Cristina Piselli*¹, *Fabio Sciurpi*¹, *Giuseppe Russo*², and *Eike D. Schmidt*²

Abstract. In museums, poor indoor air quality combined with unsuitable thermal and hygrometric conditions can affect the visitors and staff well-being as well as cause the deterioration processes of the exhibit objects. In order to assess indoor air quality of the museum, a survey was carried out in some rooms of the Uffizi Gallery of Florence by the researchers of the Laboratory of Environmental Physics of the University of Florence. Indoor temperature, relative humidity, chemical and microbiological pollutants were sampled, and the results analyzed and discussed. To do that a general methodology of investigation and evaluation of the results was defined and applied to several rooms of the Gallery. The presence of critical pollutant concentration was underlined and proper investigations on the HVAC system were scheduled. In this paper the results regarding a representative room are shown and discussed.

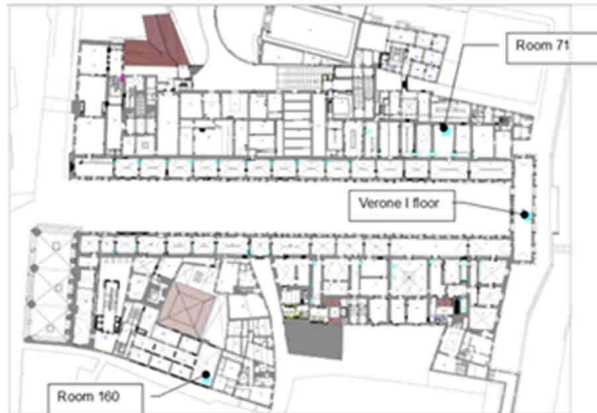
Fig. 2. First floor plan of the Uffizi Gallery indicating the analyzed rooms.

On the basis of the site inspection, and the indication of the technical staff of the Uffizi Gallery, the survey was conducted in some representative rooms. In Figure 2 and 3, the first and second floor plan of the Uffizi Gallery indicating the analyzed rooms are presented while in Table 1 the main characteristics of the analyzed rooms in the Uffizi Gallery are reported.

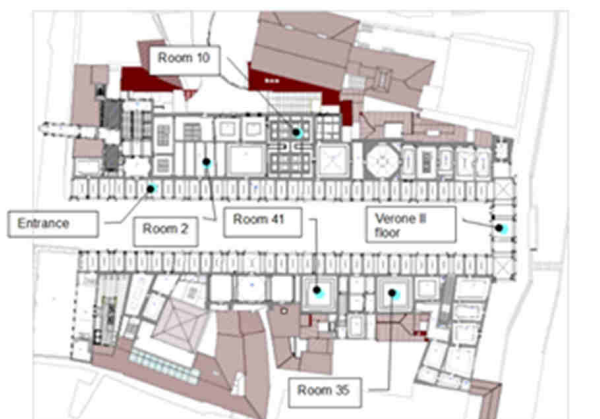
Fig. 3. Second floor plan of the Uffizi Gallery indicating the analyzed rooms.

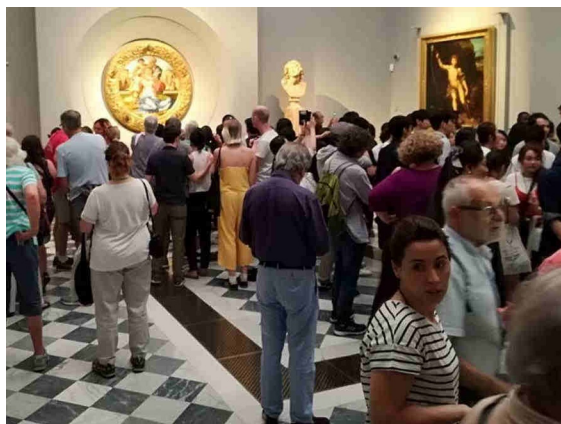
As concerns the air conditioning of the museum, different AHUs provide heating, ventilating, and air-conditioning in the different rooms, while some of the investigated rooms are non-provided with air conditioning. In particular, HVAC system for room 41 has a variable percentage of air recirculation both in winter and summer conditions with a nominal air flow rate of 10000 m³/h (Figure 4). Air inlet is provided by linear grids (in the upper part of the room near the skylight) while air outlet grids are built-in the floor (Figures

Fig. 6. Room 41: air outlet grids built-in the floor.

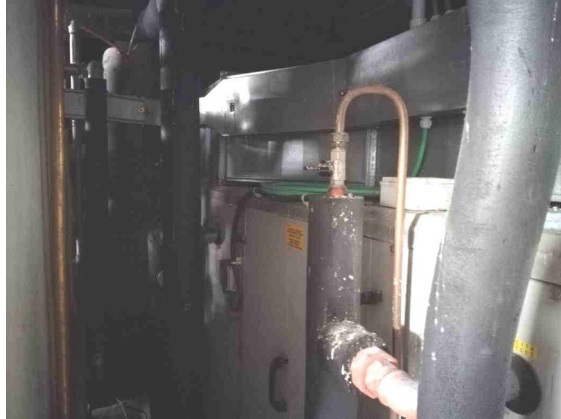
5 and 6). The AHU is located in a very narrow attic room and maintenance procedures can be particularly difficult (Figure 7).

Fig. 7. Room 41: AHU in the attic room.

Even if no pathogen was detected, indoor air quality in the museum can be improved thanks to better maintenance strategies of the building and with the improvement of hygienic maintenance procedures of the HVAC systems (ductwork, grids, filters, etc.).
