Construction of multi-layer geosynthetic containment systems to mitigate groundwater contamination

Kwasi Badu-Tweneboah^{1*}, *Ramil G. Mijares*¹, and *Kerem Esin*²

Abstract. This paper presents the construction of multi-layer geosynthetic containment systems as part of improvements to a stormwater management system to mitigate groundwater contamination at a coal combustion residual landfill in southeastern USA. The improvements consisted of lining the perimeter ditch and sedimentation pond to contain ash sediments and minimize infiltration into the groundwater. A composite liner comprised of HydroTurf synthetic turf system (i.e., a 1.5-mm thick high-density polyethylene (HDPE) textured geomembrane overlain by a synthetic turf that is covered with an infill/ballast material) underlain by a geosynthetic clay liner (GCL) was selected for the perimeter ditch. For the sedimentation pond, a 150-mm thick reinforced concrete layer underlain by a 1.5-mm thick HDPE textured geomembrane-GCL composite liner was selected to facilitate cleaning of the pond. The selection, construction, and lessons learned of the multi-layer geosynthetic containment systems are discussed.

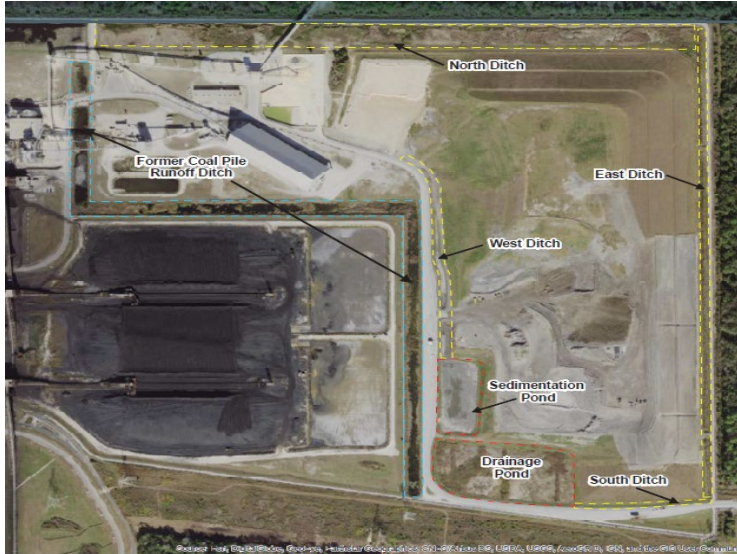
Fig. 1. Existing CCR landfill stormwater management system.

This paper presents the construction of multi-layer geosynthetic containment systems as part of improvements to a stormwater management system to mitigate groundwater contamination at a coal combustion residuals (CCR) landfill in southeastern USA. The CCR landfill was used for the disposal of CCR from electrical power generation operations of coal-fired steam units at the facility since 1982. As shown in Figure 1, the CCR landfill is bounded to the west, south, east, and north by unlined stormwater ditches and to the southwest by unlined sedimentation and drainage ponds connected to the stormwater ditches. Stormwater runoff management for the CCR landfill consists of procedures for sloping the ash as material is transferred and compacted, applying temporary and permanent cover as necessary, implementing erosion and sedimentation controls in the landfill interior, and the use of a stormwater retention and conveyance system to manage stormwater runoff from the CCR landfill. The existing West Ditch, which is one of the perimeter ditches, and Sedimentation Pond receive contact stormwater from the active face of the CCR landfill; this runoff is conveyed via culverts that connect to the existing Drainage Pond and ultimately to the other perimeter ditches (i.e., South, East, and North Ditches).

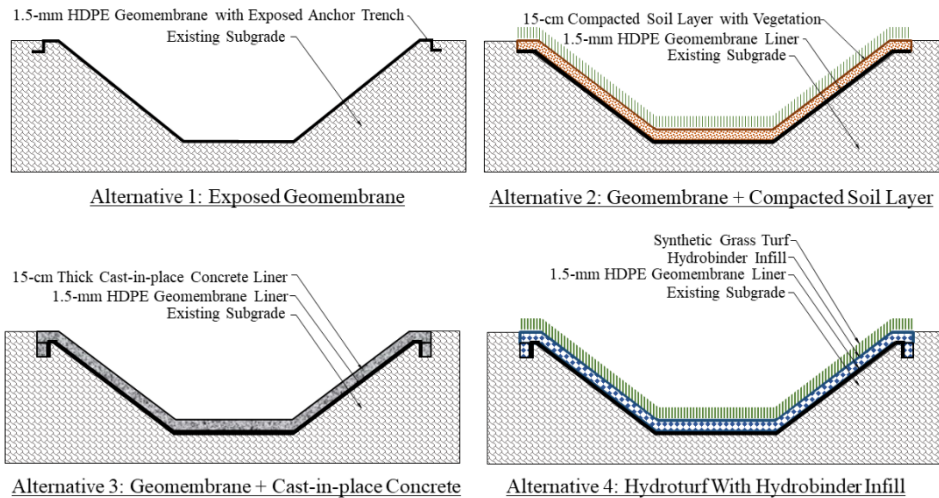
Fig. 2. Lining System Alternatives

The authors evaluated four conceptual improvement alternatives to the West Ditch and Sedimentation Pond to help reduce infiltration into the groundwater. Conceptual cross-sections for each alternative are provided in Figure 2. A geosynthetic clay liner (GCL) is placed below each liner concept to comply with internal guidance requirements for the facility. With the GCL underneath the geomembrane, all four alternatives function as composite liners with leakage rates due to advection significantly less than the leakage rates through single liners such as geomembrane liners alone or GCLs alone [1]. Due to the high groundwater table at the site, a geomembrane-backed GCL (i.e., a GCL with bentonite bonded to a geomembrane) was selected with the geomembrane side installed downwards in order to prevent premature hydration of the GCL from upward groundwater migration. Also, available laboratory data indicate that GCL is self-healing when wetted, dried, and rewetted [2, 3].

Alternative 1 – geomembrane-GCL composite liner with the 1.5-mm thick high-density polyethylene (HDPE) geomembrane exposed. This alternative was the least labor intensive

but would require frequent inspections for holes and other defects to assess the liner integrity especially following periodic cleaning/maintenance.

Alternative 2 – geomembrane-GCL composite liner overlain by 0.3-m thick compacted soil layer with vegetation. This alternative would require semi-annual vegetation management (e.g., mowing) as well as inspection and occasional replacement of the soil layer and/or vegetation.

Alternative 3 – geomembrane-GCL composite liner overlain by a 0.15-m thick cast-in-place concrete layer with reinforcement. This alternative would require visual inspection as well as occasional replacement of the concrete sections.

Alternative 4 – A HydroTurf-GCL composite liner with hydrobinder infill as a ballast. The HydroTurf system is comprised of a layer of a 1.5-mm thick HDPE textured geomembrane overlain by a synthetic turf that is covered with an infill/ballast material [4]. The infill for the HydroTurf system is a cementitious infill that gets hydrated after installation to create a layer that behaves like concrete. After hydration, the system exhibits strength behavior like concrete with hydraulic properties of a grassed channel. This concept would require visual inspection as well as occasional replacement of the HydroTurf sections.

Based on the evaluation, lining the West Ditch with the HydroTurf-GCL composite liner and the Sedimentation Pond with concrete underlain by the geomembrane-GCL composite liner would provide the improvements to the stormwater management system as part of the

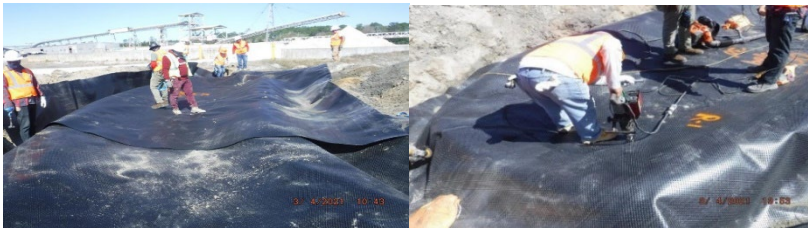
Fig. 5. Installation of the 1.25-mm thick geomembrane in the West Ditch.

Geomembrane: Installation of the 1.5-mm thick and 1.25-mm thick geomembranes included panel deployment, trial seams, production seaming, nondestructive seam testing, destructive seam sampling and testing of seams, and geomembrane repairs. These were monitored by CQA personnel to confirm compliance with the CQA Documents. Figures 5 and 6 show photos of the geomembrane installation in the West Ditch and Sedimentation Pond, respectively.

- **West Ditch:** For the 1.25-mm thick geomembrane installed in the West Ditch, two (2) fusion destructive seam samples were tested for a total seam length of approximately 275 linear m (lm).
- **Sedimentation Pond:** For the 1.5-mm thick geomembrane installed in the Sedimentation Pond, nine (9) fusion destructive seam samples were tested for a total seam length of

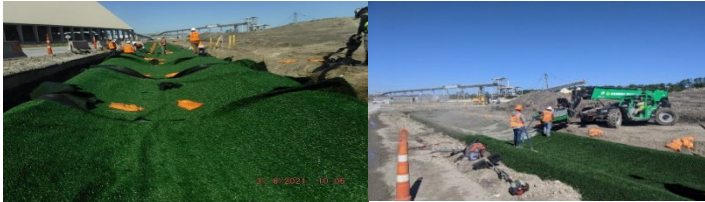
Fig. 7. Installation of synthetic turf and cementitious infill in the West Ditch.

Synthetic Turf System: CQA personnel monitored the installation of the synthetic turf and placement of cementitious infill and found them to be in compliance with the CQA Documents. Figure 7 shows photos of the installation of the synthetic turf and cementitious infill in the West Ditch. The infill was placed/spread using a top-dresser attached to a LGP equipment with dust control stationed on the outside of the West Ditch. During installation, water was applied with sprinklers to ensure appropriate hydration and curing of the cementitious infill. Thickness measurements were made to ensure that a 22-mm minimum dry thickness and a 19-mm minimum finished thickness after hydration were achieved, in accordance with the CQA Documents.
