# Research on the Strategy of Preservation and Utilization of Cultural Relics--Take the former site of the training institute for skilled workers in Nanman Army Arsenal as an example.

**ABSTRACT:** The former site of the Training Institute for Skilled Persons in Nanman Army Arsenal is located on the campus of Dadong Vocational College in Shenyang, and it is the fifth batch of cultural relics protection units announced by Shenyang. Firstly, this paper gives a brief introduction to the "old site" buildings, and then summarizes the existing diseases of cultural relics buildings by means of on-site investigation and engineering surveying and mapping. Adhering to the tenet of "utilization is the best protection", this paper focuses on the principles and strategies of protection and utilization of cultural relics buildings, so that cultural relics buildings can be well repaired and historical information and values can be better protected.

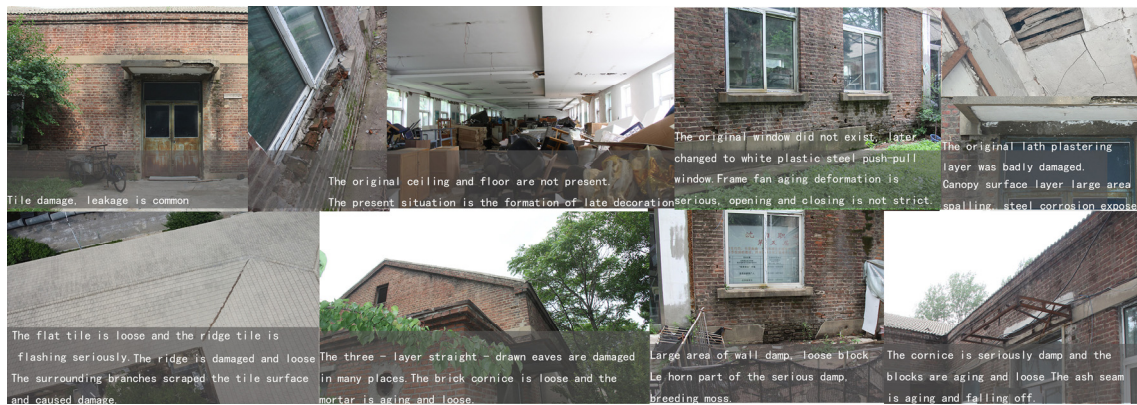
**Fig. 3. Disease of "old canteen"**

As shown in Figures 3 and 4, the two buildings have different degrees of damage on the roof, roof truss cornice, wall and floor strata (see Table 1 for specific diseases). There are many diseases in the "Old Auditorium", such as some external doors being blocked, the original windows being changed to doors, the current situation of the second-floor verandah on the south side of the building, the widespread cracking of the cantilever steel-concrete floor slab, beams and protective layers, and the corrosion of exposed steel bars. On the south side, the green space pavement and materials are aging, some paths are unreasonable, the current landscape pavilion needs to be repaired, and some branches, flowers, trees and lawns need to be trimmed.

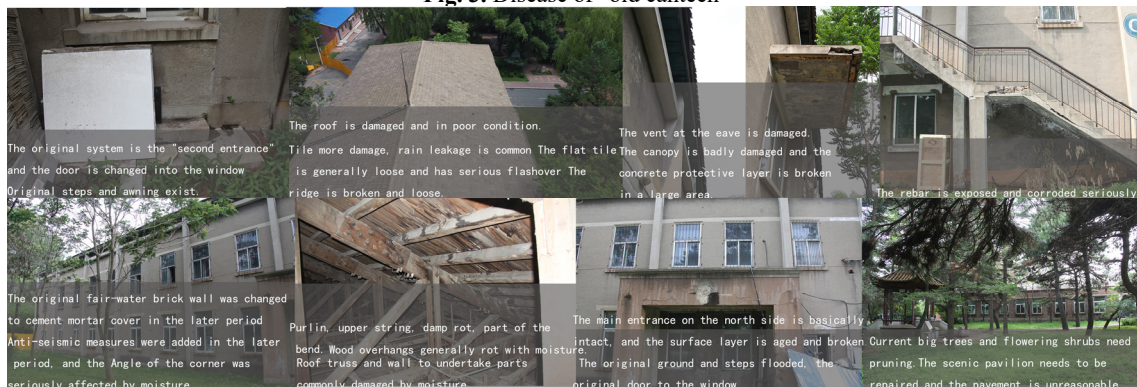
**Fig. 4. The current disease of "old auditorium"**

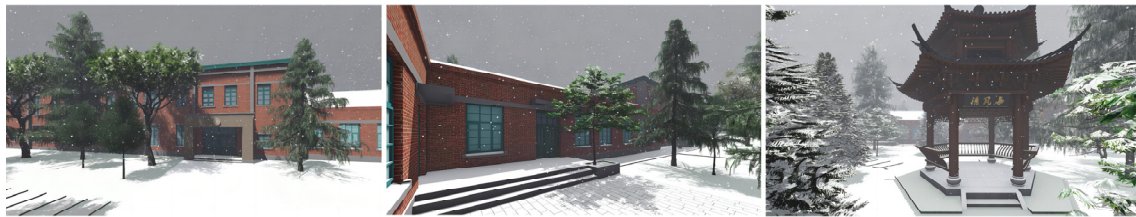
**Fig. 6.** External environment design

According to the summary of the above diseases, the study plans to renovate and transform the north and south green spaces of the "Old Auditorium" building. As shown in the graphic design of Figure 6 and Figure 8 on the left, keep and repair the landscape pavilion, protect valuable trees,

trim the lawn and flowers and shrubs in the garden, design and standardize the path in the garden, lay a trail centered on the landscape pavilion, as the main path, run through Wenwang Road on campus and the entrance to the south side of the building, add a green slate garden, walk along Yong Road, lay permeable bricks, keep the original main entrance on the north side of the building, and add a leisure platform in the venue to facilitate communication between teachers and students.

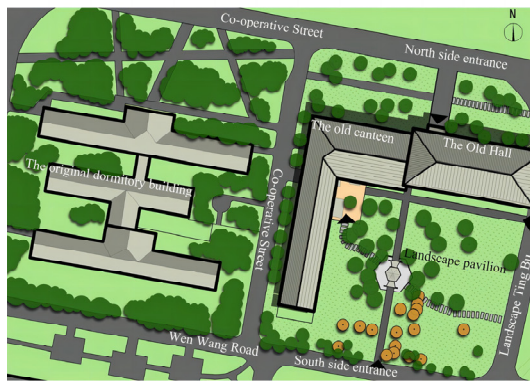
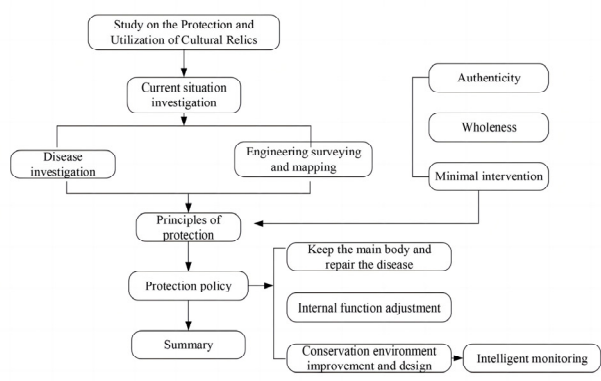
Fig. 8. Design and research route of external environment remediation
