Behaviour of a building foundation on unsaturated expansive soil

Abstract. The paper presents a case study of the behaviour of a building foundation on expansive unsaturated clay. The load-bearing masonry building started exhibiting severe cracking in its superstructure, immediately after its completion around 1950. Despite the interventions, the problems continued to exist sixty years later. In the context of identifying the causes of these problems, the paper presents the results of the laboratory tests conducted on the expansive clay in order to estimate its swelling pressure and also understand its behaviour. It is shown that the seasonal variation of the water content of the foundation soil, combined with the intrusion of the root system of the nearby trees at the level of the foundation, subjected the soil to wetting-drying cycles, resulting in its corresponding swelling-shrinking and consequently the settlement of the building. Finally, the proposed countermeasures for the solution of problems are presented, which aimed mainly in minimizing the variation of the moisture of the soil around and at the foundation of the building.

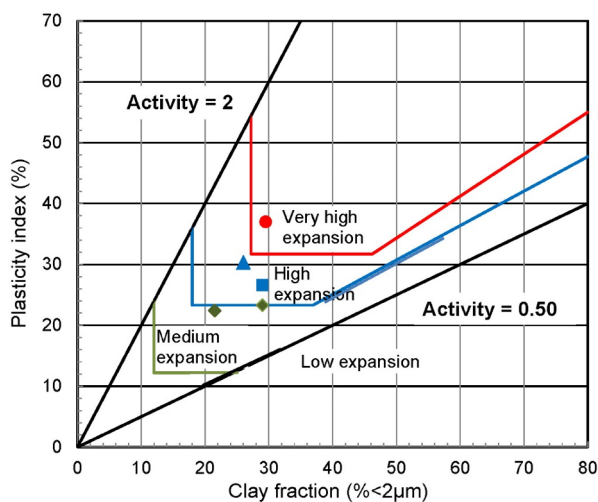
The physical properties of the samples retrieved from the upper volcanic tuff, summarized in Table 1, indicated that these were unsaturated soils of high to very high expansion potential, Fig. 3. Mineralogy analysis of a sample (T2-S1), obtained from a depth close to the foundation level of the underpinning in trial pit T2, showed that 52% of clay minerals were of the smectite type, characterized by high swelling/shrinking capacity.

Fig. 3. Expansion capacity of the samples taken from the upper volcanic tuff [6].

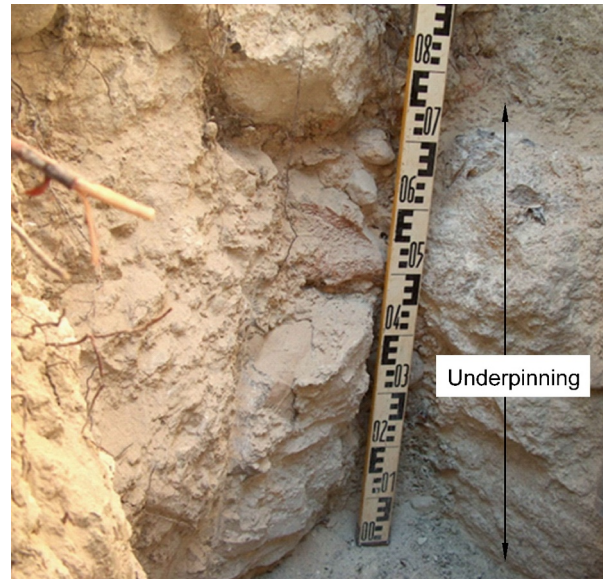
Moreover, inside trial pit T1 roots of the nearby cypress trees were found at the top of the upper volcanic tuff layer and the on the external surface of the masonry wall, probably intruding below it at its foundation level, Fig. 4. Inside trial pit T2, roots were found both inside the fill and the top 1m of the upper volcanic tuff layer and close to the foundation level of the underpinning, Fig. 5. In trial pit T3, an extended horizontal root system was found below the basement floor, Fig. 6.

Fig. 5. Soil profile in trial pit T2.

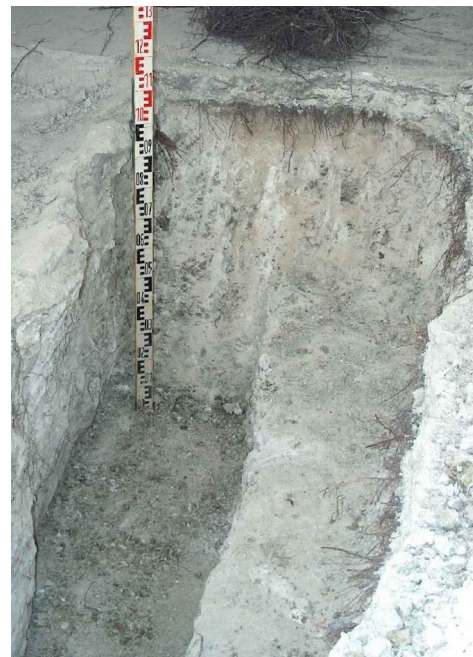
Fig. 6. Soil profile and roots system below the basement floor in trial pit T3.

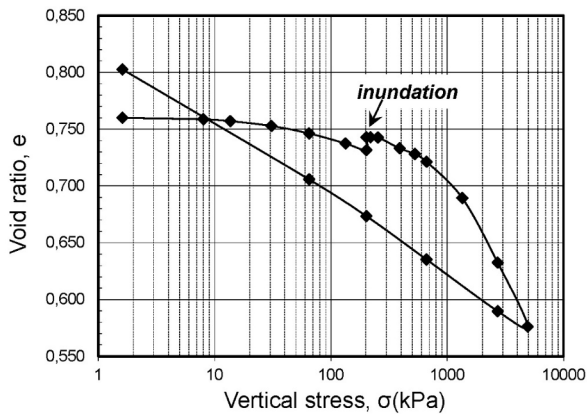
Three oedometer tests were conducted on undisturbed block sample from trial pit T2-S1. In Test 1, the specimen (D/H:6.35cm/1.92cm) was placed in the apparatus at its natural water content of 23% and loaded in steps up to 202kPa, without water in the oedometer external cell, Fig. 7. Then, the specimen was inundated for 144hr (6 days) until swelling was complete. The measured swelling corresponded to a vertical deformation of 1%. Afterwards, the typical loading (up to a maximum vertical stress of 4904kN/m²) /unloading sequence followed, with each loading/unloading step lasting 24hr.

Fig. 7. Test 1 on sample T2-S1 ($e_0=0.760$, $w_0=23\%$, $S_r=81.7\%$).

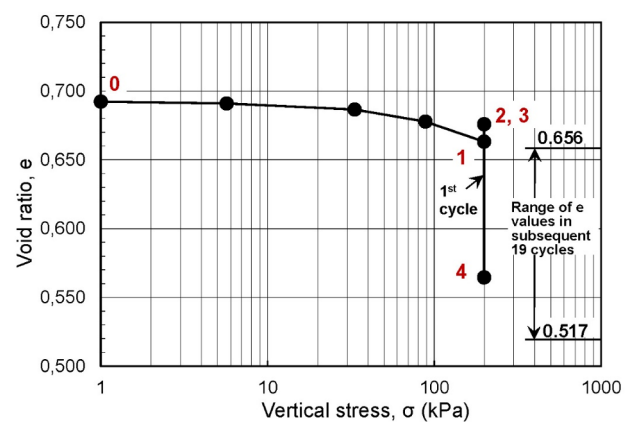
In Test 3, the specimen (D/H:5cm/2cm) was placed in the apparatus at its natural water content of 20.3% (Point 0) and loaded in steps up to 200kPa (Point 1), without water in the oedometer external cell, Fig. 9.

To simulate the cyclic alteration of wetting/drying periods, the specimen was inundated for 96hr (4 days) until full swelling. The measured swelling corresponded to a vertical deformation of 0.76%. Then the oedometer external cell was emptied from water (Point 2). This caused reduction of the specimen water content. For a period of 140hr (5 days and 20hr), after the water removal, no change of specimen height was observed (Point 3). However, then a compression of the specimen was observed for a period of 384hr (16 days). Afterwards, 19 swelling/wetting cycles, with a period ranging between 33 and 94 days approximately each, followed. During these cycles, the value of void ratio cycled between 0.656 and 0.517, and the vertical compression strain between 0.43% and 8.81%, Fig. 10.

Fig. 9. Test 3 on sample T2-S1 ($e_0=0.692$, $w_0=20.3\%$, $S_r=79.3\%$).
