Numerical Evaluation of Slope Stability based on Temporal Variation of Hydraulic Conductivity

Abstract. Slope failure is a common phenomenon all over the world on both man-made and natural slopes. Prolonged rainfall is one of the climatic factors which is largely responsible for slope failure. During heavy and prolonged rainfall, a part of the rainwater infiltrates through the soil and seeps into the slope. The infiltrated water lowers the matric suction and increases the porewater pressure. Eventually, the generated porewater pressure decreases the strength of the soil which results in slope failures. To evaluate the effect of rainwater seepage on slope stability, it is necessary to investigate the hydraulic conductivity of the slope soil. The objective of this study is to evaluate the effect of hydraulic conductivity on slope failure mechanisms. A finite element analysis of slope stability was conducted using Geo-Studio software. A numerical model was developed and calibrated with field monitoring data. The field monitoring data included the observation of hydraulic conductivity using a Guelph Permeameter. Afterward, the temporal variation of rainfall and hydraulic conductivity

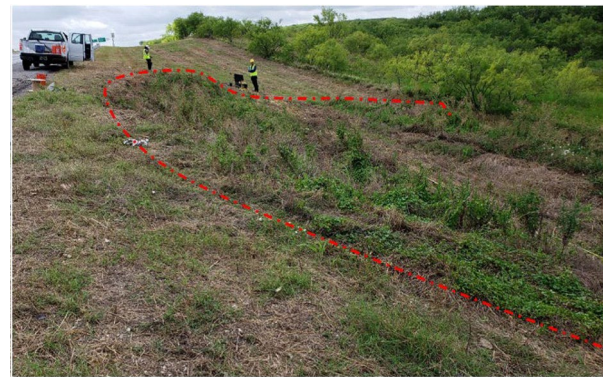
In this study, a field section located in Midlothian, Texas was selected (US-287). The selected 79.2 m (260 ft) long highway section was constructed over an embankment slope of 3H: 1V. The slope section underwent repetitive failures during its construction as shown in Fig. 1. The shoulder portion experienced numerous severe longitudinal edge cracks due to the downward slope movement or edge drop. After each failure incident, the slope was repaired.

Fig. 1. Site condition after failure in 2019.

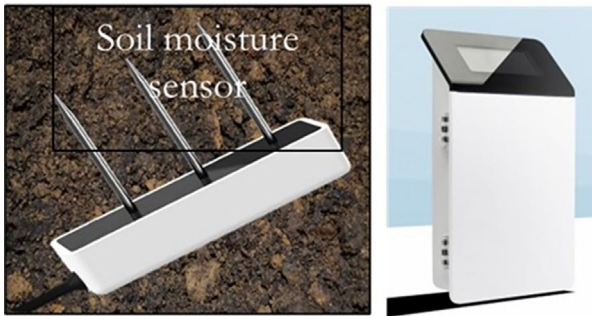
The test section was instrumented with the water potential and soil moisture sensors at 0.61m (2 ft), 2.1m (7 ft), and 3.1m (10 ft) depth (Fig. 2). In this study, TEROS 12 sensors (METER Group) were used to measure volumetric water content, and TEROS 21 (Fig. 3) Soil Water Potential sensors were used to measure the soil matric suction. For receiving and storing the field data, ZL6 model data loggers were used. The measurement interval was set to 60 minutes, which allowed for storing 24 data per day.

Fig. 3. Soil moisture sensor and data logger

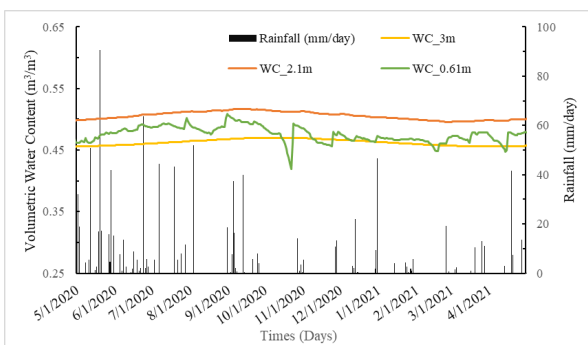
Fig. 4 shows the moisture sensor data of the slope. The initial moisture content values at 0.61m (2 ft), 2.1m (7 ft), and 3.1m (10 ft) depths were recorded at 44.4%, 52.1%, and 46.8%, respectively, which indicates that at the time of instrumentation, the soil's degree of saturation was similar. After initial adjustment, each sensor started showing different trends. The sensor at shallow depth (0.61m) fluctuated the most compared to the other two depths which had a noticeable coefficient of variation of 6.2%, whereas, the sensors at deeper depth (2.1m and 3.1m) had coefficients of variation of 1.27% and 1.0%, respectively. At shallow depths, the volumetric water content decreased after a series of dry days and increases suddenly after a series of rainfall.

Fig. 4. Change in Volumetric water content at different depths

The figures (Fig. 10) below represent the porewater pressure diagram at the end of each month. From Fig. 10 (a) to Fig. 10 (d), the seepage of water is shown over a period of one year. The porewater pressure profiles for 4 months are presented in the figures. The blue line in each figure represents the zero pressure line. Since the hydraulic conductivity becomes almost twice in the 3rd and 4th months as compared to the initial, the percolation of water is well observed in Fig. 4.

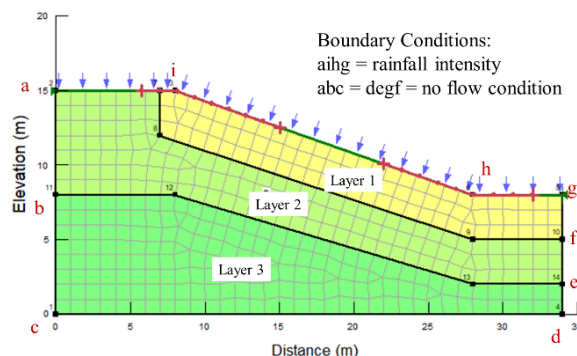
To begin with the modeling, first, a 2D model was developed using the boundary conditions as shown in Fig. 7. Three layers of the soil profile were considered where both sides had no flow condition, and the surface of the top layer was assigned rainfall intensity. Rainfall data were obtained from National Oceanic and Atmospheric Administration (NOAA) website. Then the model was calibrated with the field data. For modeling, 30% of the total rainfall was considered as 70% of the precipitation is considered as surface runoff [13].

Fig. 7. Numerical model developed using GeoStudio.

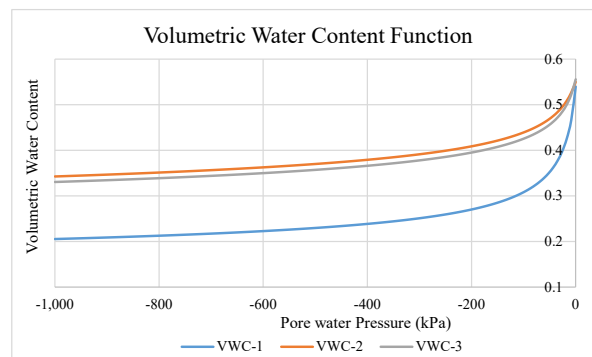
Using the SEEP/W module in GeoStudio, seepage analysis was performed. For three different layers, the considered volumetric water content functions are shown in Fig. 8. Using this volumetric water content function, the calibration was executed to compare the actual condition in the field with the current numerical analysis. The rainfall data and the volumetric water content from the sensors of January 2020 were calibrated and compared with the current seepage analysis. From Fig. 9, it was observed that the field data and the SEEP/W analysis data show a similar pattern. However, the differences in magnitudes in the field curve and the numerical curve are evident. This is due to crack propagation and evapotranspiration occurring in the field, which was not incorporated in numerical analyses. Nevertheless, the similarity in the pattern fulfills the requirement to simulate the field conditions.

Fig. 8. Volumetric water content function for three layers.

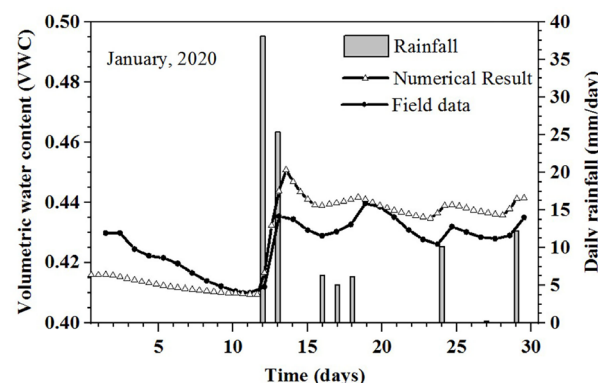
Fig. 9. Calibration of field data with numerical analysis.

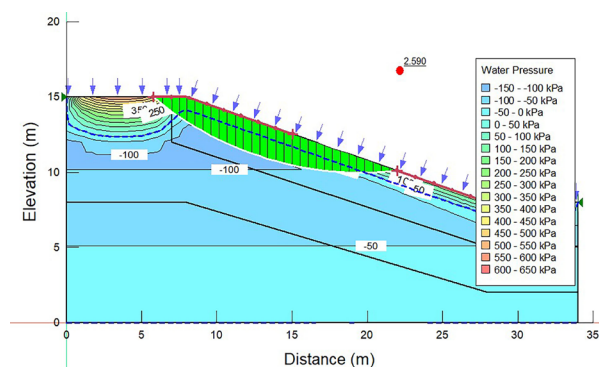
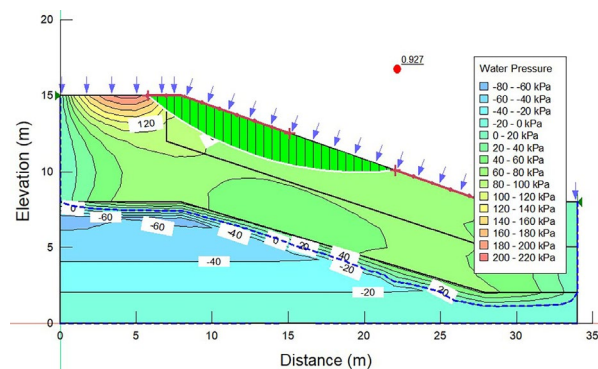
Fig. 10 (a). Porewater pressure diagram in May 2020.

Fig. 10 (b). Porewater pressure diagram in September 2020.

Fig. 10 (c). Porewater pressure diagram in December 2020.

Fig. 10 (d). Porewater pressure diagram in April 2021.

It can also be observed that the zero pressure line goes down gradually as water seeps slowly through the pore in the soil from May 2020 to November 2020. In December the drop is very significant. At the red-marked point, the porewater pressure increases from 20 kPa to 50 kPa which is an increment of almost 200%. From May 2020 to November 2020, this rate of increase was less than 70%. Later the hydraulic conductivity was estimated to be high, therefore, the porewater pressure was more than 20 kPa all across the slope section.

From day 120 to day 150 (September 2020) the hydraulic conductivity was very low and the amount of rainfall was not significant as in the other months, the factor of safety tends to increase. However, after September 2020, the hydraulic conductivity started to increase to 4×10^{-6} cm/s and water started seeping into the slope easily and generating high porewater pressure which eventually decreased the shear strength of the soil. Therefore, the factor of safety dropped below one, which indicates the failure of the slope. Furthermore, the depth of the critical failure surface was observed at 1.5-2m as shown in Fig. 10(c).

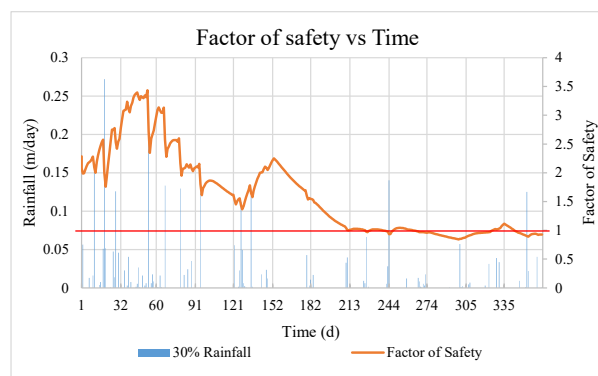
The major objective of this study was to determine the factor of safety of the slope and understand the rationalization of repetitive failure. From Fig. 11, the pattern of a slope failure (in terms of the factor of safety) can be explained.

For the initial 60 days, it was observed that the factor of safety increases almost 175% from 2 to 3.5. Initially, the water took time to seep through the pores since the hydraulic conductivity was very low in May and June 2020. However sudden drop was observed after a high-intensity rainfall. After 60 days, relatively higher hydraulic conductivity was estimated which was greater than the initial condition, The water started seeping through the soil easily compared to the previous condition, and accordingly, the drop in factor of safety was observed from day 60 to day 120. The factor of

safety decreased nearly 3 times during this period from 3.5 to 1.3.

Fig. 11. Change in factor of safety with time.
