# The importance of desiccation cracks in water migration inside expansive ground

**Abstract.** Highly plastic clays are generally regarded as very impermeable materials. However, it is well known that desiccation cracks, as well as inherent fissuring, increase the in-situ apparent permeability inside the active zone. The paper presents long-term measurements of matric suction and moisture sensors installed under a mat foundation, on the shaft of bored piles, and at the free field in expansive marls in area of Nicosia, Cyprus. The data reveal the ease with which rainwater percolates in the ground due to the presence of shrinkage cracks, especially adjacent to foundation elements. Several episodes of full saturation conditions are recorded under the mat close to its perimeter during the course of a hydrological year after significant rainfall events, even during the dry season. Moreover, rapid migration of rainwater along the gap forming between the soil and pile shaft during the dry season can lead to brief full saturation incidents down to at least 1.5m depth. Back-analysis of field wetting experiments using the finite element method indicates that the equivalent in-situ saturate

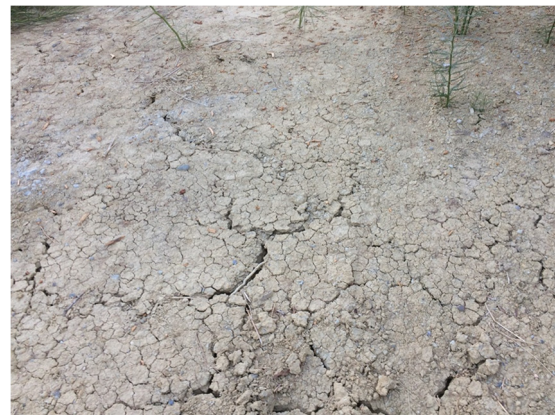
**Fig. 1.** Visible desiccation cracking at outcrop of very highly expansive Nicosia marl.

The two instrumented sites (named Site 1 and Site 3) are in the eastern part of the city of Nicosia, at locations where marl of high plasticity is outcropping. In both cases, the ground surface is excavated to create a level ground and remove any surficial topsoil. The soil profile down to 2m depth below finished grade at Site 1 consists of a 1m thick layer in which the marl has PI equal to 38 and clay content 43%, followed by a horizon in which the marl becomes more sandy and the PI drops to 25-32 and the clay content to 34%. The Nicosia marl at Site 3 is more clayey and less calcareous, with the clay content in the upper 2m of the soil profile being in the 45%-55% range and the PI in the 40-50 range. With these physical properties values, the marls at Site 3 as well as in the upper 1m of the ground profile at Site 1 are classified as very highly expansive according to the van der Merwe chart [8]. Fig. 1 shows the desiccation cracking on the free surface at Site 3 on September 2019.

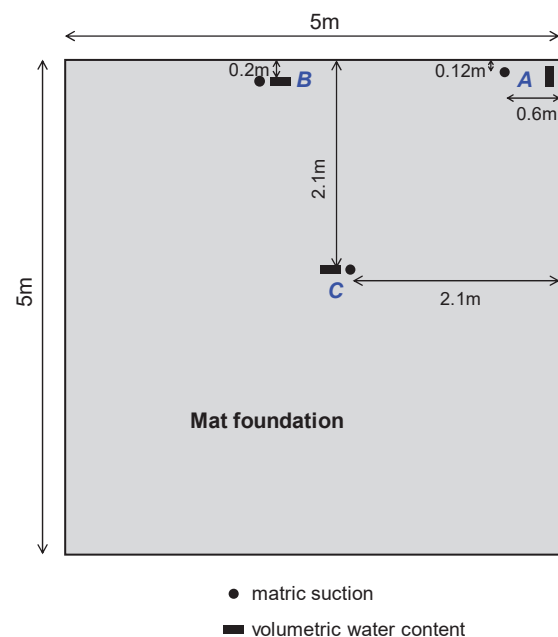
**Fig. 3.** Instrumentation of model mat at Site 1 (plan view).

A square mat foundation 5m wide and 0.4m thick was constructed at Site 1 at the end of July 2019. The concrete was poured in direct contact with the marl all-around (i.e. “neat” excavation). The top surface of the mat is 5cm below the finished ground surface. Before reinforcement and concrete placement, pairs of matric suction and volumetric water content sensors (TEROS 21 and TEROS 12) were installed at the bottom of the excavation at three locations (Fig. 3): mat corner (A), middle of mat edge (B) and near the mat center (C). The sensors are roughly at the same depth (0.5m) as the

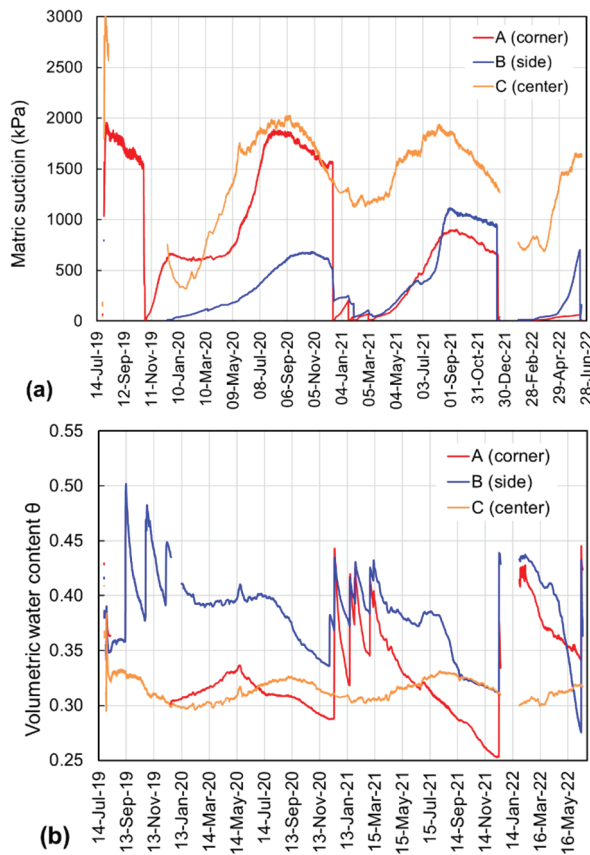
**Fig. 7.** Mat sensor measurements: a) matric suction, b) volumetric water content.

Fig. 7 presents the measurements of the sensors installed under the mat foundation. As expected, the sensors C near the center of the mat (at distance 2.1m from the mat edges) never reach a state of full saturation. Nevertheless, the seasonal fluctuation of matric suction is still significant, with the amplitude being of the order of 1.0-1.5MPa. Regarding the sensor pairs at the corner and at the side of the mat (A and B), there are several

episodes of near full saturation, more than those observed in the free field, happening shortly after episodes of daily rainfall larger than 16mm. This can be attributed mainly to the gap forming between the sides of the mat and the ground during the dry months.

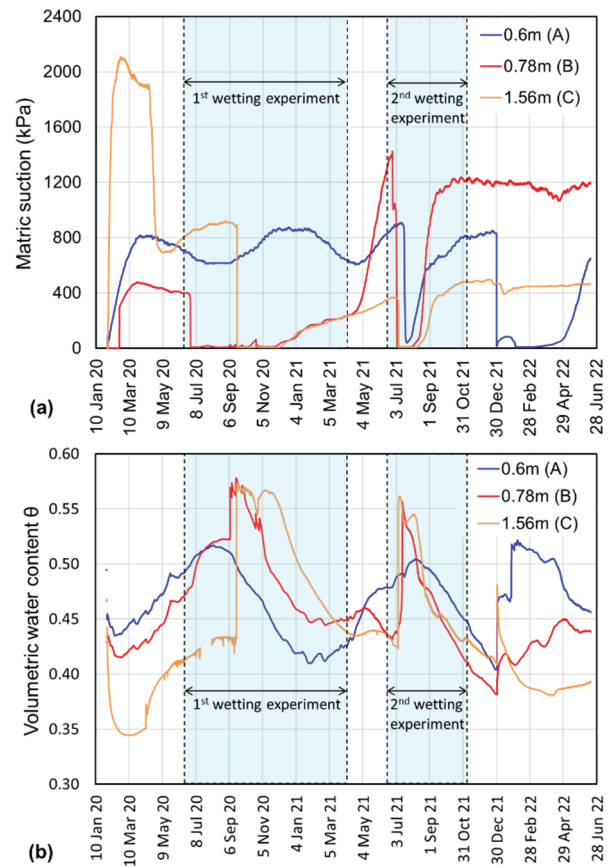
**Fig. 8.** Free-field sensor measurements at Site 3: a) matric suction, b) volumetric water content.

The free-field measurements at Site 3 are heavily influenced by the two wetting experiments that span most of the monitoring period. Unlike Site 1, full saturation incidents are not evident during the winter of 2019/20 (Fig. 8). Large and abrupt change in  $s$  and  $\theta$  are observed in the time histories in the winter 2021/22. However, they are not consistent with each other. For example, full saturation is detected by the matric suction sensor at 0.6m depth at the end of December but not by the corresponding water content sensor. Moreover,  $\theta$  at 1.56m depth exhibits a sharp peak while  $s$  drops only slightly. This is probably due to rainwater percolation through cracks that formed irregularly during the desaturation and recovery of swelling that followed the wetting experiments.

on the regime in the matrix of the soil. Finally, the data also demonstrate that the matric suction values in this very highly plastic marl (PI=40-50) can be in excess of 2MPa even at 1.3-1.6m depth (Figs. 8,9).

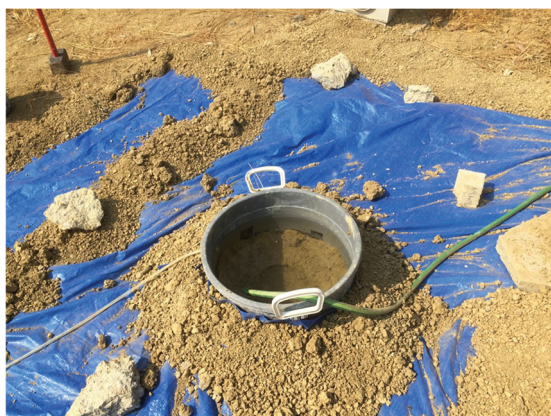
**Fig. 10.** Field wetting experiment setup at Site 3.

In order to establish the in-situ equivalent permeability of the marl, field wetting experiments were conducted at the two experimental sites. Ground wetting was done through a cylindrical drum that was placed directly above the location of the sensor pairs B and C (Fig. 2), i.e. the pairs that lie on the same vertical axis at two different depths. The drum was supplied with water from a large tank and the water level inside the drum was kept at a constant level with the help of an overflow outlet (Fig. 10). To prevent leakage at the contact between the drum and the soil, the drum was placed at a depth of a few centimeters from the ground surface in a notch filled with marl putty and additional soil was subsequently placed around the drum walls. An area 2m × 2m around the drum was covered with plastic sheets in order to minimize evaporation of water from the ground to the atmosphere or infiltration of rainwater.

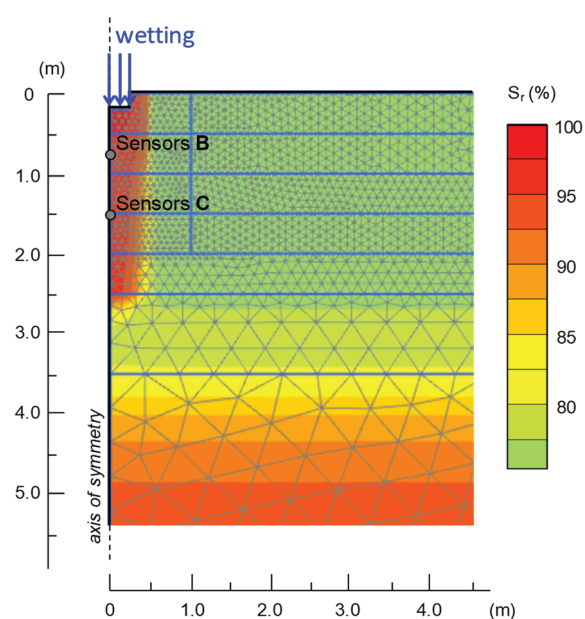
**Fig. 11.** Contours of degree of saturation at the end of the wetting phase from simulation of the experiment at Site 3.

Fig. 11 shows contours of the degree of saturation ( $S_r$ ) at the end of the wetting phase from a simulation of the wetting experiment at Site 3 that best fits the sensor recordings. It can be seen that the saturation bulb is quite narrow. Fig. 12 plots the profile of back-calculated values of equivalent  $k_{y,sat}$ . The  $k_{y,sat}$  near the ground surface turns out to be 4000 (Site 1) and 6000 times (Site 3) larger than that measured in the laboratory on intact samples, a finding that can be attributed to the dense network of wide desiccation cracks observed near the ground surface for these very highly expansive marls.
