Ecological and engineering solutions for the reconstruction of anti-mudflow hydraulic structures of the Crimea

Abstract. The article studies the territorial features of the formation of a dangerous process - mudflows. The factors of mudflow hazard formation are described, the classification and characteristics of mudflows formed in the Crimea are given. The methods of studying mudflows are considered, the parameters of the mudflow are calculated on the example of the Shelen River, on the basis of which options for the reconstruction of existing mudflow protection structures are proposed. The purpose of the article is to substantiate environmental engineering solutions for the reconstruction of anti-mudflow hydraulic structures in mudflow-prone Crimean river basins. The object of research is the basin of the Shelen River typical for the South-Eastern rural area. The purpose of the research is to substantiate technical solutions for the reconstruction of anti-mudflow structures in the Shelen River basin. Research objectives: to study the conditions for the formation of Crimean mudflows, the history of research and classification; consider existing methods for studying mudflow hazard

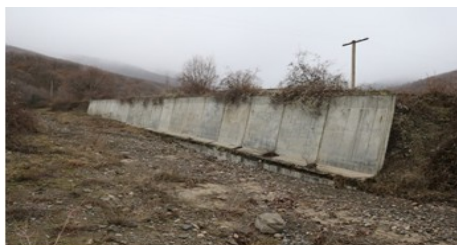
Fig. 2. The current state of the cantilever retaining wall p. Gromovka.

- Thin-walled gravity (corner) cantilever retaining wall. The walls are made of monolithic reinforced concrete on a natural base. Length 1.5 m, width 0.25 m, height 2.5 m (Figure 2).
- Retaining wall of rock fragments and bonding material. The shape of the wall is stepped, consisting of three rises. The width of the steps is 0.4 m. The width of the wall is 1.2 m, the height is 2.2 m (Figure 3).
- Retaining wall made of blocks fastened with mortar. The blocks were set on a foundation, which was made of stone and mortar. Block parameters: length 0.6 m, width 0.2 m, height 0.2 m (Figure 4).

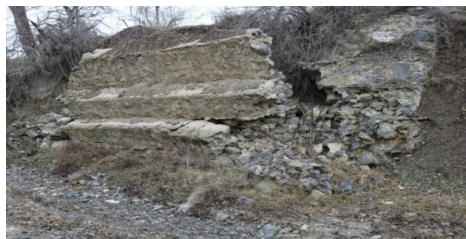
Fig. 3. Retaining wall made of rock fragments of the Shelen River.

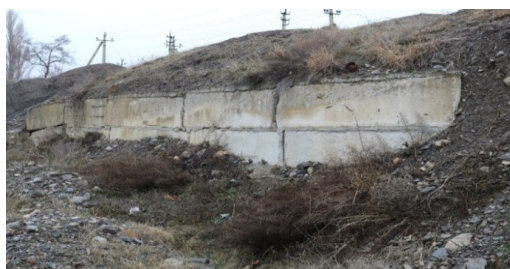
Fig. 4. Block retaining wall on the banks of the Shelen River.
