Ground Improvement of Dhu Al-Kifil Minaret Using Micropile and Cement Grouting

Abstract. The Minaret of Dhu Al-Kifil Nabi (PBUH), located in the city of Kifil with a height of about 25 meters, is one of the historical monuments of Iraq. The 4.5 degree deviation of this Minaret has become a challenge for authorities in recent years. Various reasons, such as the old age of the building and manipulation of the soil of the minaret bed, damage the structure and have caused it to deviate from the vertical direction and form cracks at its height. A temporary metal retaining structure is currently constructed on the site to maintain the building in its current state. Still, in order to remove it and repair the body and foundation of the Minaret, the designs have been carried out by Iranian engineering groups. After that, its strengthening operations have also finished. In this article, after the introduction of the project, the analytical and numerical results of the bed improvement plan using the combination of inclined and vertical micropiles are presented. Finally, the reliability of the plan in controlling the heterogeneous settlement of the Minaret is assessed.

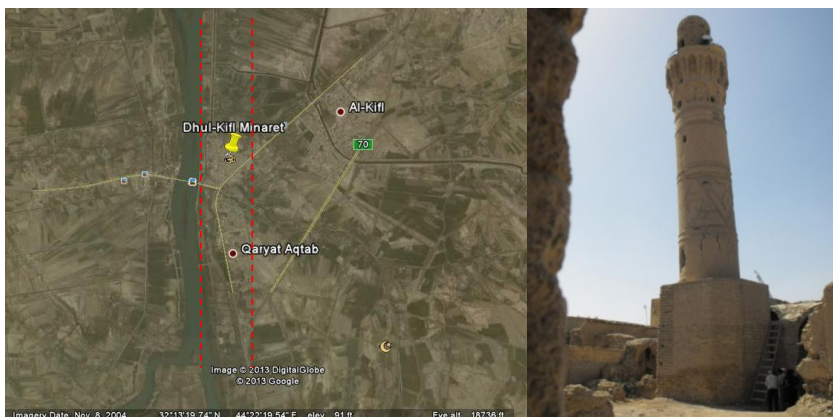
Figure 1: Site location and a view of Minaret.

Among the characteristics of the studied masonry minaret are the 6-meter height of the base with a square section, the 14.5 m body of the Minaret with a circular section, and the head of the Minaret with a height of 4.10 meters (Figure 1). In the past decades, because of unknown reasons such as the passage of time, the age and archaism of the building, and manipulation of soil, deviations from the vertical direction have appeared in the height of the Minaret, which has caused serious concern among the residents and authorities. However, the exact time of the beginning of deviation movements in the Minaret has not yet been revealed to the researchers. Based on the studies conducted in the past years on the Minaret, two reports were published by Iraqi universities. In 1998, the Idrisi Center of the Ministry of Construction of Iraq declared the deviation of the Minaret to be 3.5 degrees. In 2008, the Engineering Consulting Center of Al-Qadisiya University announced a deviation of 4.56 degrees (Figure 2). For this reason, the management of the complex (Diwan Waqf Shia) decided to stabilize the Minaret to stop this deviation. For this purpose, steel elements were added to the Minaret in 2010. It believes that creating such a protective structure to prevent further deviation of the Minaret was considered a suitable solution. However, its implementation with such materials and in these dimensions has created many problems for the study and access to the Minaret (Figure 2).

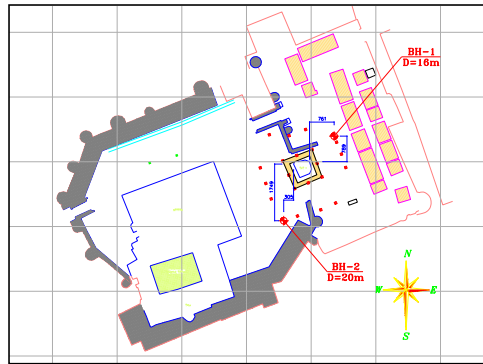
Figure 3: The location of exploratory boreholes in the studied site.

To evaluate the geotechnical conditions of the site, two mechanical boreholes were drilled in the closest possible places to the Minaret, and disturbed and undisturbed samples were taken from the site (Figure 3) to perform the required laboratory tests on them (physical, mechanical and chemical tests). Moreover, field tests (standard SPT penetration, etc.) were also conducted in the mentioned boreholes. It should be noted that the

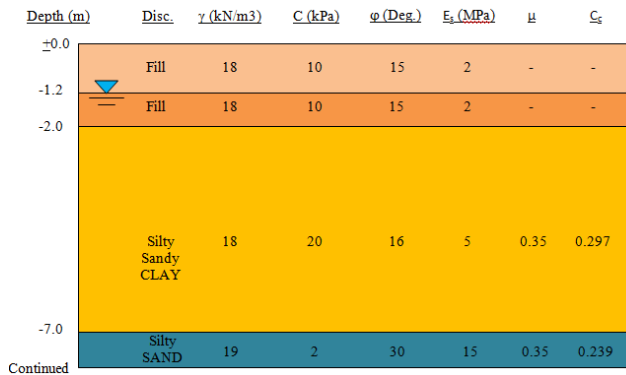
Figure 4: Assessed geotechnical profile of the site.

metal protective structure was an obstacle to access and made the exploration operation difficult. A summary of subsurface soil parameters is presented in Figure 4. One of the most important issues that was evaluated during the study was determining the shape and dimensions of the foundation of the historical Minaret. The various test pit which was digged around the foundation provided appropriate information for the dimensions of the foundation shown in Figure 5.

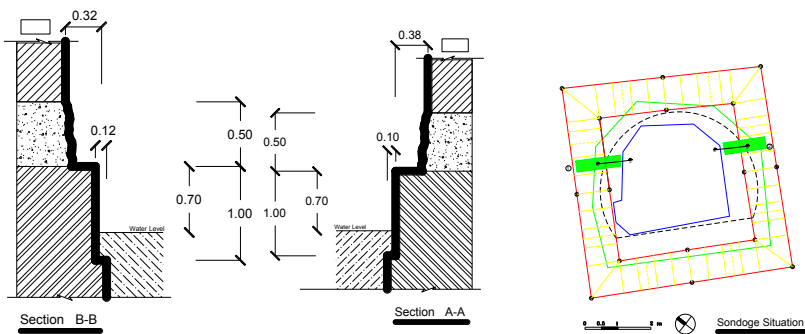
Figure 5: Sections and plans of the minaret foundation.

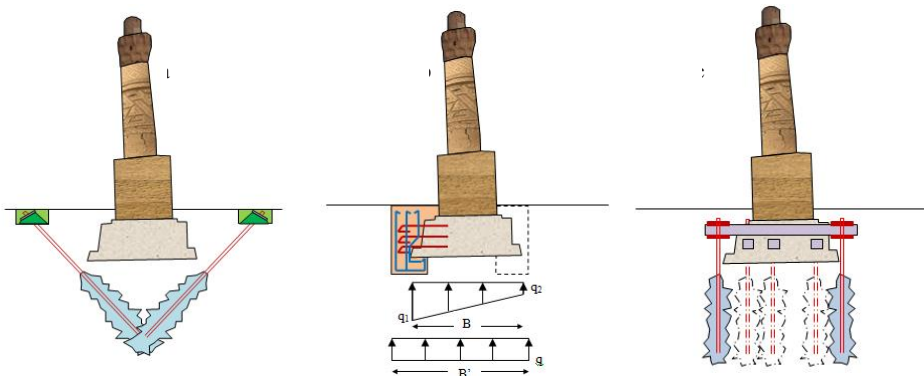
Figure 6: Conceptual proposals for strengthening the foundation and improving subsurface soil a) Injection of slurry in weak soil layers, b) Increasing the dimensions of the foundation, c) Combination of vertical micropile and bearing beam.

The above cases and observations indicate that with the current conditions, rupture has probably occurred in the soil, and plastic deformations have continued. If no action is taken to strengthen the foundation, the Minaret will fall and be destroyed without a protective structure. Conceptual proposals for strengthening the foundation and improving subsurface soil as shown in Figure 6. Generally, bearing problems of the minaret ground can be listed according to the following:

- Increasing the foundation's bearing capacity by increasing the foundation's dimensions.
- Increasing the bearing capacity of the bed soil by using cement slurry injection.
- Transferring part of the structure's load to the strong layer of the underlying soil using vertical micropiles.

According to the evaluation steps described in Table 1, and regarding the advantages of the above-mentioned methods, the final plan was considered using a combination of the three methods mentioned earlier (Figure 6). In this design, in addition to using vertical micropiles to increase the bearing capacity of the foundation, it was also used to increase the dimensions of the foundation around the brick foundation, which helps to increase the integrity of micropiles in settlement control. Diagonal micropiles were also used to inject limited points under the foundation to improve its geotechnical parameters (Figure 8). In the following, the results of the analyses and evaluations are presented.

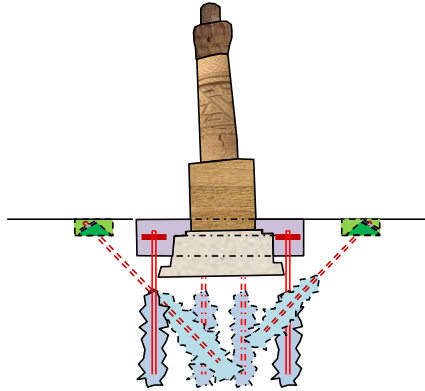
Figure 8: Schematic cross-section of the final design to improve the ground and strengthen the Minaret of Dhu Al-Kifil.

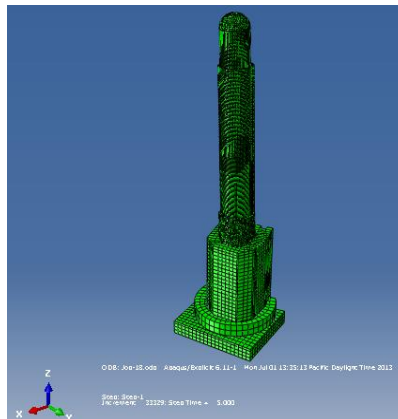
Figure 9: A view of the model made using the ABAQUS software.

As it was mentioned in the previous section, a remote beam (or foundation) was used to strengthen the foot of the Minaret. To strengthen the body of the Minaret, a concrete shell was designed. The task of this concrete shell is to control the twist created in the Minaret because of the deviation from the vertical direction and to create balance in its behavior. After passing over the bottom pedestal, this shell is finally connected to the foot of the bottom pedestal. In the relevant analysis, the structure working group used the powerful finite element program ABAQUS (Figure 9).

In the modeling mentioned above, the staged construction scenario includes the following steps:

- a) Applying the load of the entire minaret structure to the soil.

- b) Strengthening the body of the Minaret, removing the existing metal protective structure, and applying the anchor because of deviation from the vertical direction.
- c) Creating micropiles transfers the load from the reinforcement structure to the lower part and applies deformation, which is likely to happen in the future.

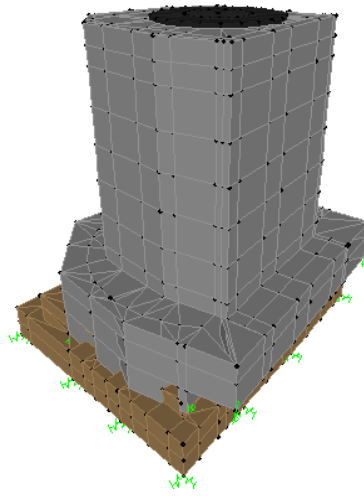
Figure 10: Modeling of the lower part of the Minaret with the SAP finite element software.

To speed up the selection of the right arrangement of vertical micropiles, because of the time-consuming of the three-dimensional analyzes of the ABAQUS program, it was decided that the outputs of this software were transferred to the SAP software at the location of the minaret seat body. Then, by trial and error, choose the right arrangement of vertical micropiles. For this purpose, a model, according to Figure 10, was developed in the SAP software and was subjected to phased construction analysis in the above-mentioned method. After improvement, the amount of deformation in the soil is limited to 1.5 cm. The stress in the soil is also limited to less than 0.6 kg/cm² (Figure 11). It should be noted that the mentioned values have been obtained according to the choice of 1500-2000 kN/m³ for the modulus of the soil bed and the arrangement of vertical micropiles, so the requirement to achieve such a bed modulus is to use the injection method in the soil under the brick foundation.

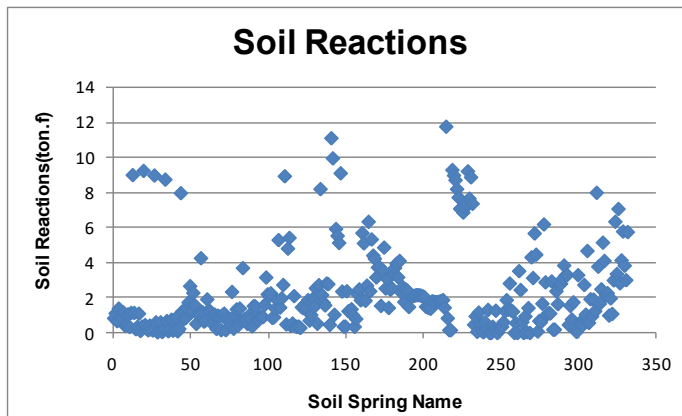
Figure 11: Soil reaction and deformation results based on the SAP finite element software outputs.

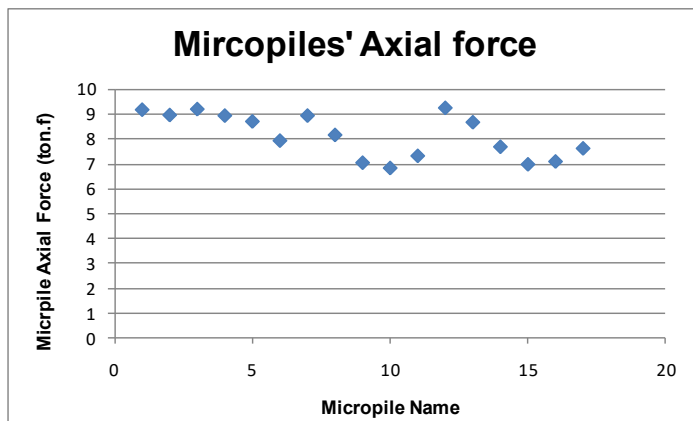
Figure 12: Axial force results in micropiles under stepwise loading without coefficient-program output.

Vertical micropiles were modeled using spring elements in SAP program, and their vertical stiffness was considered equal to 75-100 tons force/cm. The output of the forces generated in the micropiles at the end of the analysis is according to Figure 12. As it can be seen, the maximum forces generated are around 10 tons with a load factor of 1, and in their design, geotechnical, structural, and punch control considerations were made based on the recommendations of FHWA-SA97-070. The vertical deformation of the mentioned micropiles is limited to 0.1 cm because of the aforementioned hardness value. The final design that was used to improve the foundation of the Minaret is shown in Figure 13. This plan includes the implementation of vertical micropiles with a length of 9 meters and injection through diagonal micropiles with lengths of 6 meters and 9 meters (with an angle of 45 degrees) at the closest distance to the Minaret.

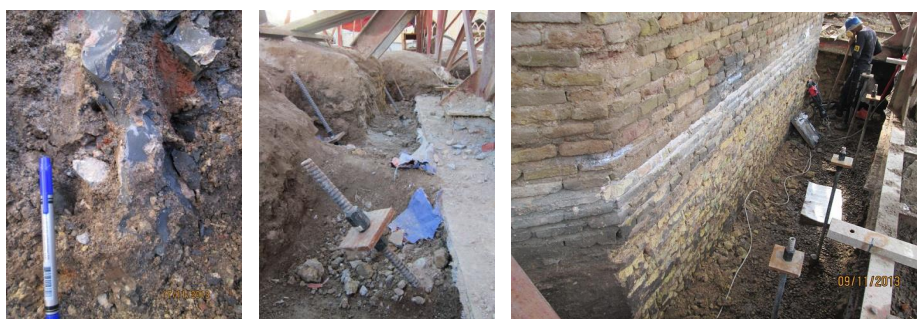
Figure 14: Views of the vertical and inclined micropiles implemented near the seat of the Minaret of Dhu Al-Kifil Nabi (PBUH) along with the size of the injected area.

It should be noted that access and logistic restrictions made it difficult to choose the right place to implement the aforementioned micropiles. To achieve a higher degree of safety and more uniform performance of micropiles, increasing the dimensions of the minaret foundation, which has the role of CAP for micropiles, was also included in the construction plan. Figure 14 presents views of the implementation of vertical micropiles drilled in the vicinity of the Minaret of Dhu Al-Kifil Nabi (PBUH).
