Experimental Studies on the Fire Flame Behavior of Reinforced Concrete Beams with Construction Joints

Abstract. This study was experimentally investigated experimentally, investigating the effect of such mechanical properties and deflection behavior on the performance of reinforced concrete beams with construction joints exposed to fire flame. These beams were built using a slanted connection at a 45° angle in the middle of the beams. Four beams were for a wide temperature range (25–800°C) for the fire flames used on the concrete beams. Two temperature levels (600°C and 800°C) were chosen, with (1 and 2) hrs. period time, respectively. One beam wasn't burnt (Reference specimen). When put through a fire, flexural strength drastically decreased. The experimental program's results suggested the worst effect on construction joint beam for temperature 800°C with 2 hrs. period time because that heating reduces the bonds between two surfaces in the joint and makes like slip and disconnect between the joint after exposure to load. After 1 and 2 hours in a fire at 600°C, the residual flexural strength was 85% and 72%, respectively, whereas, after 1 and 2 hours in a fire at 800°C, it was 41

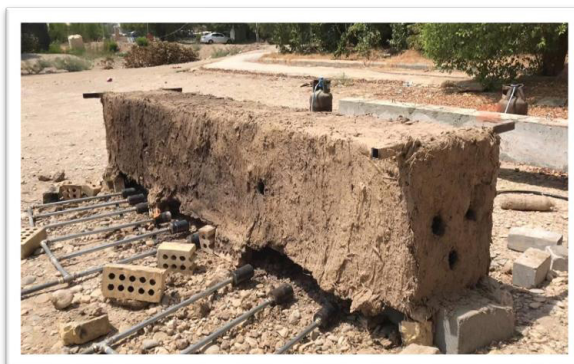
Figure 2: The furnace.

To burn one specimen at a time, the furnace was constructed from a 3 mm thick steel plate in the configuration of two L-shapes or beam covers (see Figure 2). From the fire sources, to get to the fire flame (high temperature), the inner clear area was 500 mm in height, 500 mm in width, and 3000 mm in length, which matched the proportions of the concrete beam (nozzle). All 18 of the beam's nozzles fired off at the same instant.

Four beams were burned by fire at two temperature levels (600 and 800°C) for one and two hours, respectively. The furnace was covered with mud insulation to preserve the high temperature within attaining the desired temperature. The fire was extinguished after this time. The specimen was progressively cooled by keeping it in the air after the furnace case was removed. This study's experimental effort included analyzing

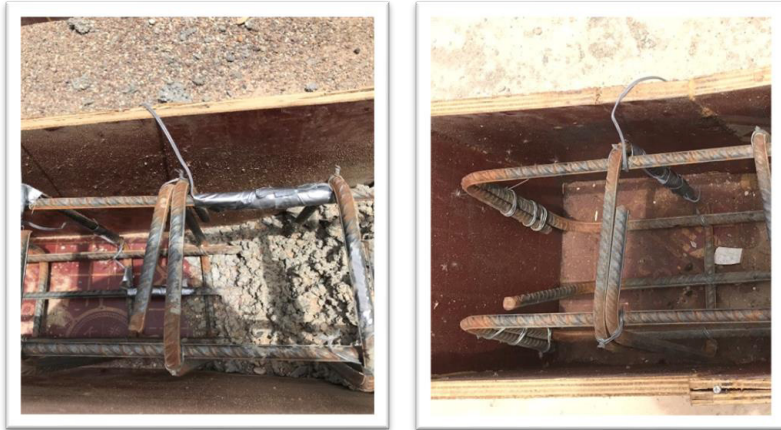
Figure 3: Locations of the steel strain gauge.

several variables such as strain, deflection, and load capacity utilizing measurement equipment. Three 5 mm strain gauges were installed on the reinforcing steel bars of the unburned beam, as shown in Figure 3. One strain gauge was placed in the center of the main reinforcement, another in the center of the top reinforcement, and the last one on the first stirrup. Figure 4 shows the location of the concrete strain gauge of 60 mm, which was placed in the center of the beam on the compression extreme sides. The strain gauges were connected to a data logger, which recorded the strains per second, as illustrated in Figure 5. The beams were tested in a load-control protocol and subjected to monotonic increasing loading until failure. The beams were loaded using a hydraulic jack with a capacity of 1000 kN, as indicated in Figure 6. The applied load was measured using a load cell with a 500 kN loading capacity. Vertical deflection at mid-span was measured using LVDT. The length of LVDT was 150 mm, as shown. Figure 7 presents the test setup utilized in this experiment. Figure 8 shows a thermocouple sensor wire attached to a digital thermometer reading.

A. Top and bottom steel strain

B. stirrup steel strain

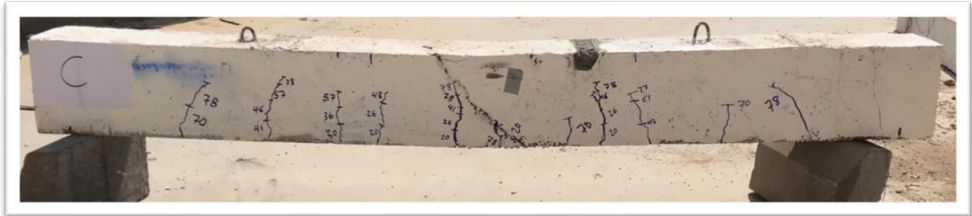
Figure 16: Cracks pattern for specimen (C).

All of the burned beams had a flexural failure. Cracks have appeared on all sides of the beams, which grew from the fire cracks. The cracks were noticed on the specimens' side faces. The crack pattern for the burned specimens is shown in Figures 16 to 20. The control beam C (without burn) failed in flexural mode due to the yielding of the bottom reinforcement, as evidenced by the visible large cracks at the beam mid-zone near the failure load with increasing deformation at the same applied load, as well as the visible permanent deformation after removing the applied load. Initially, there were flexural fractures along the bottom of the beam when the applied load was around 20 kN. Some of these flexural cracks in the intermediate zone of the beam progressed toward the beam's compression zone. Figure 16 depicts the failure of the beam at a total applied load of 86.4 kN. As the applied load rose, new cracks occurred throughout the beam and widened and propagated until the beam failed C.

- Two types of cracks formed when the beams were exposed to fire. The first was thermal cracking, which occurred all over the surface in a honeycomb pattern. The second kind of crack, known as flexural cracks, formed in the mid-span area due to bending caused by the applied stress, making burnt beams weak.

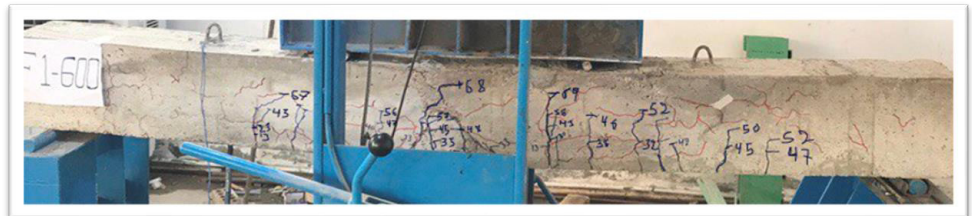
Figure 17: Cracks pattern for the specimen (F1-600).

The beams experienced cracks before the static load was applied due to the burning and cooling processes. Therefore, it was challenging to tell the new cracks apart. Beam F1/F2 -600 burned for one and two hours at a temperature of 600°C. These beams behaved the same way during the initial stages of loading, but as the applied load reached nearly 13 kN for beam F1-600 and 14 kN for beam F2-600, the cracks grew wider and spread, leading to failure of the beams at loadings of 72 and 61 kN, respectively, which illustrated in Figures 17 and 18. Significant deterioration was noticed in specimen F2-800, where cracks emerge and the concrete surface spalls, particularly close to the corners. Consequently, when the beam was tested under static load, it was very difficult to tell when new cracks formed from those caused by burning and cooling. However, when the applied load was 10 and 4 kN for the beams, which reached 800°C for 1 hour and 800°C for 2 hours, respectively, the cracks grew upward, propagated, and became wider until failure occurred at loads of 35.9 and 24.9 kN, respectively according to Figures 19 and 20, for beams burnt at 800°C.
