Behavior of Damaged Continuous Reinforced Concrete Beams Repaired by CFRP Sheets

Abstract. Despite the widespread use of RC continuous beams, the performance of these beams, when repaired via Fiber Reinforced Polymer (FRP) composite material, has received less attention. Furthermore, several features of the flexural aspect of repaired RC continuous beams still demand experimental and analytical evaluation. However, many anchoring methods have been developed to delay premature failure in the RC beams, which are strengthened with FRP composite materials. The plan of this experimental study consists of eight continuous beams cast with dimensions (150*250*2800) mm considering the length of the clear span is 1300mm. Except for one, all specimens were attached via Carbon FRP sheets about 70% of the span length in negative and positive moment zones beyond a predetermined damage level. Moreover, this study suggested modifying the end-anchor technique and adding CFRP layers with (45, 65, and 95) % as damage ratios. According to the results, the optimal percentage of restored ultimate capacity was 108.8% with peeling-off concrete cover failure mode, which was obtained from using an end-anch

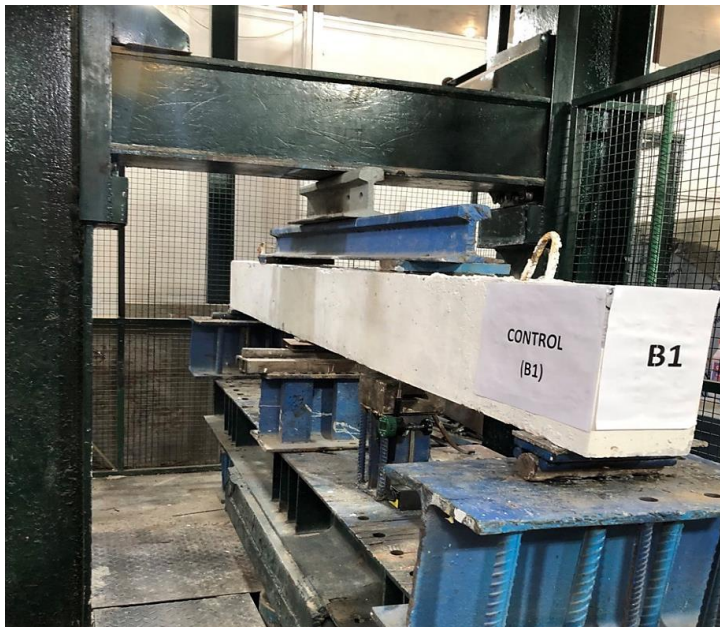
Figure 4: Control under the compression hydraulic machine.

As for the testing continuous beam, it is shown in Figure 4. The type of support was a roller, and the loading was contributed through two metal plates.

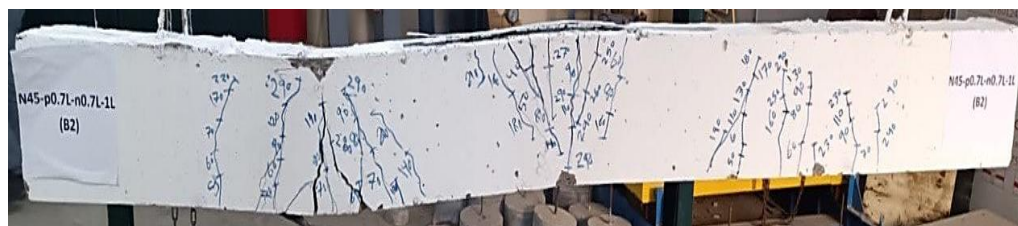
Figure 6: Map of cracks for N45-p0.7L-n0.7L-1L

The external bonding of the CFRP sheet in this beam was equal to 0.7L for both negative and positive zones with one layer with a preloading ratio of 45%. At the second tested stage, it can be observed that when the applied load increased, there were a series of small shear cracks through the side view of the beam. Compared with the reference beam, 101.7% of the capacity was restored when the mentioned repairing configuration was adopted. Also, it was capable of withstanding load failure 290 kN. From the map of crack propagation in Figure 6, it can be observed the first crack appeared at 13.8% of the ultimate load in the region of maximum moments. Furthermore, some cracks began to become clear with an angle of more than 45°, but then they tended to take the straight path. This may be classified as shear-flexural cracks.

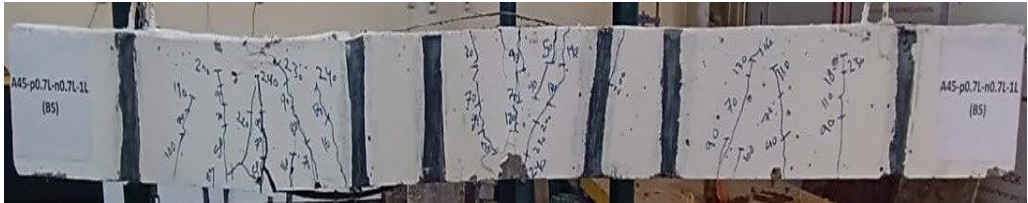
Figure 7: Map of cracks for A45-p0.7L-n0.7L-1L.

This beam was initially loaded to about 45%Po, and then the specimen was repaired as the N45-p0.7L-n0.7L-1L specimen but adopted end anchors at each end of each sheet. From Figure 7, It behaved as like the control beam during the first loading phase. At a load of about 20 kN, the first crack appeared obviously in the middle beam and mid-right span at the tension face. Furthermore, many cracks tend to initiate straightly. In the

left mid-span, there was a widened crack that appeared at 50 kN, and it kept penetrating the concrete block vertically until 240 kN, resulting in specimen failure.

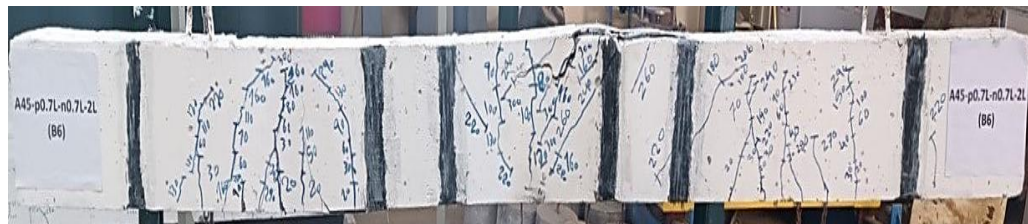
Figure 8: Map of cracks for A45-p0.7L-n0.7L-2L.

This beam has been initially loaded up to 45% ultimate load. During the first stage of loading, the specimen showed a similarity in behavior with the control beam. As in Figure 8, the first crack appeared straightly with 90° at 7.4% from the ultimate load in the center of the two spans at the tension face. It is clear that the vertical cracking shifted considerably to be diagonal at 29% of its ultimate load and penetrated through all the depth of the concrete section. The cracks tended to expand and enlengthen towards the compression zone in the maximum moment area. Furthermore, a crack formed near the plate loading and expanded horizontally with the cover of concrete and after that, it stretched upwards with the peeling of the cover, causing the failure of the beam. Compared with the control specimen, it can be noted that the restored capacity was about 108.8%, which is the largest value. This may be attributed to the small value of the initial loading and the use of two layers of CFRP with anchors.

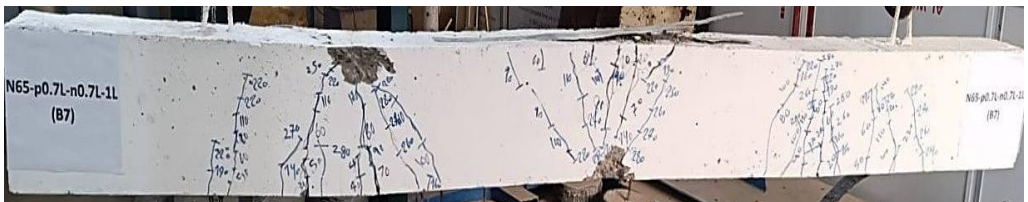
Figure 9: Map of cracks for N65-p0.7L-n0.7L-1L.

This specimen was loaded initially with a load level of 65% of the failure load of the control specimen before the repairing process. After reaching the predetermined level of loading, the load is removed, and the specimen is retrofitted on each side. Then, it is subjected to the second stage of loading. Figure 9 shows the crack pattern. It is observed as the load increases. The first crack appeared at 7.1% from the failure load. A clear flexural crack and a few shear cracks diagonally oriented directly to the compression zone. At 90% of the final loading stage, a sudden sheet rupture occurred at the positive moment section. Where the cracks were able to expand and achieve a flexural path failure. The specimen (N65-p0.7L-n0.7L-1L) could withstand load up to 280 kN with rupturing in the CFRP sheet.

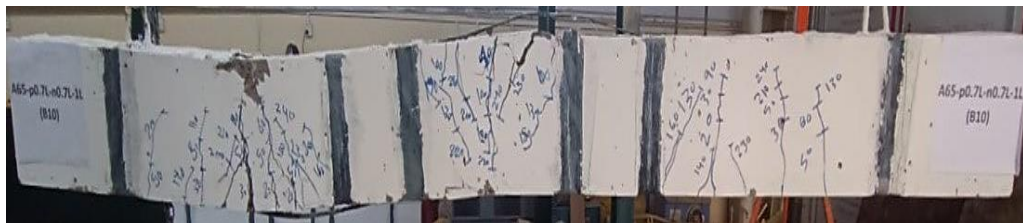
Figure 10: Map of cracks for A65-p0.7L-n0.7L-1L.

185 kN was the load applied to this specimen before using 0.7L of the CFRP sheets with an end-anchor. After the repairing stage, 30 kN was the first cracking load in both mid-pans. However, more cracks were clear in the left span with an angle of more than 80°, all of them extending towards the loading source. When the load increased, the sheet debonding happened, and the crushing concrete appeared, which led to failing the specimen with high noise was heard. The map of the crack pattern is explained clearly in Figure 10.

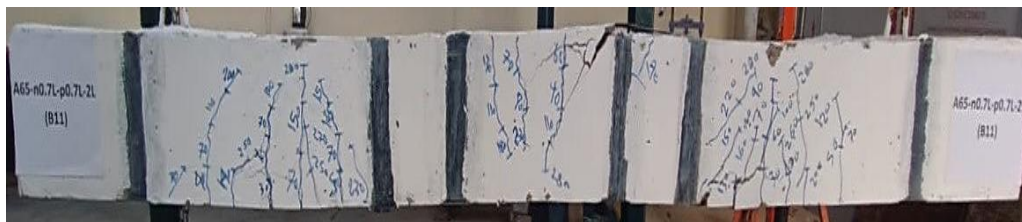
Figure 11: Map of cracks for A65-p0.7L-n0.7L-2L.

This model of bonding used the U shape of an anchor wrapped in two layers of CFRP after preloading 65% of the ultimate control load. Firstly, two cracks were initiated in the center of both spans at loading 30 kN vertically. Then, a flexure crack appeared from the top of the beam center at 60 kN. As it is obvious, the shear-flexural cracks started to appear close to flexure cracks with inclined at different angles at increasing the load. In addition, it continued to extend significantly until three-quarters of the beam height and then stopped. All cracks were directed toward the sources of the applied loads. At the same time, the cracks continued to expand until the sudden peeling failure of the concrete cover occurred at a loading of 280 kN. Figure 11 shows the crack propagation history of this beam.

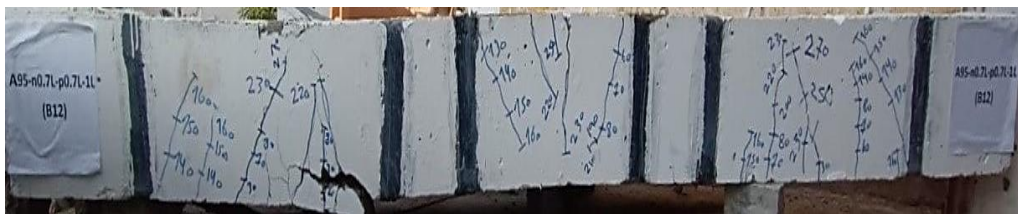
Figure 12: Map of cracks for A95-p0.7L-n0.7L-1L.

95% was the percentage of damage for this specimen, and then it was externally bonding one layer of the CFRP sheet with an anchor at the ends. At 30 kN, the crack began to appear in the center of the continuous beam spans. However, a clear vertical crack can be noted in the middle of the negative moment area with an inclined crack accompanying it. Some cracks propagated by an angle of more than 60° were directed to the compression part. The concrete cover started to peel, causing the failure for the specimen with the restored force of about 94.7% of the control model, as well as. There was no crushing of concrete at the loading and supporting points, as illustrated in Figure 12.
