Analysis of land management expertise in order to determine the location of the boundaries of a residential building and land plot

Abstract. The article discusses the issue related to determining the real location of a residential building using available archival documents. The location of the land plot on which the capital structure specified in the documents should be located is also determined. A study was conducted using remote sensing data taken from various years and presented to determine the location of a residential building.

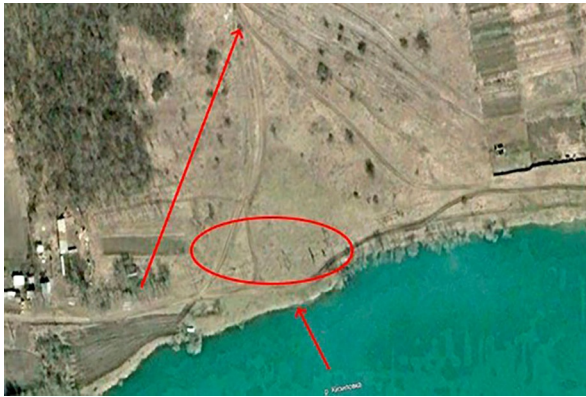
Fig. 2. Study of the situation in the area where the land plot with cadastral number 26:11:021003:35 is located on different dates using the photogrammetric method based on satellite image data for 2004.

The image taken in March 2004 shows characteristic objects for visual reference: a fork in the road, a coastline. The territory of the site cadastral number 26:11:021003:35 and the adjacent territory does not contain signs of the presence of buildings, foundations, or traces of construction work. There is also no road in the area, along which at the time of the survey the boundaries of the site 26:11:021003:35 are located.

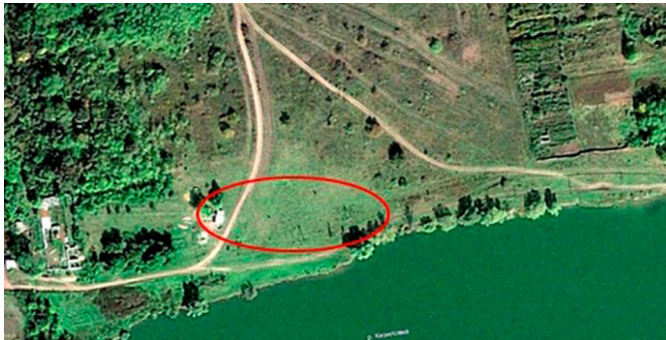
Fig. 3. Study of the situation in the area where the land plot with cadastral number 26:11:021003:35 is located on different dates using the photogrammetric method based on satellite image data for 2009.

Similar to the previous image, the territory of site cadastral number 26:11:021003:35 and the adjacent territory do not contain signs of the presence of buildings, foundations, or traces of construction work. There is also no road in the area, along which at the time of the survey the boundaries of the site 26:11:021003:35 are located.

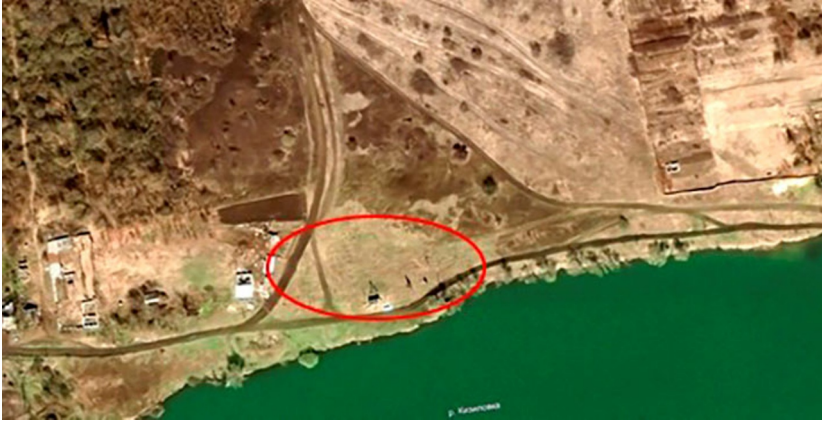
Fig. 4. Study of the situation in the area where the land plot with cadastral number 26:11:021003:35 is located on different dates using the photogrammetric method based on satellite imagery for 2012.

The image taken in April 2012 showed that the territory of site cadastral number 26:11:021003:35 and the adjacent territory also do not contain signs of the presence of buildings, foundations, or traces of construction work. There is also no road in the area, along which at the time of the survey the boundaries of the site 26:11:021003:35 are located.

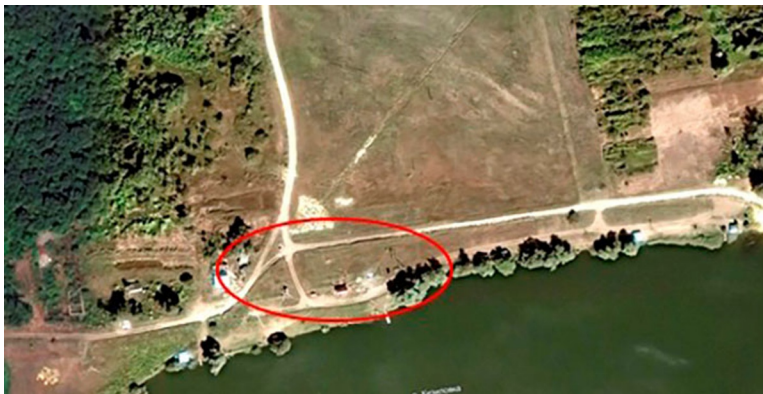
Fig. 5. Study of the situation in the area where the land plot with cadastral number 26:11:021003:35 is located on different dates using the photogrammetric method based on satellite imagery for 2015.

According to remote sensing data taken for July 2015, a road appears on the ground along which the boundaries of the land plot cadastral number 26:11:021003:35 are located at the time of the survey. The territory of the site cadastral number 26:11:021003:35 and the adjacent territory does not contain signs of the presence of buildings, foundations, or traces of construction work.

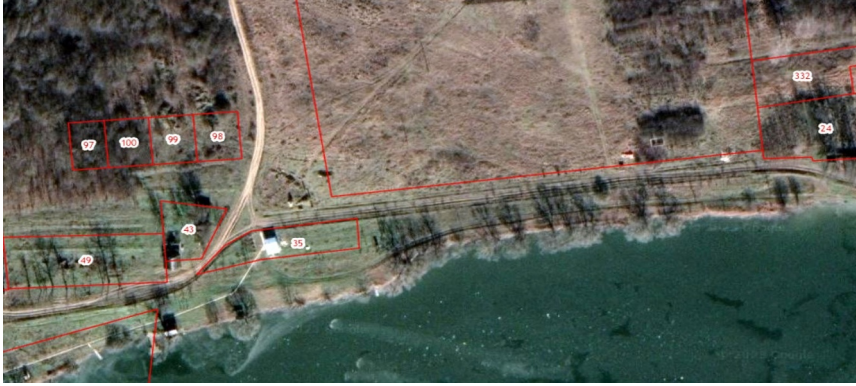
Fig. 6. Study of the situation in the area where the land plot with cadastral number 26:11:021003:35 is located for different dates using the photogrammetric method based on satellite imagery for 2022.

From the images taken in December 2022, it is clear that the boundaries of the cadastral number 26:11:021003:35 section and other sections are aligned with the image. There are no signs of the presence of the object specified in the 2008 technical passport on the site.

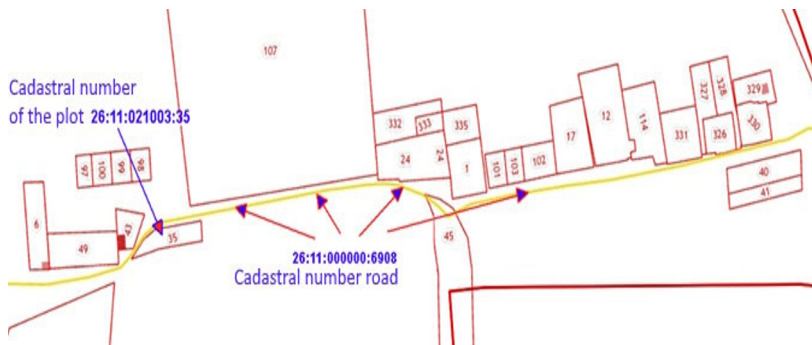
In order to determine the possible location of the building and land plot at address x. Balki, 8/2, cadastral registration data (USRN) of the territory of the x. Beams. It was revealed that the road along which the land plot with cadastral number 26:11:021003:35 is located at the time of the survey was registered in the Unified State Register of Real Estate as a Structure with cadastral number 26:11:000000:6908.

Fig. 7. Location of the road with cadastral number 26:11:000000:6908.

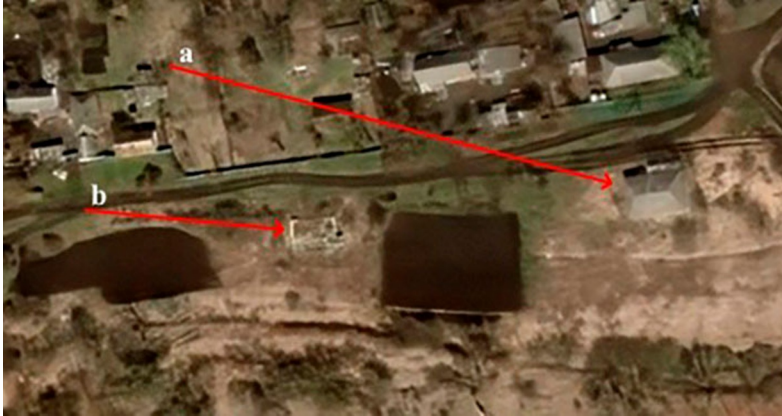
Fig. 8. Location a) building on site 26:11:021003:40 and b) building next door.

In this photo, the remains of the foundation or walls are clearly visible, the road is also visible, the dimensions of the structure next to the site 26:11:021003:40 (H. Balki, 8) correspond to the dimensions specified in the technical passport of the unfinished construction project - a residential building at X. Beams, 8/2 as of 01/17/2008 (10.4 by 5.0 meters).

In fact, on the ground next to the site with cadastral number 26:11:021003:40 x. Beams, 8 there are remains of a structure made of sawn rubble. This structure has been clearly visible in space photographs since 2004. The dimensions of the structure measured from a satellite image correspond to technical data. passports from 2008. The location of the discovered remains of the sawmill structure does not correspond to the location of the site with cadastral number 26:11:021003:35 in the coordinates at which the site is registered in the Unified State Register of Real Estate. At the same time, the location, shape and size of the discovered remains of a structure made of sawn rubble corresponds to the situational plan, size and shape specified in the technical documents. passport 2008. According to satellite images, the structure existed in this place at the time of preparation. passports from 2008 to address x. Beams 8/2 and is located next to a land plot with cadastral number 26:11:021003:40, having the address x. Beams, 8.

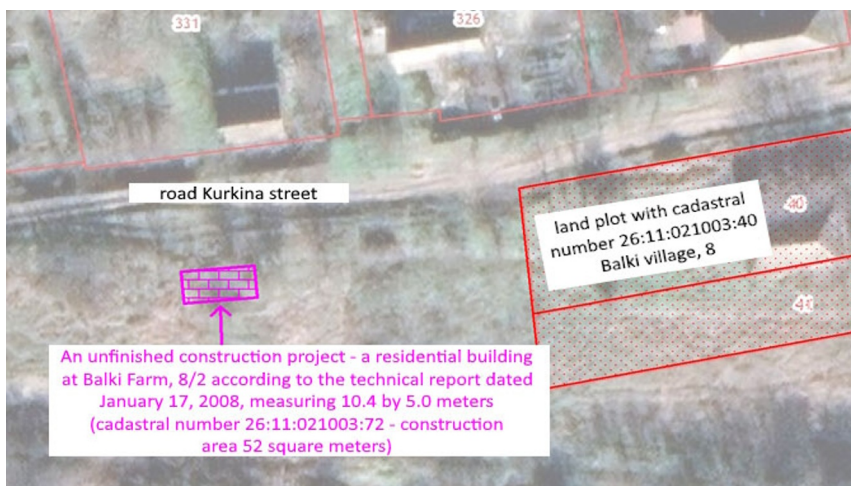
To establish the location of the actual boundaries of the structure, geodetic measurements were made on the ground using satellite geodetic equipment in RTK mode. The measurements were carried out in the MSK-26 coordinate system from SK-95 zone 1, adopted for cadastral registration.

Thus, the location of the structure with cadastral number 26:11:021003:72 is determined according to the Technical Data Sheet dated January 17, 2008 for the Unfinished Construction Project - a residential building at address x. Balki, 8/2, satellite imagery and on-site survey data

Fig. 9. Location of the structure with cadastral number 26:11:021003:72.
