Characteristics of landslides induced by an earthquake from a hidden strike-slip active fault in the Cianjur Area of West Java

Abstract. On November 21, 2022, the Cianjur area in West Java, Indonesia, experienced devastating landslides caused by a magnitude 5.6 earthquake, with the epicenter traced to a hidden active fault approximately 11 kilometers beneath the surface, known as the Cugenang Fault. This study investigates the post-disaster landslides and aims to discover the characteristics of the landslides triggered by this earthquake. The methodology involves literature review, lithology descriptions, landslide slip surface analysis, soil analysis, slope assessment, land cover and land use change examination, landslide orientation evaluation, and distance measurements to the earthquake's epicenter and the Cugenang fault. Drones aided spatial landslide analysis. The study highlights the strong link between intense shaking along the active fault and landslide occurrences. Due to lithological bedding control, these landslides all head southwest and are located 0.35 to 0.67 kilometres from the fault. The residual soil, highly weathered breccia, and possible tuff volcanic deposits,

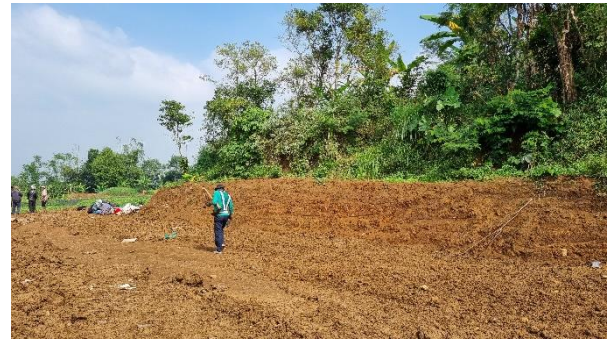
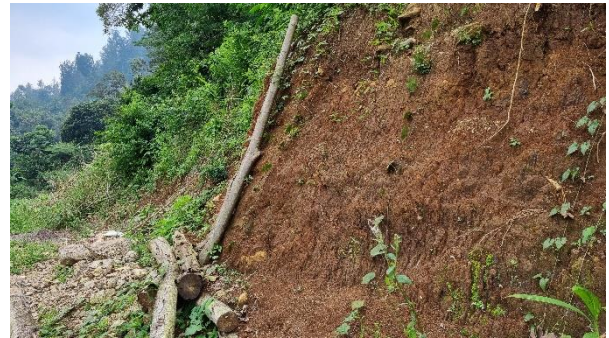
Fig. 1. Typical yellowish to dark brown residual soil and highly weathered breccia in the landslide area, exposed in the middle of the Cijedil Landslide (top) and in the crown area of Cugenang landslide (bottom).

In the areas of breccia and lahar deposits, small hills or basalt blocks are found locally. Based on field surveys, it was observed that the landslides in Cijedil, Cugenang, Sarampad, and Rawacina occur on the residual soil and weathered rock in the upper layer, with thickness of about 3 meters to 10 meters. The residual soil and the highly weathered breccia layer can be seen in figure 1.

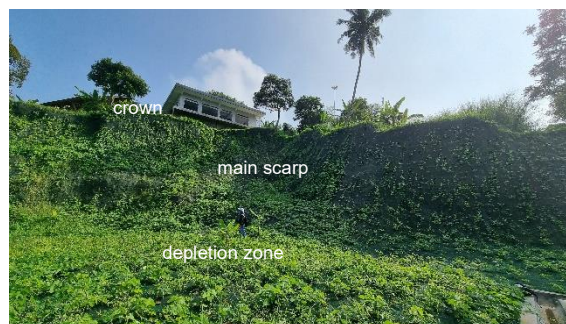
The Cijedil landslide occurred at coordinates 107.083194° E and 6.800222° S. At this landslide site, lithology resulting from volcanic breccia weathering is exposed, with the highly weathered breccia lies at the bottom part and dark brown residual soil at the uppermost layer. The exposure at this site shows variations in weathered soil, ranging in colors from dark brown (silty), light brown (sandy), to dark brownish-black (clayey) from upper to bottom, with a thickness of approximately 8 meters. At the base of the landslide, there is a spring, indicating the presence of an impermeable layer beneath the surface. The sliding plane of the landslide is believed to be the result of weathered, impermeable tuff layer. The slope is about 19° and the dip slope is predicted to be in the same direction as the ground surface slope, with the landslide movement direction approximately N165°E.

The landslide morphology exhibits the characteristic horseshoe shape at the crown, with the sliding material reaching the river at the base of the landslide. The

distance of the Cijedil landslide from the earthquake's epicenter is 3.96 km, while the estimated distance from the Cugenang Fault is 0.46 km. The landslide area covers 17.536 m², with a length of 234.75 – 272.68 meters and a width of 65.98 to 70 meters. Before the landslide incident, the land use in the area was a mixed plantation, and at the base of the landslide, there were slope cuttings for a district road without reinforced on the cut slope.

The landslide occurred due to the earthquake's shaking on the saturated weathered breccia layer, which had an impermeable layer beneath it. During the survey, the post-landslide condition showed that the road construction had reinforced the cut slope area, and the landslide body and crown had been covered with plastic netting and planted with ground cover crops.

Fig. 3. Cijedil landslide showing the crown, main scarp and depletion zone.

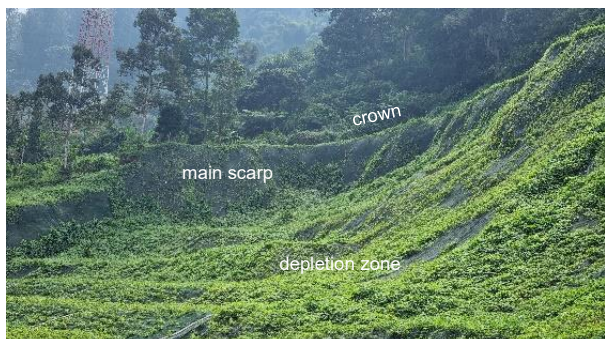
The Cugenang landslide occurred at coordinates 107.080219° E 6.79496° S. The exposed lithology on the surface consists of brown residual soil resulting from weathered volcanic rocks, with a thickness of approximately up to 12 meters. The landslide exhibits a distinctive morphology with a sizeable horseshoe-shaped crown, followed by a more miniature horseshoe indicating two primary and one more minor landslide at this location. The sequence of events suggests that the more significant landslide occurred first, followed by the smaller one. The slope is about 20°.

At the base of the sliding terrain, exposed at the bottom of the landslide, there is a moderately weathered volcanic breccia with component sizes ranging up to boulders. The sliding plane of the landslide is estimated to be composed of compact volcanic breccia, of slightly weathered or an impermeable layer derived from tuff rocks.

During the event, the landslide material covered the Puncak - Cianjur national road in Cugenang and reached the river at the base of the landslide. The main landslide direction is approximately N168°E, while the minor is N211°E. The distance from the landslide to the earthquake's epicenter is 4.62 km, and the estimated distance from the Cugenang Fault is 0.35 km. The landslide area covers 29.833 m², with a length of 260.94 – 297.66 meters and a width of 94 to 117.57 meters.

Before the occurrence, the area of the landslide was a mixture of gardens and secondary forest vegetation, some of which had been cleared. At the base of the

landslide, there were slope cuttings for the national road that had yet to be reinforced before the landslide.

Fig. 4. Cugenang landslide showing the distinct horseshoe-shaped of the crown and main scarp and the depletion zone.

After the landslide, the area has been reinforced with rock gabions along the road edge, and the sliding area has been covered with plastic netting planted with ground cover crops.

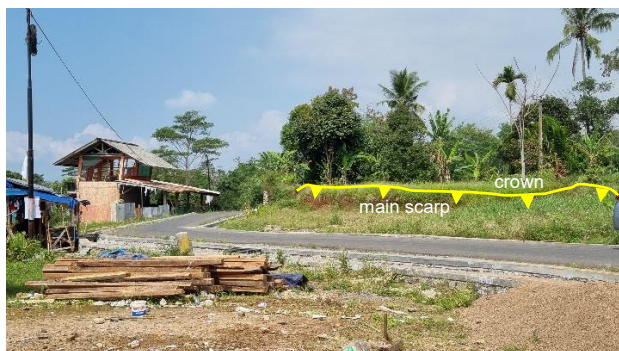
The Sarampad landslide occurred at coordinates 6.802749° S and 107.074958° E. The landslide area was relatively gentle, with a slope of about 9 degrees. The landslide crown was on the west side of the road and did not show a clear horseshoe morphology, but there was a 1.5-meter drop in the ground with a sliding direction of N120°E. The exposed surface of the landslide consisted of light brown to yellowish soil with a relatively porous sandy texture. Considering the sand fraction in this soil exposure, the landslide is likely to be a liquefaction event. However, other supporting evidence has yet to be more detailed and investigated.

Fig. 5. Sarampad landslide shows the main scarp, crown, and road rebuilt in the depletion zone.

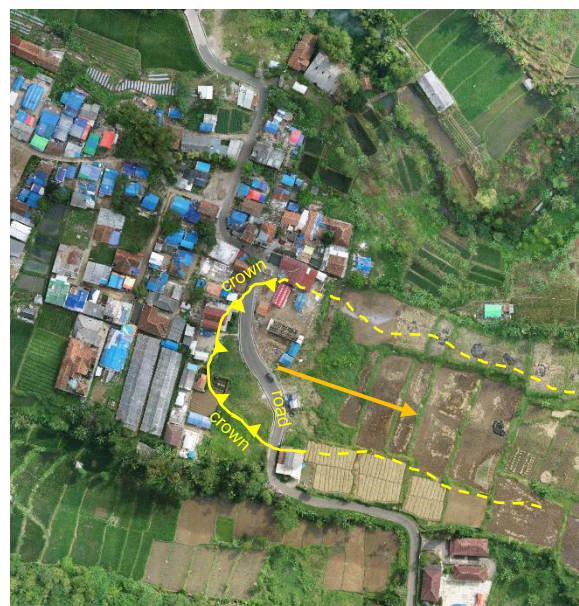
The sliding plane of the landslide is estimated to be an impermeable layer composed of tuff. The landslide location is within a residential and rice field area, with a road cutting through the housing area, and about 60 meters to the north is a small river. The landslide affected part of the houses and rice fields in the eastern housing area. The distance of this landslide location from the earthquake's epicenter is 4.03 km, while the estimated distance from the Cugenang Fault is 0.43 km. The landslide area covers 6.331 m², with a length of 65.75 – 96.25 meters and a width of 60.70 to 63.09

meters. The landslide occurred when water-saturated sandy lithology was above an impermeable layer, possibly composed of tuff, on a gentle slope.

Fig. 6. UAV image of Sarampad landslide showing the gentle slope morphology of the head scarp area.

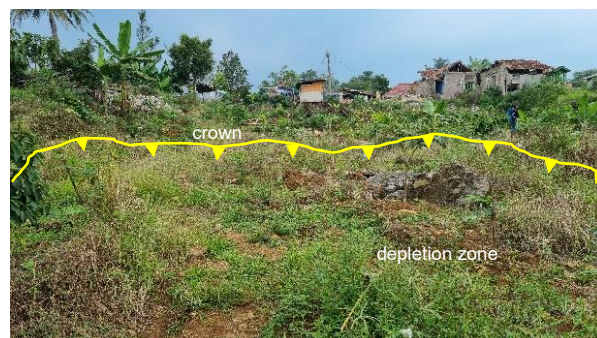
The Rawacina landslide occurred at coordinates 6.833086° S, 107.095808° E. The landslide occurred on a relatively gentle slope, around 7 degrees, with an undulating morphology in the depletion zone. The exposed lithology is a weathered brown breccia with an estimated thickness of about 3 meters, underlain by an impermeable brownish tuff rock that acts as the sliding surface. The landslide area is covered with shrubs and sparsely planted with garden crops.

The movement direction of the landslide is estimated to be towards N100°E. The distance from the landslide to the earthquake's epicenter is 0.7 km, while the estimated distance from the Cugenang Fault is 0.67 km. The landslide area covers 3.237 m², with a length of 92.78 – 103.42 meters and a width of 26.93 to 42.39 meters. This landslide is similar to the one in Sarampad, resulting from the earthquake shaking with a liquefaction effect. However, supporting evidence has yet to be more detailed and investigated.

Fig. 7. Rawacina landslide showing the crown, a gentle slope and the undulating morphology of the depletion zone.

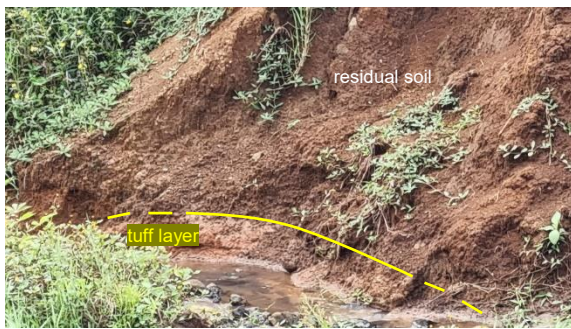
Fig. 8. Light brown tuff layer exposed at the toe side of Rawacina Landslide underneath the completely weathered breccia's light to dark residual soil.
