Assessment of tunnels stability in the Maya archaeological area of Copán, Honduras

Abstract. Copan is an important heritage site known by its preserved Maya ruins and recognized by UNESCO as a World Heritage Property since 1980. To investigate and understand the site development, extensive archaeological tunnels were excavated in the earthen fills of the temples in the twentieth century. Archaeologists found a series of superimposed temples, built one upon another, in a very complex chronological sequence and spatial disposition. Even though the tunnels were initially excavated in the earthen fill without putting in place any supporting structure, masonry lining was applied in parts of the tunnels years after they were excavated, in areas that suffered local collapses. Thick walls were built, forming tunnels about 1.0 m wide and 2.0 to 3.0 m high. The excavated soil is unsaturated, and thus has a strength depending on its water content and suction. Since most of the observed collapses take place during raining events, the effect of the change of the saturation degree on tunnels stability was investigated with numerical analyses. As typical in numerical simulations, the positive ef

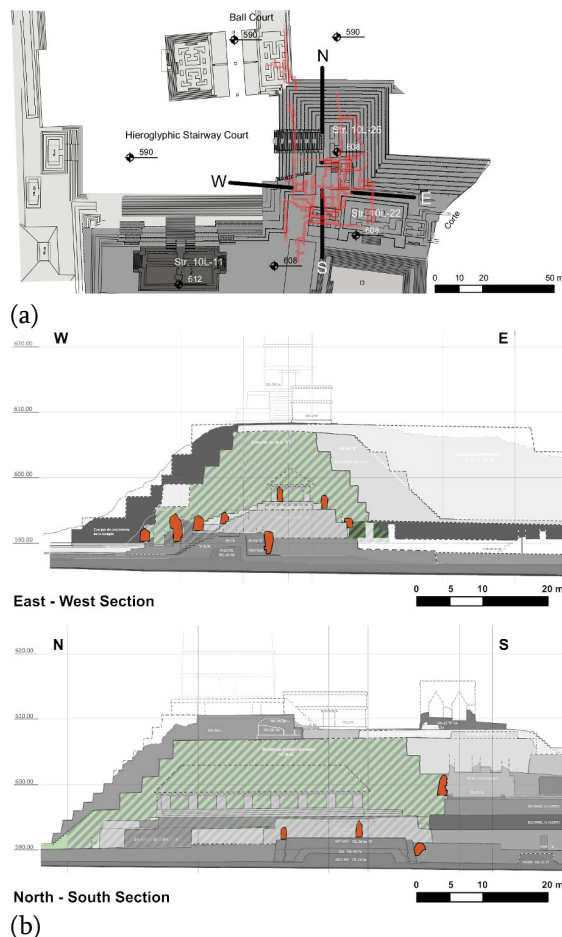
Fig. 3. (a) detail of the Acropolis plan showing the extension of currently open tunnels under the Hieroglyphic Stairway Temple (in red); (b) Sections showing the approximate positions of tunnels (in red) and the green hatch of the Esmeralda volume – adapted from C. Rudy Larios' PAAC drawings [14].

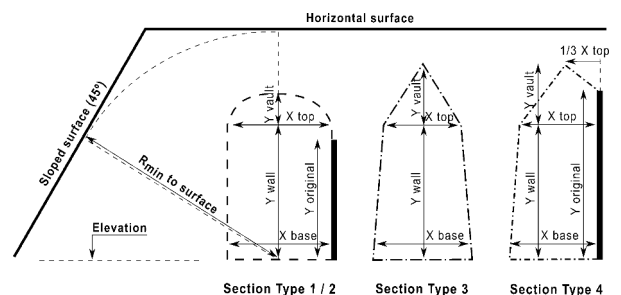
Fig. 4. Tunnel typical sections shapes: Types 1 and 2 (left), Type 3 (center) and Type 4 (right).

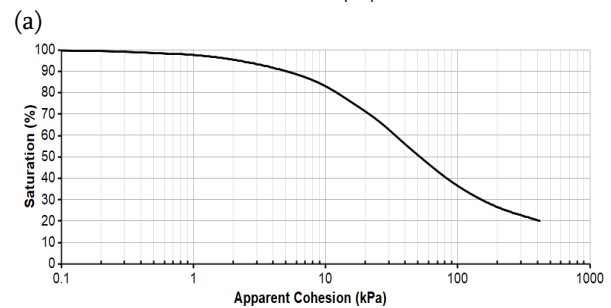
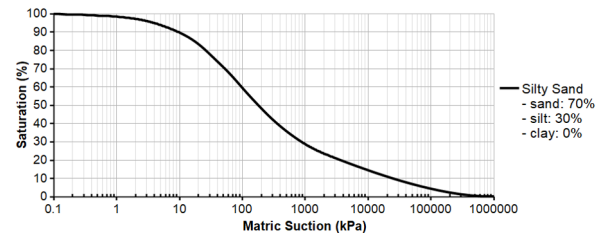
Based on the available information on the grain-size distribution of a soil sample of the silty sand named '*girún*', the following values have been adopted: $a = 46$, $m = 1.2$ and $n = 0.86$ [16]. Figure 6a shows the water retention curve and Figure 6b the resulting curve expressing the relation between apparent cohesion and saturation (assuming $\varphi = 30°$).

Fig. 6. Assumed SWCC and apparent cohesion versus saturation for the silty sand infill ('*girùn*').

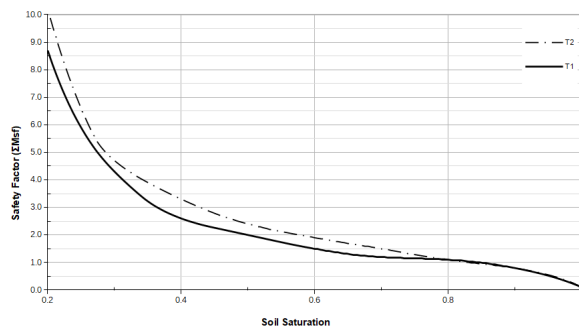
Figure 7 plots the safety factors for the unlined section T1 and T2, at a same depth H = 20 m, for different value of apparent cohesion. This shows the effect of a side wall on the stability of the unlined section of

tunnels: for apparent cohesion values corresponding to clearly unsaturated soil conditions (S_r up to 70%), the safety factor of section with an ancient wall on one side (T2) is 10% to 30% higher than in T1 section, without the wall. However, approaching saturation the two curves converge around the value S_r = 85% (when in both sections SF=1), due to the failure of the lateral wall.

Fig. 7. Comparison of safety factors for T1 and T2 typical sections at maximum depth (H = 20 m).

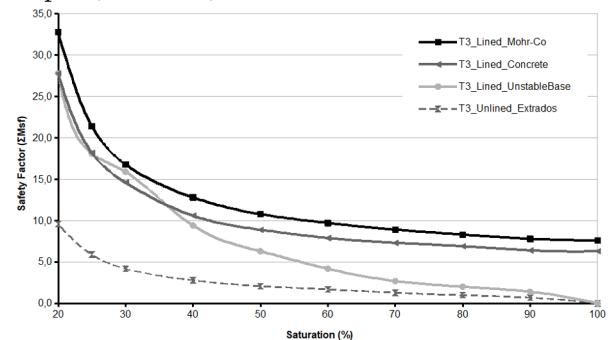
All the analyses carried out on lined sections show a typical out-of-plane failure mechanism of the side walls, leading to tunnel instability. The walls bulge inwards being their top and base movements restrained, due to the masonry arch at the top and to the unchanging cohesion in the soil at the base (unaffected by a change of the saturation degree in the soil above). Would the latter condition be removed, the stability reduces drastically with the increase of saturation ("T3_Lined_UnstableBase" in Figure 8).

Fig. 8. Safety factors for different material models and tunnel sections and conditions as a function of the degree of saturation of soil.
