# Cause Analysis and Countermeasures of a Breakdown Failure of Flexible 110 kV Cable Terminal

Feng Huang

Electric Power Research Institute of Guangxi Power Grid Co., Ltd., Nanning, Guangxi 500023, China

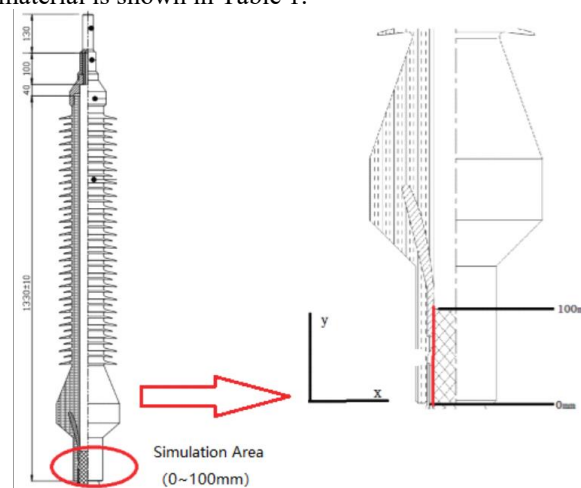
**Fig. 3.** Model of Flexible Terminal.

Referring to the structural parameters of the cable terminal, a complete cable terminal model is established according to the actual size (1:1). The finite element method is applied to simulate and calculate the electric field numerical value of the terminal when the applied voltage is 64 kV. The structure of the terminal model is shown in Figure 3, and the dielectric constant of the material is shown in Table 1.
