Damage Analysis of Moldboard Plow

Abstract. Moldboard plow is a tool used to cultivate the agricultural land. The material of the moldboard is a double layer where the outer layer is high carbon steel and the inside is a low carbon steel. The findings on the side edge of the moldboard plow are often damaged due to bent deformation and then broken. The study was conducted to determine the cause of the damage through simulation and testing laboratory. The simulation results show that the moldboard is overloaded by its material capability. This is shown also from the results of testing the chemical composition that this material is a low-alloy steel single layer without surface hardening. Hardness tests conducted using Rockwell C show that this steel has a tensile strength of only about 400 MPa. This is reinforced by the results of microstructural observations showing that more than 99% of the phases are ferrite.

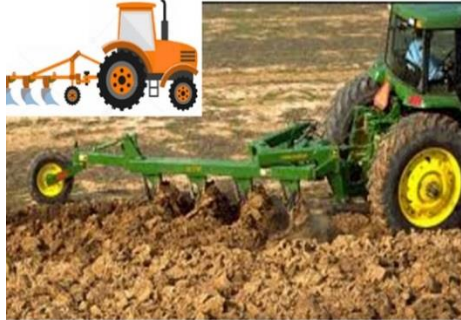
Currently, multiple moldboard plows are used as shown in Figure 1 (a) and (b) show the bottom of the moldboard plow. The edge of the moldboard is the most easily cracked, broken, or deformed plastic part.

Fig. 1. Multiple moldboard plow

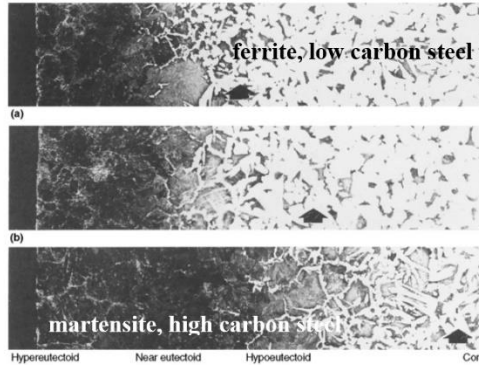
Moldboard usually is made of two layers of steel. The outer layer is high carbon steel with the chemical composition are 0.9 to 1.05 %C. However, the middle layer has carbon composition of 0.08 to 1.3% [2]. Near to the surface of the double layer, the material contains martensite phase in the outer and ferrite in the inner, whereas martensite is consist of high carbon steel and ferrite is low carbon steel[3]. Figure 2 shown double layer steel.

Fig. 3. Double layer microstructure consisting of martensite and ferrite [3]

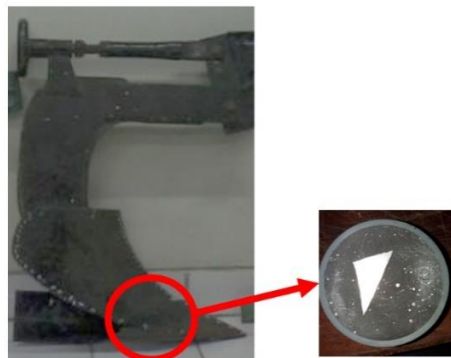
Fig. 4. Specimen moldboard plow
