Sinkhole hazard in the post-mining area of Old Copper District, Lower Silesia, Poland

Abstract. This study discusses the occurrence of sinkholes and the removal of their effects in the territory of the Old Copper District in the municipality of Lubków, Warta Bolesławiecka, located in the voivodeship of Lower Silesia. Three sinkholes appeared more than 25 years after mining activities ceased with the closure of the “Konrad” Mine of KGHM Polska Miedź S.A. The sinkholes appeared in the former mining areas in the years 2017 – 2018: the first in the area of the Lubichów III shaft located in the municipality of Lubków – the downcast and transport shaft of the “Lubichów” and “Konrad” mines; the second in the area of Lubichów IVa in Lubków – the ventilation shaft of the “Lubichów” and “Konrad” mines; and the third in the area of the Lubichów IVa shaft - in the village of Lubków. The “Lubin” Mine of KGHM Polska Miedź S.A. commissioned development of projects to mitigate the risk and to secure the areas and remove the dangers.

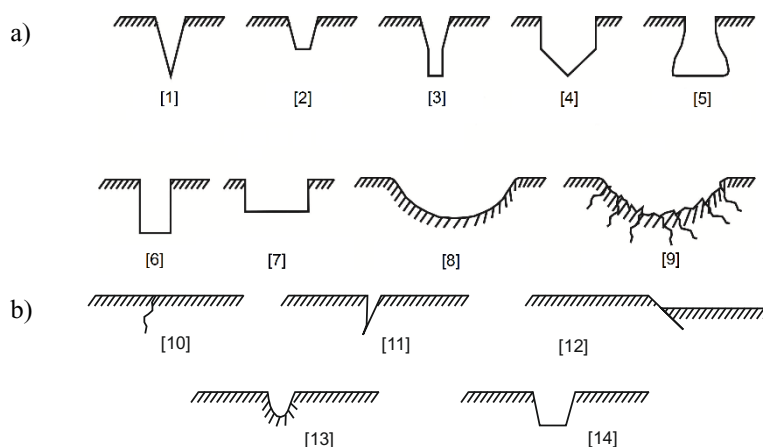
Fig. 1. Kinds of discontinuous deformations of the terrain surface in the vertical section observed in the area of shallow exploitation in UCSB (on the basis [2, 3, 14]); [1] – conical sinkhole, [2] – truncated sinkhole, [3] – conical-cylindrical sinkhole, [4] – cylindrical – conical sinkhole, [5] – bell sinkhole, [6] – cylindrical sinkhole, [7] – cuboid sinkhole, [8] – continuous syncline, [9] – discontinuous syncline, [10] – crack, [11] – fissure, [12] – fault deformation, [13] – ditch, [14] – smoothed ditch
