Seismic capacity evaluation of the damaged reinforced concrete building during Palu earthquake 2018

Fajar Nugroho^{1,2*}

Abstract. This paper presents an evaluation of the seismic capacity of the Dean Building of The Faculty of Social and Political Science of Tadulako University due to the Palu Earthquake 2018. The building was built in 2016 and went into use in 2017. The building is made from a reinforced concrete frame consisting of three floors and collapsed after the earthquake. Data for the analysis are taken from the Detail Engineering Design of the Dean Building of The Faculty of Social And Political Science of Tadulako University in 2015. Seismic capacity evaluated based on Standard for Seismic Evaluation of Existing Reinforced Concrete Buildings issued by the Japan Country. The analysis are done on the 1st-floor structure because the most significant sliding force happens on the first floor. Seismic capacity is invoked in the form of a link between the lateral strength and the ductility index. By using Japanese standards, the building's seismic capacity is relatively small in withstanding the earthquake load and collapsed the building. Based on observations in the field

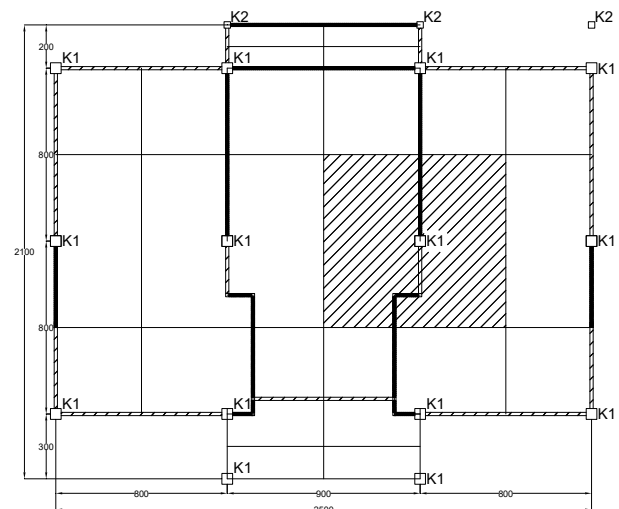
Fig. 5. Floor Plan and Floor Area of the Dean Building

Another detail information on the building structure that required for calculation such as column size, column detail, reinforcement quality is obtained from detailed engineering design (DED) drawing of the Dean Building. Fig. 5 shows the first-floor plan of the building.
