# Pitting corrosion of galvanized pipes in hot water supply systems

Alexey Andrianov\*

**Abstract.** The mechanism of pitting corrosion of galvanized pipes in hot water supply systems is considered. The analysis of the literature to determine the conditions and mechanism that cause abnormally rapid corrosion of steel galvanized water pipes in water supply systems is carried out. The results of a laboratory study of the initial stage of corrosion of galvanized pipes are presented. The results of a survey of hot water supply systems of a number of residential buildings are presented. Recommendations and measures to reduce the impact of corrosion in hot water supply systems are presented.

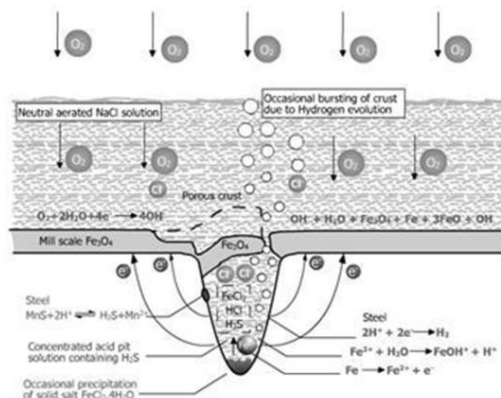
Fig. 3. Pitting formation scheme [10].

The further development of corrosion with a complete damage to the zinc coating can be illustrated by the scheme proposed in [10]. Figure 3 shows a diagram of pitting development in the wall of a steel pipe. The diagram shows that the presence of oxygen in the water causes corrosion. However, the formation of pitting becomes possible only when the passive film, which is located on the metal surface, is destroyed, and the potential between the cathode and the anode exceeds the value of  $P_{pitt}$  (pitting potential). This value can be achieved in the absence of oxygen at the point of origin of pitting. In the case of galvanized pipes, the zinc layer acts as a passive film.

Pitting, as a rule, is covered by a layer of sediment ( $\text{Fe}_3\text{O}_4$  in the diagram) forming a tubercle. The tubercle structure is well studied and includes at least three elements: the upper surface layer, a dense layer that conducts electrons, and a loose core [11]. The source of the iron oxides that form the tubercle is the corrosive metal of the pipe and the hydroxyl ions  $\text{OH}^-$  formed from the water as a result of hydrolysis. The tubercle creates a barrier between the water in the pipe and the water inside the pitting.

The accumulation of iron ions in the place of the anode (the lower part of the pitting in Figure 3) causes the diffusion of chlorides and sulfates anions from the bulk of the water. Inside the pitting, iron salts,  $\text{FeCl}_2$ ,  $\text{FeSO}_4$  are formed, which undergo hydrolysis according to reactions (3-4) [12]:
