Surveillance of the banks of reservoirs on the Drava River in Slovenia after extensive floods

Pavel Žvanut*¹

¹Slovenian National Building and Civil Engineering Institute, Ljubljana, Slovenia

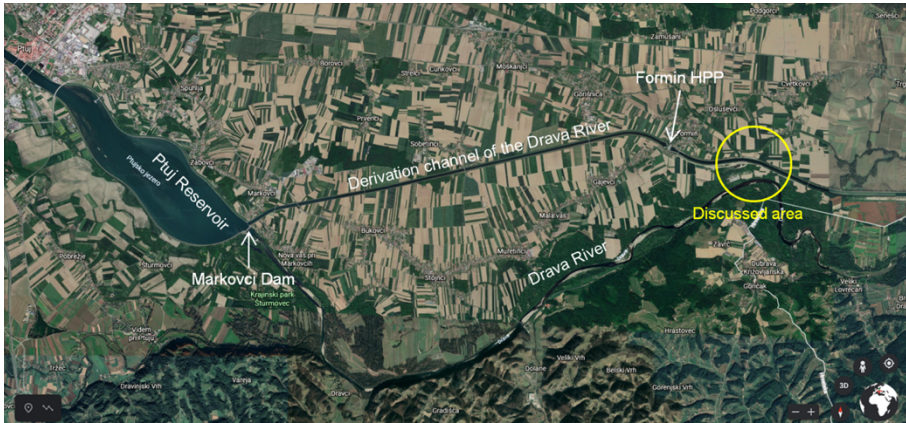
Fig. 10. General location of the discussed area (Source: Google Earth).

The most extensive damage was registered in the area of the derivation channel of the Drava River, about 1.5 km downstream of the Formin HPP (see Figs. 10 and 11), where the flood waters of the Drava River caused an additional river flow, which first broke through the right levee of the derivation channel and then also broke through the left levee of the derivation channel (see Figs. 12 and 13), where caused the erosion of the left bank of the derivation channel (see Fig. 14). Of course, the concrete diaphragm walls, installed in levees on both sides of the derivation channel, which prevented the drainage of groundwater into the derivation channel, were also demolished in this area (see Fig. 15). In addition, the flood waters of the Drava River transported large amounts of gravel into the derivation channel (see Fig. 14), which dammed water in the channel, with that caused rising of the water level in the channel and consequently flooding of the machine hall area of the upstream located Formin HPP [12-14]. Due to the high risk of additional damage and deterioration of the stability of the damaged banks of derivation channel, the main rehabilitation works began immediately after the detailed inventory of all noticeable damage was made, and they were completed quickly and successfully.
