Ecology and mining industry development in high-mountain areas (the Inner Tien Shan)

Abstract. The genesis and transformation in time of risks in the areas of high altitude tailings storage facilities with respect to changing climate are considered. Based on the example of the Kumtor mine in the center of the Tien Shan at a height of 3600–4300 m, three groups of risk factors were allocated concerning a large, ecologically hazardous facility – the tailings dam containing cyanide waste. For one of the factors, calculations of an accidental dam burst were made using the Fault Tree Analysis (FTA) method. It was concluded that the construction of large-scaled and geoenvironmentally hazardous facilities in less researched high-mountain areas has to be drawn upon detailed and permanent monitoring of the facility itself and its environment. It is crucial to be prepared for operational adjustment of projects and an immediate rehabilitation of constructed facilities.

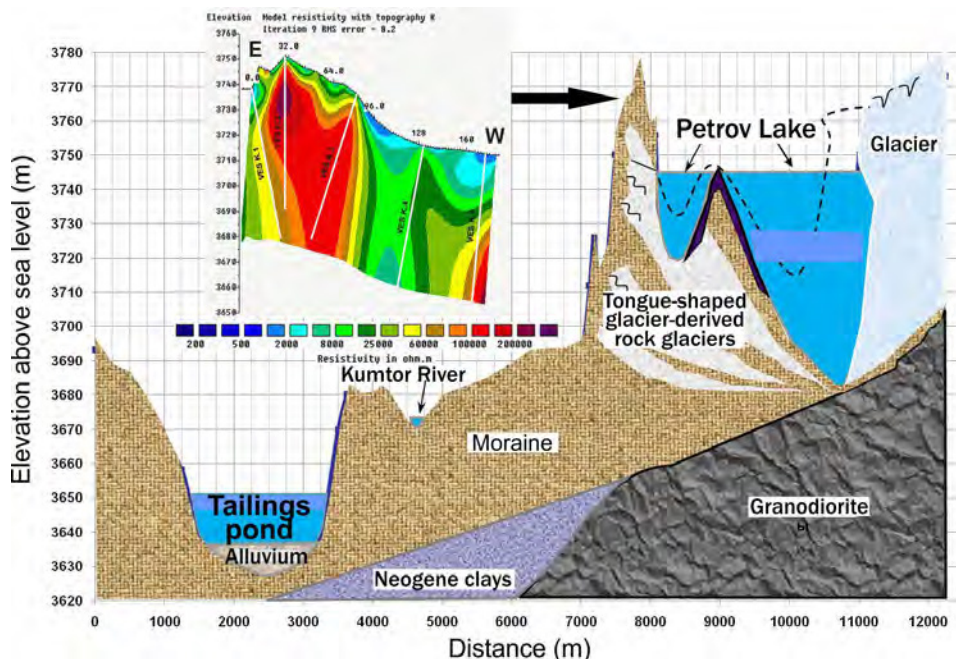
Fig. 3. Schematic geological cross-section in the area of formation of the debris flow and flood hazard in case of Lake Petrov dam breaching. The inset shows the geoelectrical image of the dam cross section.

Factors of the third group form the danger of Petrov Lake moraine dam breaching (Figure 3), followed by the formation of a heavy debris flood, of which the solid phase will contain large blocks of buried glacier ice [3]. In [4] we discussed various reasons and scenarios for the development of such catastrophic process. During the spreading of debris flow along the outwash plain and the Kumtor River, a stream blockage in a narrow part of the valley and the overflow through a low lateral moraine into the tailings pond, followed by the destruction of the tailings dam and the release of cyanide-containing waste substances into the environment is not unlikely. It should be noted that the small difference in altitude (approximately 10 m) between the Kumtor valley bottom and the lateral moraine that surrounds the tailing pond can be eliminated when removing debris from the Lysii Glacier or in time by the degradation of the moraine itself through buried glacier ice melting. Judging by the special "pockmarked" relief of its surface, these processes are already actively occurring.
