# Long-term study of the impact of temperature changes, material aging and service load on the strains of a reinforced concrete structure

**Abstract:** The article discusses five year long measurements of strains of a concrete floor of a hangar. That hangar, originally meant for servicing light military aircraft, was rebuilt with a view to making it fit for servicing larger and heavier passenger planes. As part of that redevelopment, a new floor – reinforced concrete slab, capable of withstanding the weight of the planes – was constructed. In the areas of the floor where the greatest loads occur, ie. in the areas of the concrete slab on which the wheels of the three undercarriage legs rest, three strain rosettes were installed so that the slab strains could be measured. The rosettes were connected to two meters - dataloggers. The latter were programmed in such a way as to register the measured strains and additionally temperatures many times during every 24 hours. The monitoring process, conducted in such an automatic way, demonstrated the occurrence of strains resulting from service load, aging of the reinforced concrete, as well as changes in its temperature.

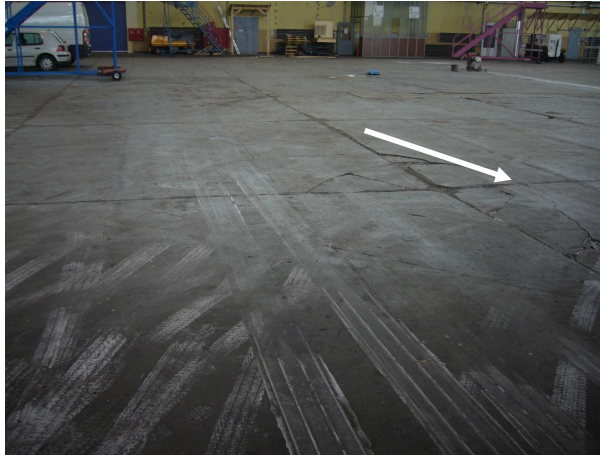
**Fig. 1.** The inside of the hangar. Damages to the floor are visible.

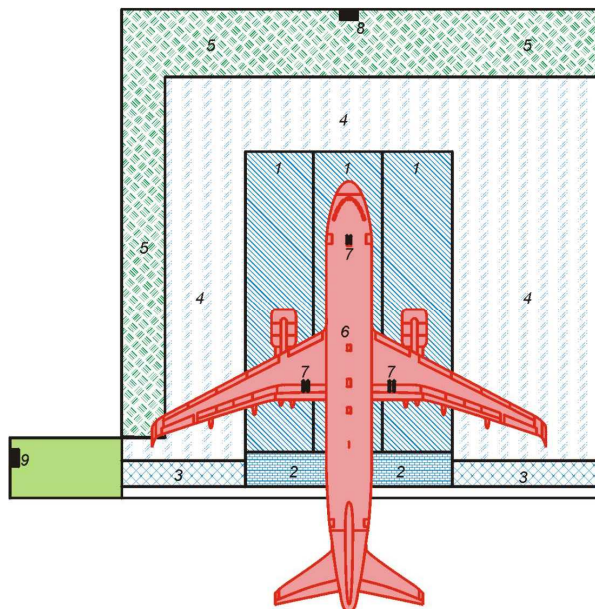
**Fig. 2.** Scheme of the hangar floor after the redevelopment, the eastern part: 1 - constituent slabs of the main slab, 2,3 – slabs in the door area, 4 – buffer slab, 5 – fragment of the previous slab, 6 – silhouette of an Airbus A320, 7 – undercarriage wheels, 8,9 – measuring instruments – recorders.

Figure 2 presents, in a simplified way, the construction of the eastern part of the hangar floor after redevelopment of the place. The western part is its mirror image. The construction of the roof was left largely unchanged, which – due to its height – makes it impossible to park an entire plane inside the hangar. It was assumed that the control surfaces and the back of the fuselage will be protruding outside the gate during servicing.

Taking into consideration the damages to the previous hangar floor, it was decided that measuring equipment would be installed in the hangar with a view to determining the strains of the new floor during its exploitation. These strains might be caused by contraction and drying up [2] of the concrete used to build the floor, as well as by changes in the temperature and the load from the planes serviced in the hangar. That load poses a particular threat to these parts of the floor on which the wheels of the three undercarriage legs rest (Fig. 2). The prescribed location spot of the front leg (in the nose) during parking is precisely determined. At the same time, the wheels of the main legs (under the wings) may rest in different places, depending on the type of aircraft being serviced, although the latter happens mostly to be the Airbus A320. Also, it is not necessary that the axis of the fuselage of a plane parked in a hangar should overlap with the axis of the main slab (Fig. 2).

All the extensometers and thermistors of the rosettes were connected to two meters - recorders (8,9 – Fig. 2). The period of measurement repetition for these instruments can be readjusted. In the first period of its activity, lasting ca. 3 years, the system performed 50 measurement a day, a number which was later reduced to 25 measurements a day. Figure 6 presents the values of strains calculated on the basis of the readings of particular extensometers of the left rosette, as registered in November 2011.

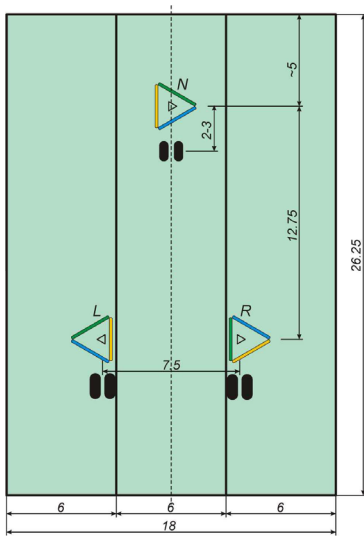
**Fig. 3.** Distribution of the strain rosettes in the main slab.

The measuring system (Fig. 3) consists of three equilateral strain rosettes and two meters – strain recorders. The rosettes were installed in the spots where the biggest load from the undercarriage wheels of the serviced Airbus A320 planes is expected. For clarity's sake, the rosettes presented in Figure 3 are magnified; as a matter of fact, their real dimensions correspond to the dimensions of the small triangles pictured inside them. Each of the rosettes is built of three identical vibrating wire transducers that had been set in the floor's body, some 5 cm above its lower surface adjacent to the gliding layer (Fig. 4). In order to ensure proper identification of particular extensometers, they were marked with three colored „jackets” (yellow, green and blue) pulled over their wires (Fig. 3, 4). To measure the temperature of the concrete in the place where the rosettes are set, three thermistors were used. Thermistors of the same type were applied to measure the temperature of the air inside the hangar.

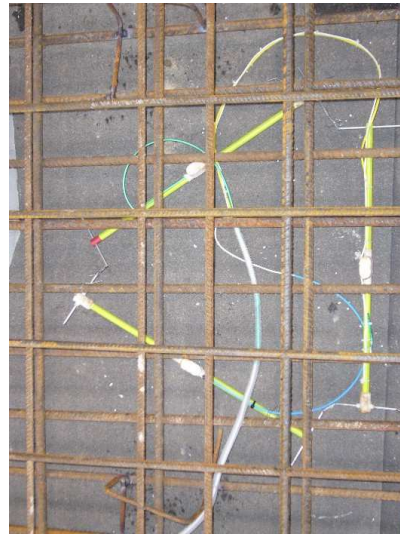
**Fig. 4.** The rosette installed in the area of the load from the wheels of the left main undercarriage leg.

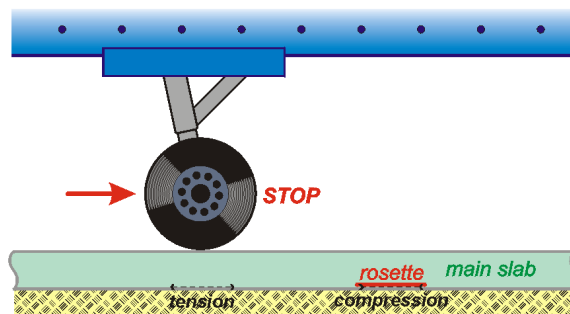
**Fig. 5.** The position of the plane's undercarriage wheels in relation to the rosettes.

Unfortunately, the refurbishment of the hangar roof that followed the construction of the floor, along with the installation of the new gate, necessitated a minor correction of the prescribed location of the planes in the hangar, which, however, was of great importance in the light of the conducted measurements. Under the correction, the planes are parked in the hangar in such a way that the undercarriage wheels do not stop above the installed rosettes, but some 2 meters above them, looking from the plane's nose (Fig. 3, 5). Thus, the deformations calculated on the basis of the readings of the extensometers are smaller than in the places of the wheels' resistance, and they are of the opposite sign (compression instead of stretching).

As it was shown in Figure 5, in the current, prescribed location of the plane during the time of its parking, the wheels of the main undercarriage legs exert a load on the hangar floor in spots other than those in which the strain rosettes are installed. Still, of all the 1,442

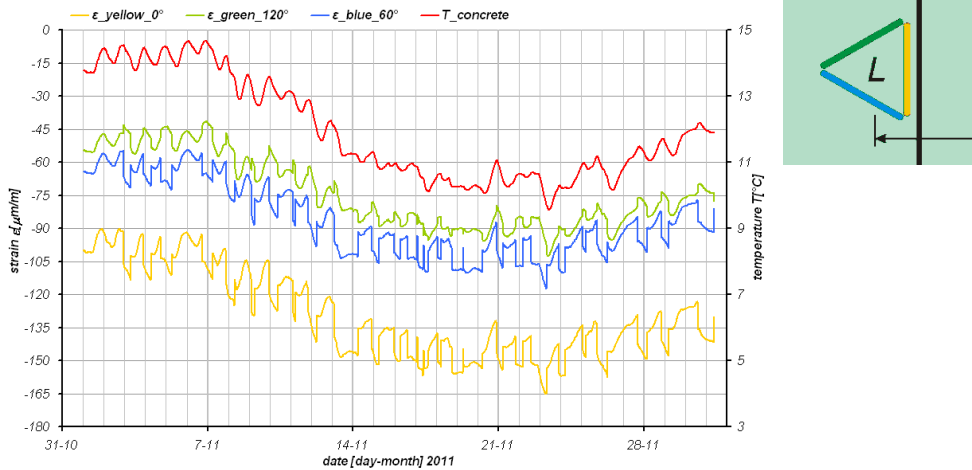
**Fig. 6.** Left strain rosette. The values of strains calculated on the basis of readings of particular extensometers (“yellow”, “green” and “blue” one), under the temperature of the bottom layer of the floor (the temperature of concrete). November 2011.

All the extensometers reacted to changes in the temperature of concrete and exploitation loads in the way they were supposed to. Every time the plane was driven into the hangar and out of it, sudden changes in the strains of the main slab of the floor occurred, especially in the area where that slab was impacted by the main undercarriage legs' wheel load. These changes might be determined by means of a software developed specifically for that purpose. That software's task is to single out the deformations caused by the aforementioned load and, on that basis, establish the values of the major strains and their directions. Figure 7 presents the established values of the major strains for each case of parking the plane inside the hangar in November 2011. The plane driven into the hangar some time after midnight on November 11 caused compression strains of  $20.25 \mu\text{m/m}$  and stretching strains of  $6.35 \mu\text{m/m}$ . The values of the strains obtained by means of the rosette placed in the area of the load from the wheels of the right undercarriage leg, in the same period of time, are almost two times smaller. The moments of driving the plane into the hangar and out of it coincide.

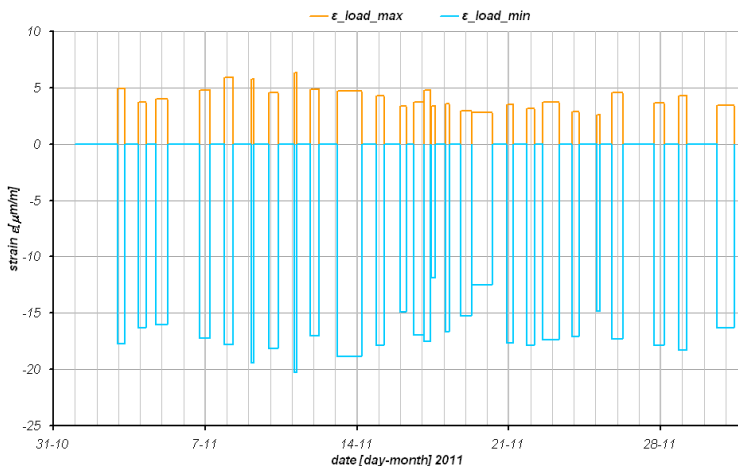
**Fig. 7.** Left rosette. The values of the major strains: maximum ( $\epsilon_{psAmax}$ ), minimum ( $\epsilon_{psAmin}$ ), caused by the load exerted on the main slab of the hangar floor by a plane. November 2011.

Figure 7 presents just the values of the major strains of the floor caused by the wheel load from the main undercarriage legs. In order to depict graphically both the values and directions of the major strains of the hangar floor in the spots where the left and right rosettes were installed, the method explained in Figures 8-10 was adopted:

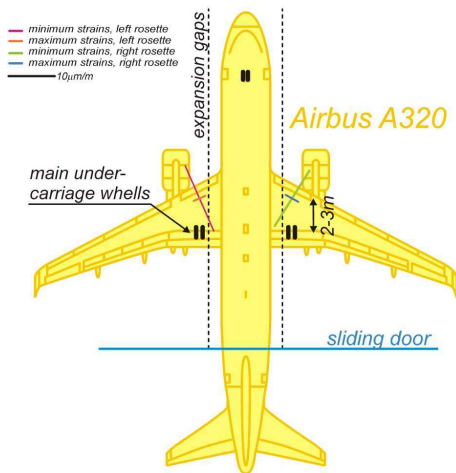
**Fig. 8.** Graphic interpretation of the measurement results: values and major strains for a single registered case of parking a plane inside the hangar.

Figure 8 presents an outline of a plane, with dotted lines marking longitudinal expansion gaps of the slabs making up the main slab. In front of the wheels of the main left undercarriage (in the direction of the plane's nose), two segments intersecting at a right angle were drawn. The intersection spot marks the place where a rosette is installed. The longer segment, drawn with a purple line, is oriented in accordance with the direction of the minimum, compression strains. The shorter, "red" segment, is oriented in accordance with the direction of the maximum, stretching strain. The lengths of the segments are proportional to the values of the deformations. Similarly, the segments represented by green and blue lines depict the major strains determined by the rosette installed in front of the wheels of the right main undercarriage. It is clearly visible that the outermost components of the main slab are dented towards the middle slab. It may certainly be attributed to the fact that each particular slab, as presented in Figure 3, is 6m wide, and the spacing between the main undercarriage legs of an Airbus A320 is ca. 7.5 m. Figure 9 presents all the registered cases of parking the plane inside the hangar in November 2011.

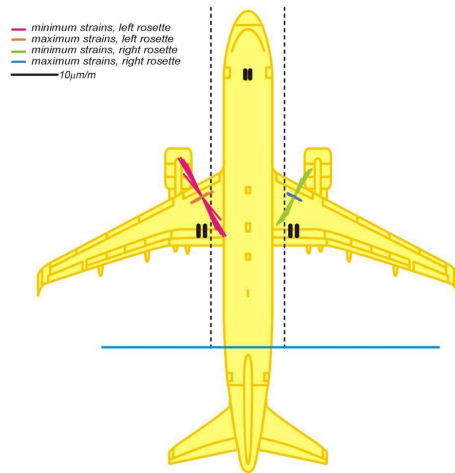
**Fig. 9.** Graphic interpretation of the measurement results: values and major strains for all the registered cases of parking a plane inside the hangar in November 2011.

After removing the plane outline from Figure 9, adding the time axis to that Figure and properly locating all the cases of parking the plane in time, we obtain a clear temporal graph illustrating the values and directions of major strains calculated on the basis of the readings of both rosettes' extensometers (Fig. 10). The points where the pairs of segments intersect correspond, time-wise, to the midpoints of the periods when the plane was parked in the hangar. It can clearly be seen that the strains measured by the left rosette are larger than those measured by the right rosette.

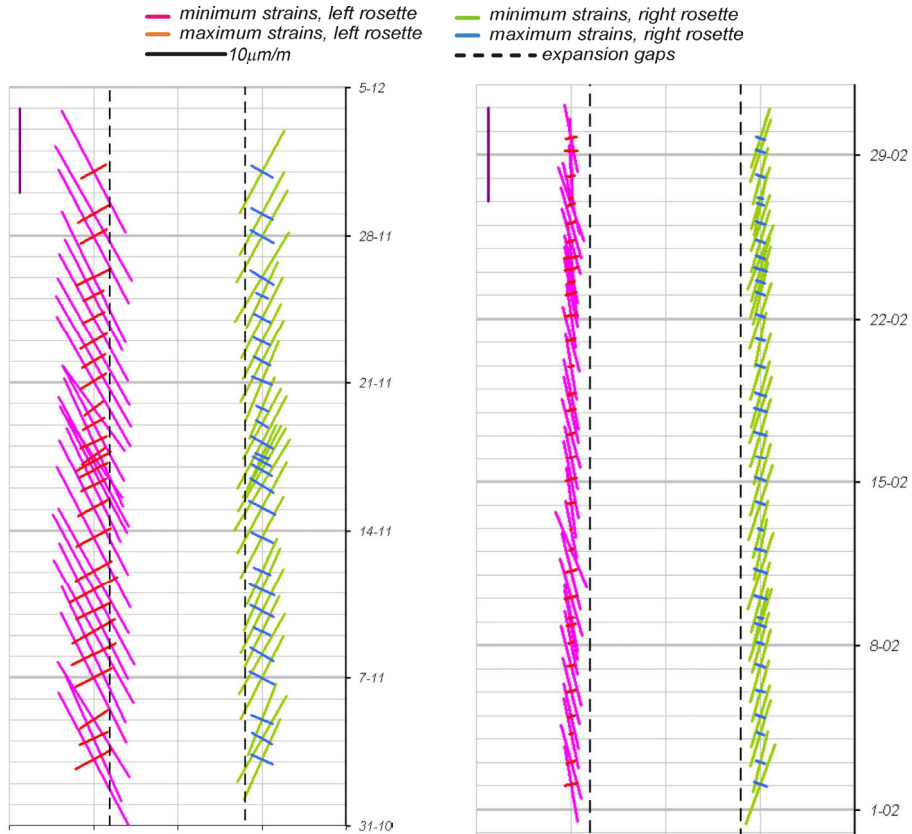
**Fig. 10.** Major strains of the components of the main slab in the rosettes' installation spots, for each case of parking the plane in the hangar in November 2011.

Just like in Figure 10, the graphs were also drawn for each of the observation months that followed, from June 2011 to April 2016. Strains of the hangar floor are still being measured.

Figure 10 presents the strains recorded in November 2011, nine months after the main slab of the hangar floor was built. With time, due to the stabilization of the slab and its foundation, the values of the strains became considerably smaller. Figure 11 presents the strains of the slab in February 2016.

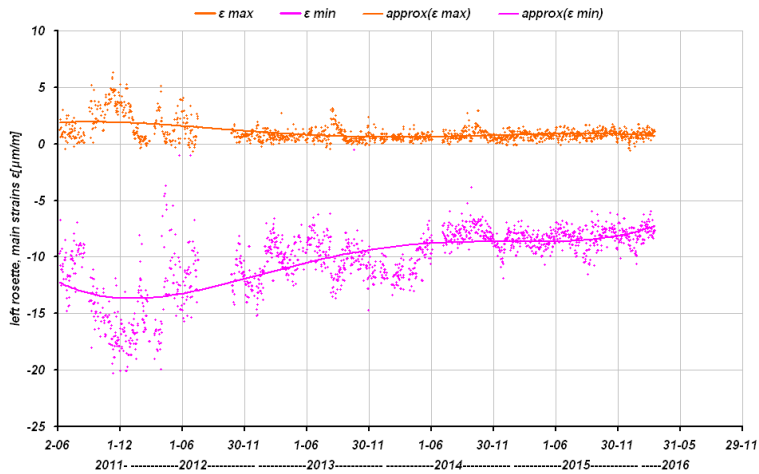
**Fig. 12.** Left rosette, the tendency of reduction in the values of maximum strains ( $\epsilon\_max$ ) and minimum strains ( $\epsilon\_min$ ) for each case of parking a plane inside the hangar.

The tendency of temporal reduction in the values of strains caused by planes parked in the hangar is demonstrated by Figure 12 (left rosette) and Figure 13 (right rosette). Each pair of points – one above the dotted line and the other below it – represent the values of the strains: stretching and compression ones, respectively, caused by a single case of parking a plane in a hangar. The total number of such cases is 1,442.

Figures 12 and 13 clearly show that in the initial, year-long period of using the hangar, the values of the strains, module-wise, displayed a tendency to grow. That tendency later changed into a tendency to decrease, resulting in a stabilization of the strain values. Apart from the aforementioned reason for the stabilization of strains, there is also another potential reason, i.e. building a ca. 30 cm thick concrete parking slab of an area of 11 ha in the vicinity of the hangar. That investment was carried out in the summer months of 2012. During that time, the hangar was not used, which is visible in Figures 12 and 13. For sure, the load from the constructed parking slab had an impact on migration of waters, which resulted in an increase in humidity and bearing capacity of the ground beneath the hangar. This is confirmed by increased water content in the servicing wells of the hangar, as well as by a small, several millimeter uplift of the floor along the gate.

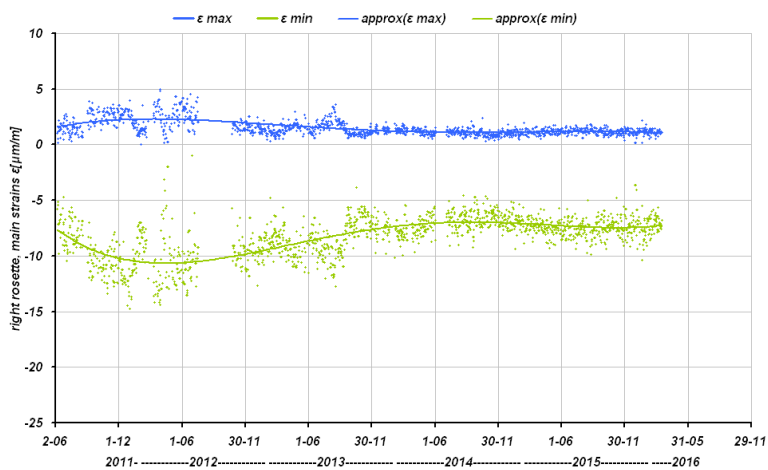
**Fig. 13.** Right rosette, the tendency of reduction in the values of maximum strains ( $\epsilon\_max$ ) and minimum strains ( $\epsilon\_min$ ) for each case of parking a plane inside the hangar.

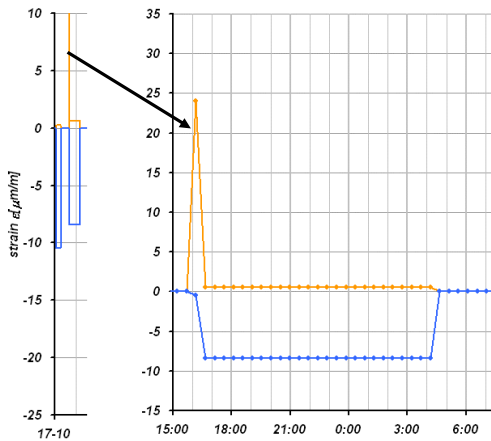
**Fig. 14.** Values of the major strains registered on October 17 and October 18, 2013. Left rosette.

registered cases of parking the plane in the hangar, there was only one short instance when the aircraft was not parked in a prescribed manner. Figures 14 and 15 present the major strains of the hangar floor in the spots where the rosettes were installed.

On October 17, 2013, at 16:00, the values of the major strains for the left rosette were: 24  $\mu\text{m/m}$  (stretching) and 0.5  $\mu\text{m/m}$  (compression), and for the right rosette – 30.9  $\mu\text{m/m}$  (stretching) and 3.9  $\mu\text{m/m}$  (compression). The strains registered half an hour later were: 8.4  $\mu\text{m/m}$  (left rosette) and 6.7  $\mu\text{m/m}$  (right rosette). Therefore, module-wise, they are 2.9 and 4.6 times smaller, respectively, than the values registered at 16:00. Most likely, in the initial stage of parking, the plane was driven considerably further into the hangar (it might have been the case that the wheels of the main undercarriage leg stopped in the rosettes' installation spot), and then pushed back to the prescribed position. It may be expected that, if such a situation had occurred on November 11, 2011, the registered stretching strains would have reached the values:  $20.25 \times 2.9 \approx 59 \mu\text{m/m}$  for the left rosette, and  $10.8 \times 4.6 \approx 50 \mu\text{m/m}$  for the right rosette.

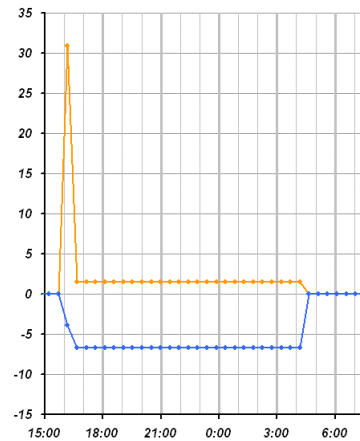
**Fig. 15.** Values of the major strains registered on October 17 and October 18, 2013. Right rosette.

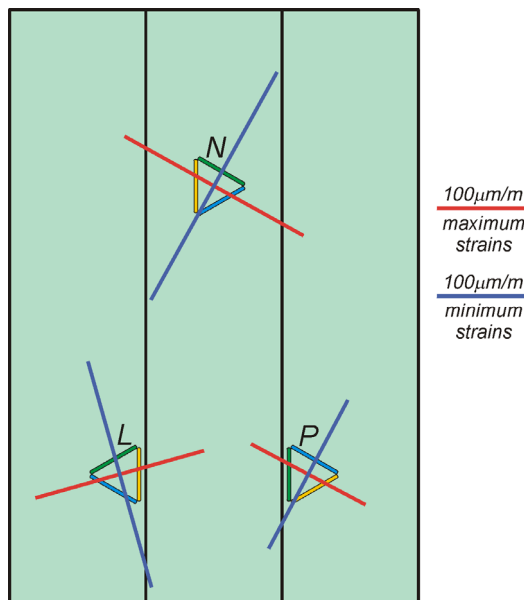
**Fig. 16.** Contraction of the slab's building material (reinforced concrete) in the installation spot of strain rosettes.

As each rosette was equipped with a thermistor, it is possible to estimate the thermal strains of the slabs in the spots where the rosettes were installed. These strains fall within the range of 10–14  $\mu\text{m/m}$ , so they approximate the values of the concrete strains as specified in the tables [3]. The hangar is heated in wintertime, and in summer, the temperature in its inside may reach up to 30°C, which results in a temperature gradient on the floor slabs. That gradient causes the slabs to dent, especially on the edges, which was demonstrated by measurements [4]. The aging of the material of which the slabs were built, i.e. reinforced concrete, results in its slow contraction. After an almost six year long observation period (cf. Fig. 16), that contraction reached the values within the range of 120  $\mu\text{m/m}$  (rosette *P*, minimum deformation) – 230  $\mu\text{m/m}$  (rosette *N*, maximum deformation).
