# Mitigation of the Wonorejo active fault on the Probolinggo-Banyuwangi toll road

<sup>1</sup> Manager of Design Control, Technical Division, PT. Jasamarga Probolinggo Banyuwangi, Indonesia

**Abstract.** As the world's largest archipelago, Indonesia is located between the world's most active seismic region. This situation leads Indonesia to be part of the region that has the highest seismic potential in the world. In recent years, one of the infrastructures that experiences significant development is the toll road. As Indonesia is located in active tectonic areas, it is certainly a challenge in the process of determining the alignment and technical design of the toll road. The original alignment (based on basic design) of Probolinggo-Banyuwangi toll road which is now in the planning stage was passing the Wonorejo fault which is an active fault based on the Seismic Hazard Maps of Indonesia 2017. Because earthquakes are natural events that have not been accurately calculated and estimated, both when and where they occur as well as their magnitude, according to the mitigation strategies for fault rupture suggested by FEMA (Federal Emergency Management Agency), the fault rupture shou

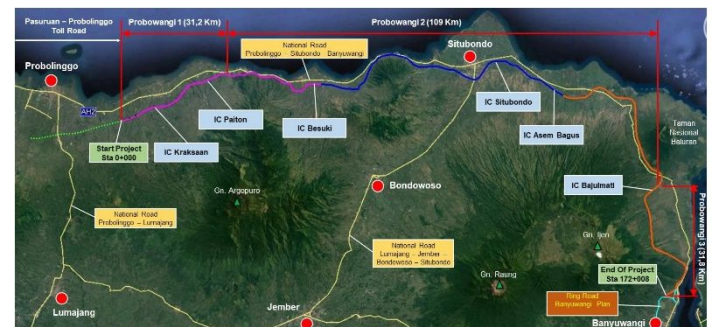
**Fig. 5.** Original Probolinggo–Banyuwangi Toll Road Alignment

The original alignment (based on basic design) of the Probolinggo-Banyuwangi toll road which is now in the planning stage was passing the Wonorejo fault which is an active fault based on the Seismic Hazard Maps of Indonesia in 2017. The location of this fault needs to be watched out, because it is indicated that it is an active fault and it can cause an earthquake. Based on Seismic Hazard Maps of Indonesia in 2017, the maximum magnitude of this fault is 5.7 and the slip rate geodetic is 0.3 mm/year. Earthquake does not just deal with the strength or magnitude of the earthquake. In the case of this fault, the infrastructures or buildings that stand just above the fault line are in dangerous situation.

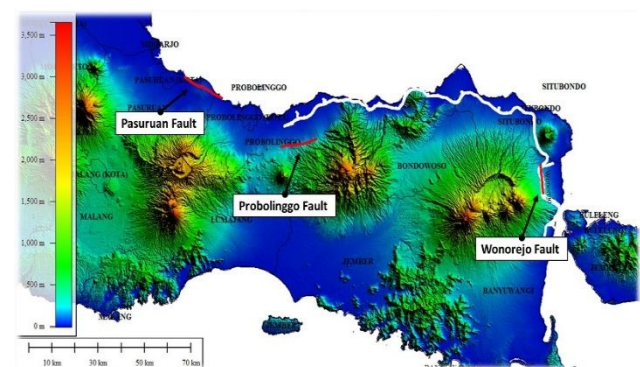
**Fig. 6.** Probolinggo – Banyuwangi Toll Road Alignment and the location of the Faults (BPPU ITS, 2018)
