# Seismic performance of brick masonry infilled frame structures with bed joint reinforcements

**Abstract.** This paper presents the evaluation of the seismic performance of brick infilled RC frame structures with bed joint reinforcements based on reversed cyclic lateral load tests. Three specimens of the structural model of 1/4 scale-down single-story single-bay brick infilled RC frame was prepared, which were brick infilled RC frames with and without bed joint reinforcements. Two specimens of brick infills with bed joint reinforcements were different in the spacing of bed joint rebars. The specimens were tested by applying a reversed cyclic lateral loading in-plane direction. During the tests, the crack propagation was observed at the peak and residual drifts of each loading cycle to recognize the failure mechanisms of the specimens. As the results, although the use of the bed joint reinforcements ineffective to increase the lateral strength of the overall infilled frame structure. The rebars in mortar bed joints role to sustain the lateral strength in plastic deformation, and provide the whole structure with high ductility. It seemed that the rebars in mortar bed joints confine

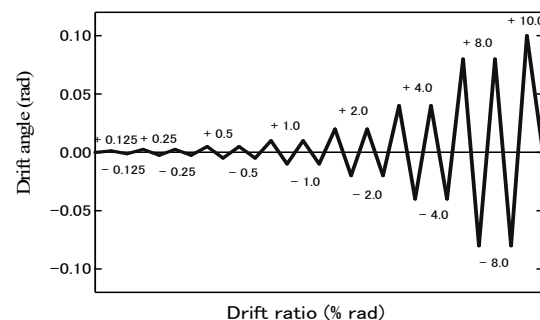
**Fig. 4.** Lateral loading history.

According to the FEMA 461 [13], the lateral loading program was employed to specimen with initial cycles to  $R=1/800$  followed by two cycles to  $R=1/400$ ,  $R=1/200$ ,  $R=1/100$ ,  $R=1/50$ ,  $R=1/25$ ,  $R=1/12.5$  and the a final load by a pushover to  $R=+1/10$  rad where  $R$  was drift angle that was a ratio of lateral displacement to column height, used for controlling the incremental loading. The lateral loading history applied to specimens is shown in Fig. 4. Incremental of the applied lateral static load and lateral deformation were monitored and recorded throughout the tests. An initial crack and its crack propagation were drawn on the RC frame and brick masonry infill in every loading cycle for identifying the failure mechanism of the specimen.

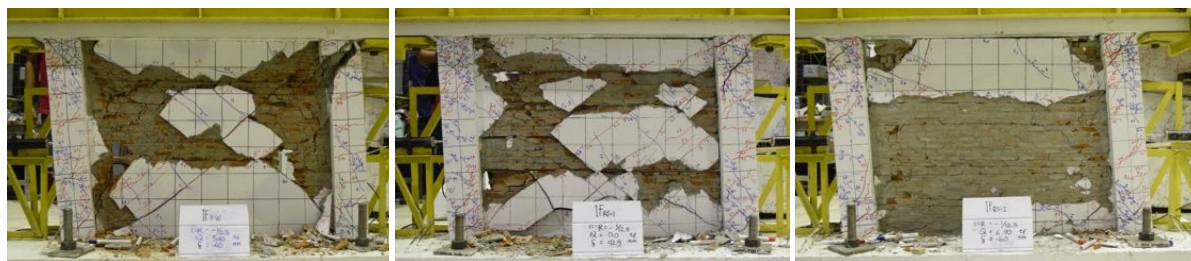
a) IF-BM specimen

b) IF-RM-01 specimen

c) IF-RM-02 specimen

**Fig. 5.** The final condition of specimens a drift angle to  $R=1/12.5$ .

Under cyclic lateral load on brick infilled RC frame (IF-BM) specimen, the initial flexural crack was observed at the bottom of the tensile column in the cycle 1/800 at a drift ratio of 0.13%. The flexural cracks were developed on the bottom of both columns during the cycles of drift angle 1/400. Initial shear crack on the center of brick infill occurred during the cycle 1/200 at a drift ratio of 0.47%. Further, flexural cracks in both columns grown, and shear cracks on infill widened/elongated during the cycles of 1/100. The maximum lateral strength was observed at these cycles. At the next cycles of 1/50, an initial shear crack occurred at the top of the tensile column at a drift ratio of 1.11%, the plaster mortar started to peel off, the shear cracks on the ends of tensile columns were widened, and the lateral strength was gradually degraded. Consequently, the brick infill failed in shear during the cycle 1/25 at a drift ratio of 3.65%. Moreover, the boundary column failed in shear during the cycle 1/12.5, and the brick infill failed in out of plane direction during the cycle 1/10. After the failure of column and brick infill, the lateral strength significantly dropped. The condition of the IF-BM specimen after the cycle of 1/12.5 is shown in Fig. 5(a).

the plane direction. Fig 5(b) shows the cracks of the IF-RM-01 specimen at the cycle of 1/12.5.

Initial shear crack on brick infill of IF-RM-02 specimen appeared at the first cycle of 1/800 at a drift ratio of 0.05%. Further, in this cycle, an initial flexural crack occurred on brick infill at a drift ratio of 0.12%. During the cycle 1/400, initial flexural and shear cracks were observed on the compressive column and tensile columns, respectively, at a drift ratio of 0.22%. In subsequent cycles, several shear cracks dominantly appeared in the center area of infill, and the plaster of mortar started to peel off during the cycles 1/200. However, the plaster of mortar collapsed during the cycles 1/50, and then brick infill failed in shear, the development of shear cracks on infill was slower when it was compared to brick infill without bed joint reinforcements. Further, the tensile column failed in shear during the cycles 1/12.5 at a drift ratio of 3.9%. After the shear failure of the column, the whole structure dropped its lateral strength to 67% of the peak, but the infill persisted from out of plane failure. The final condition of the IF-RM-02 specimen at drift angle  $R=1/12.5$  is shown in Fig. 5(c).
