# Specific Issues with Liquidation of the Mineral Deposit in Vazany by the Kromeriz

**Abstract.** This paper investigates the problematic liquidation of now unused deposit of brick clay in south – eastern part of Czech Republic approximately 1.5 km to SW from the city centre of Kromeriz. Initially the condition of the deposit is described from the time of closure to the present day, including a detailed discussion of the problem. Main part of this paper is devoted to the design concept of reclamation of the unused deposit. The purpose and aim of this conception is to design a proposal of technical and biotechnical measures to create conditions for full-fledged reintegration of this segment of land, affected by mining, into it's surrounding area. The conception summarises the whole scale of necessary tasks needed to achieve remediation and reclamation of the area.

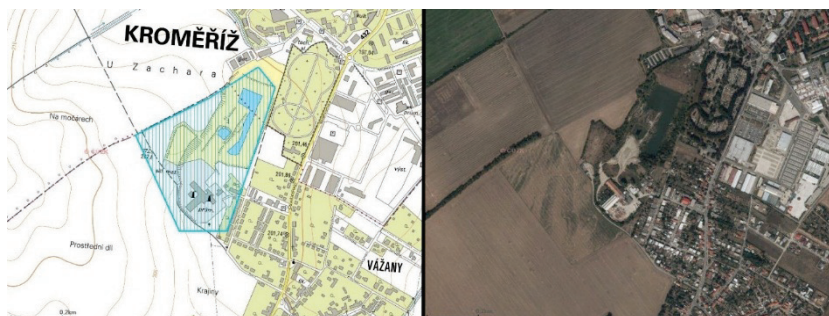
**Fig. 1.** Mining area of clay pit in Vazany (left) and satellite view (right).

There is an obligation in Czech Republic to liquidate the mines after the mining is terminated stipulated by Act No. 44/1989 Coll. about protection and utilization of mineral resources (Mining Act) [1]. Mining organization is according to § 32 of this Act obligated to provide a Plan for the opening, preparation and extraction of mineral deposits which also includes the Project of remediation and reclamation. During the liquidation of extracted and unused mining area several complications may occur. These should be resolved by the mining organization, which was carrying out the mining, (Fig. 1).

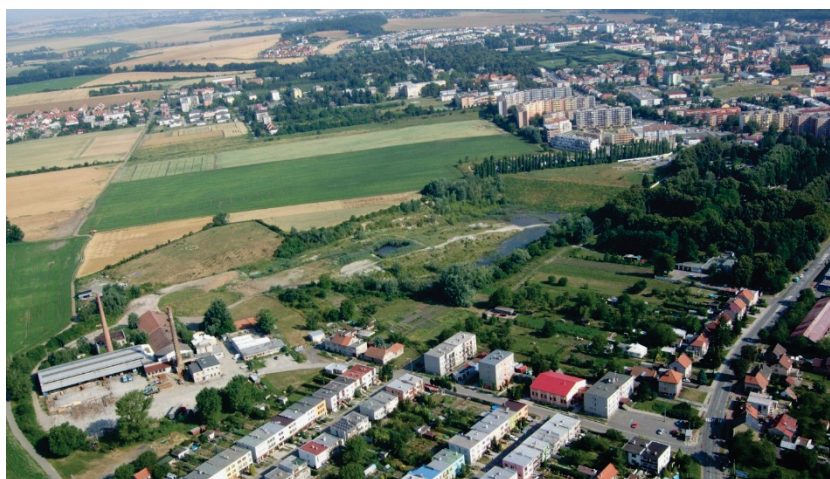
**Fig. 3.** Clay pit, former brickyard and housing estate.

The whole area designated for reclamation occupies about 7 ha, 2 ha of that are water bodies, (Fig. 3). Water surface is on the bottom of the clay pit and is in contact with the frontal slop of the reclaimed landfill owned by the city Kromeriz. A total of 95 304 m<sup>3</sup> of mine drainage was accumulated in the mining area in February 2018.

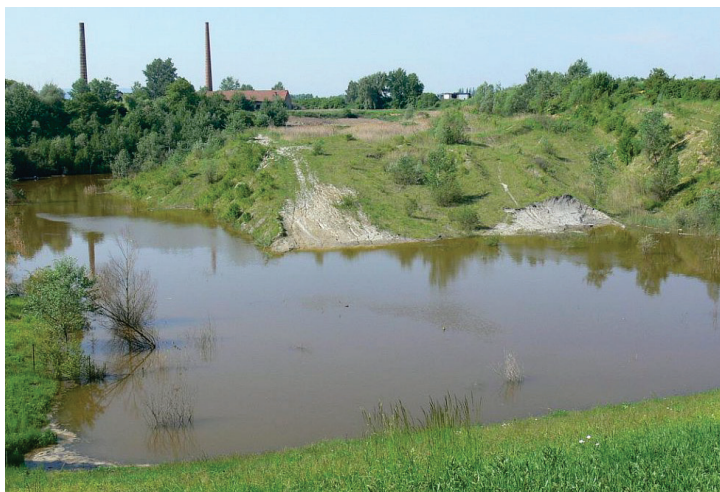
**Fig. 4.** Lake of mine drainage.

A total of 95 304 m<sup>3</sup> of mine drainage were accumulated in the mining area in 2018, see Fig. 4. The area has characteristics of no drainage basin, so accumulation is to be expected. The project of remediation and reclamation had to solve further security of the landfill regarding the rising water levels in the mining area and the amount of seepage mine drainage into the body of the landfill.

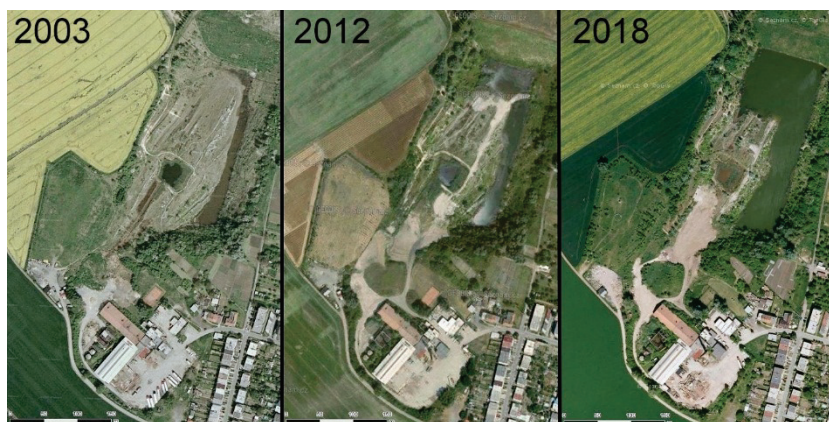
**Fig. 5.** Development of clay pit from the ceasing of mining to the current time.

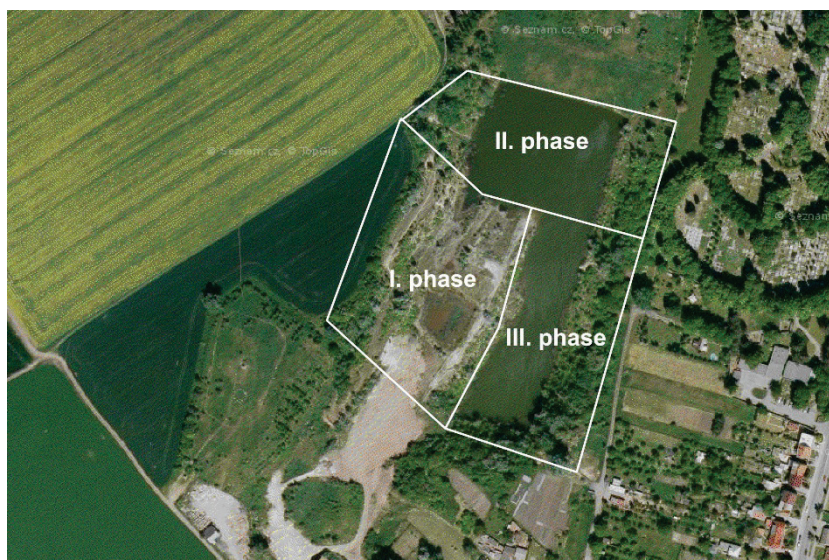
**Fig. 6.** Scheme of reclamation phases.

Reclamation is designed to be done in three phases, (Fig. 6), in succession to filling up with technological materials at the liquidation. The first phase is to do reclamation of the southern part above the area of the brickyard, the second phase is to reclaim the northern parts next to the landfill Vazany – Zachar and the third phase is to finish the middle part in between the previous ones, (Fig. 6).
