# Predicting remaining life of lattice steel transmission tower based on condition assessment and corrosion hazard data

**Abstract.** This paper presents a novel approach for predicting the remaining life of lattice steel transmission towers in Malaysia. The transmission tower components assessment grouped into ground corrosive condition, foundation condition, lattice steel body of the tower, and conductor. Significant and scientific field investigation and visual assessment evaluate the state of the tower. The corrosion hazard, which is a product of climate and air pollution data, is used. Three separated lines and 84 towers were selected with different ages of the tower in service. The Weighing Scoring Method with Analytical Hierarchy Process to impose the weighed factor was used. The survival function analysis is used to predict service life, and the tower remaining life was determined. The paper shows how to use the model to predict the remaining life of a transmission tower and how this can be used to advise maintenance planning.

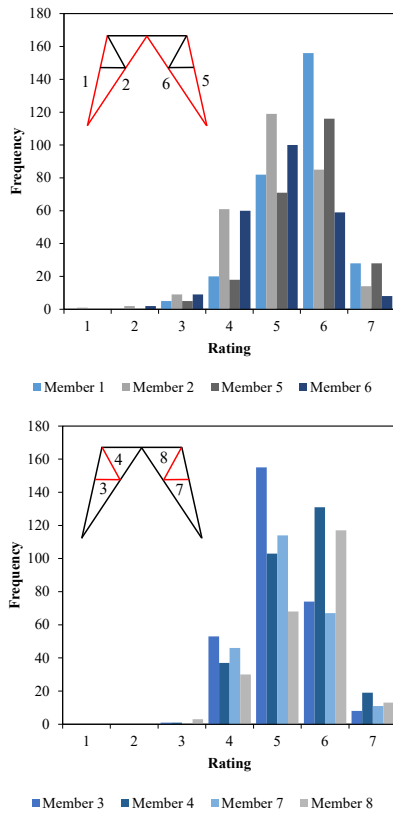
**Fig. 2.** Corrosion rating distribution for main member and bracing.

Corrosion was the common sign of deterioration observed during the assessment. The corrosion was on the galvanized coating with no significant further corrosion to the carbon steel member. The galvanized Zink coating observed has more than 100 microns of thickness. Figure 2 shows the distribution of corrosion on tower members. It shows that corrosion is observed more often on redundant members with less slanted or flat-oriented members. There is 25% soil with high and highly corrosivity conditions recorded and affecting the concrete condition. Figure 3 shows the Partial correlation graph of soil corrosivity and concrete condition.
