Low-speed impact damage analysis of aviation composite material structure

Abstract. Although the carbon fiber reinforced composite material has high specific strength and stiffness, design-versatility, anti-corrosion and other excellent features, but the impact resistance of composite structures is poor. Therefore, the composite laminates low-speed damage analysis has important significance. Based on a three-dimensional analysis theory of cumulative damage, using the commercial finite element analysis software ABAQUS to establish laminates subjected to low velocity impact finite element model. according to the numerical results and the consistency of the test results, shows that the used model of the article is reasonable and accurate, and the numerical simulation method is verified to be feasible. Finally, through the numerical simulation of process of laminated plates low speed impact damage, the damage characteristics and damage mechanism of the laminates at different times are analyzed, and the forming reasons and expanding rules of the main damage forms of fiber damage and matrix damage are revealed.

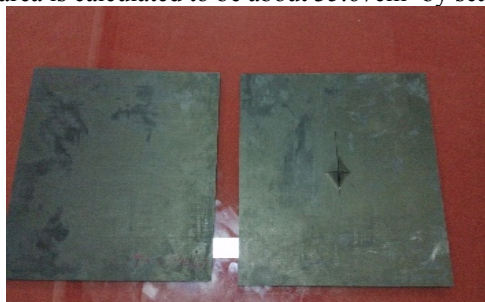
Fig. 1. Comparison of before and after injury

Through the impact test of the laminate, under the action of the impact force, with the gradual penetration of the punch, the depth of the pit of the laminate becomes larger and the bulge on the back becomes more and more obvious, and the crack length of the substrate gradually increases. Extend along the boundary of the laminate. At the same time, the force-displacement curve is drawn from the data obtained through the low-speed impact experiment. The absorbed energy of the material under the impact energy of 20.01J is calculated to be 2.38J through the force-displacement curve.

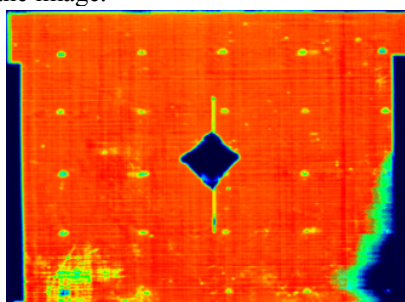
The quality of the punch used in this test is a hemispherical hammer with a diameter of, the height of the test punch is set to $h=0.4002m$, and the impact energy is 20.01J. After the test, an ultrasonic C scanner was used to detect damage to the damaged laminated structure. The damage when the impact energy is 20.01J is shown in Figure 1 below. The damage image scanned by the ultrasound C scanner is shown in Figure 2. It can be observed from the figure that the shape of the damaged part is approximately a quadrilateral, and the damage area is calculated to be about $35.67cm^2$ by scanning the image.

Fig. 2. C-scanned laminate damage image

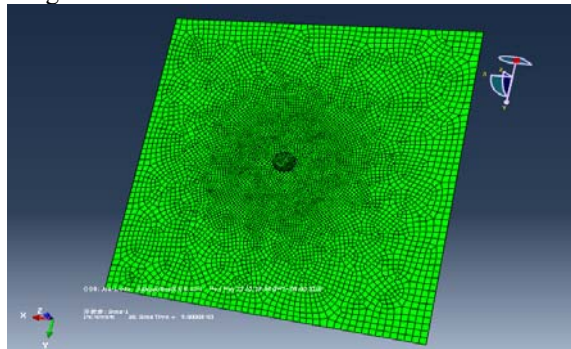
The composite laminate is composed of multiple fiber-reinforced single layers and interlayer bonding layers. The simulated laminate in this paper is the above-mentioned experimental specimen, with a geometric size of 250mm×250mm, a single layer thickness of 0.125mm, and a total of 24 layers. The composite laminate after modeling has a total of 7195 solid elements, and the punch has 1193 solid elements. The numerical simulation diagram is shown in Figure 3.

Fig. 3. Numerical simulation diagram of laminated structure

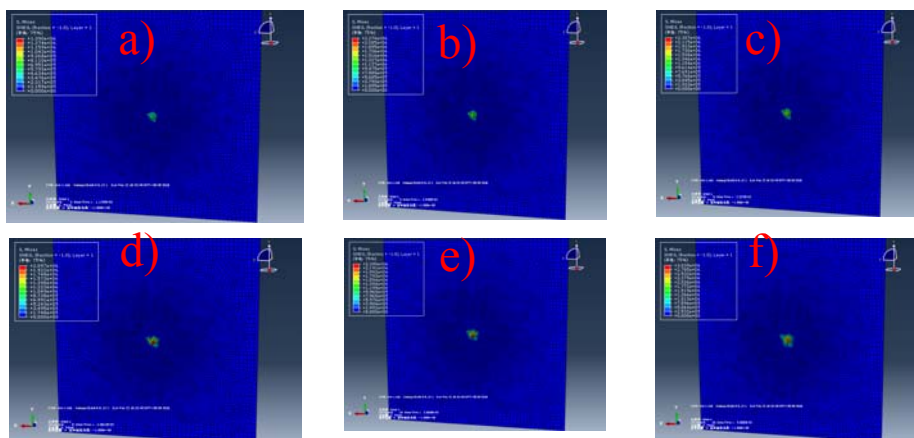
Figure 4 shows the progressive damage process of the matrix and fibers of the composite laminate at different times when the impact energy is 20.01J. The red that appears at the damage of the laminate is the matrix damage, and the colors other than the red are the fiber damage.

Fig. 4. Matrix and fiber damage diagrams at different times a) $t=1.18\text{ms}$, b) $t=2.94\text{ms}$, c) $t=3.53\text{ms}$, d) $t=4.68\text{ms}$, e) $t=5.81\text{ms}$, f) $t=9\text{ms}$

It can be observed from Figure 4 that at the beginning of the impact, the laminate is subjected to bending stress, the front side of the impact is subjected to compressive stress, and the reverse side of the impact is subjected to tensile stress. The reverse side of the laminate first produces tensile failure of the matrix. With the continuous decline of the punch, a significant depression appeared in the center of the impact, and the damage range of the matrix on the reverse side of the impact was further expanded and gradually expanded to the front of the impact.
