# Study on early warning of rapid sinking of large land caisson in silt layer

The south anchor caisson foundation of a suspension bridge is the first large-scale land caisson constructed with a deep silt layer. The plane size is 70×63meters (m) and the total height is 67.5m. There are 30 rectangular wells (10.84×10m) in total. Except for the steel shell concrete caisson in the first section, the rest are reinforced concrete caisson. The process of “three times of height connection, three times of sinking” was adopted to complete the height connection and sinking of the caisson.

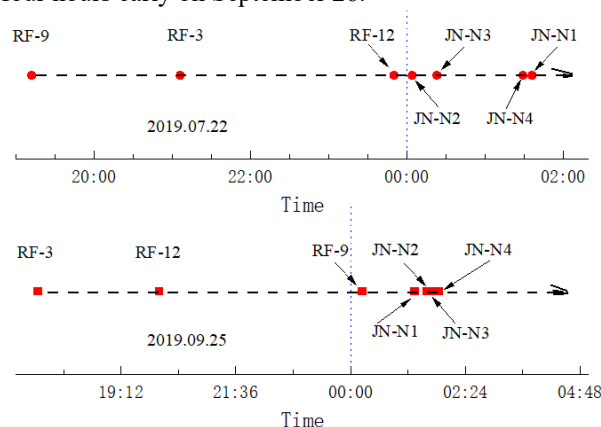
The early warning timeline of rapid sinking is shown in figure 11. The settlement warning was later than the earth pressure warning at the corresponding point, and there was a time difference between them. The earth pressure warning time and settlement warning time of the side with a small supporting area were earlier than those on the other side, and it was more sensitive to dewatering. The above-mentioned early warning mechanism was established after the rapid sinking on July 22, and successfully issued a level three warning four hours early on September 26.

**Figure 11.** Warning time line of rapid sinking
