# Mosul Dam: Challenges and Innovative Solutions

Juan Vargas<sup>1</sup>, David Sawitzki<sup>2</sup>, and Nagesh Malyala<sup>3\*</sup>

**Abstract.** Reservoir siting, permitting, construction and operation can, at times, face insurmountable challenges. Mosul Dam, a multipurpose dam located in Northern Iraq, is constructed on a dissolvable anhydrite, gypsum and limestone formation. To mitigate long-term impacts to the foundation, the dam designers opted for a structural solution. They incorporated into the design a grouting gallery for long-term maintenance grouting of the foundation cutoff grout curtain. In 2016, concerns with the risk posed by the deteriorating foundation resulted in the execution of the Mosul Dam emergency grouting and maintenance project. This paper illustrates how the international community proactively came together to prevent an incident of potential tragic proportions well before it could manifest itself. The emergency grouting work is an excellent example of Governments investing in preventing a disaster rather than investing in fixing a disaster. The paper presents the general approach adopted for the execution of the emergency project and discusses how

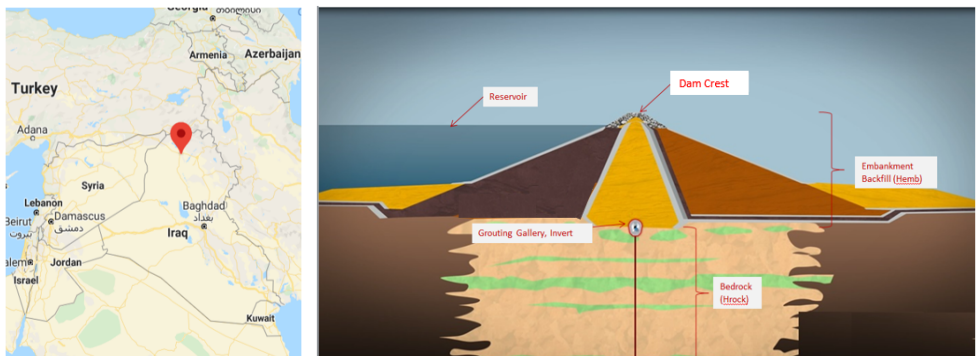
**Fig. 1.** Project Location Map. Source Google Maps. **Fig. 2.** Dam Cross Section and Grouting Gallery.

Mosul Dam, in Northern Iraq (See figure 1), is constructed on a dissolvable anhydrite, gypsum and limestone formation. As the gypsum dissolves, it can form interconnecting openings in the foundation that can compromise the stability of the dam. To mitigate long-term impacts to the foundation, the dam designers opted for a structural solution. They incorporated into the design, a grouting gallery, for long-term maintenance grouting of the foundation grout curtain (See figure 2). Maintenance grouting has been performed continuously since the end of construction; however, concerns with seepage through the foundation prompted a board of consultants to recommend limiting the reservoir pool elevation from El.335 to El.319. This non-structural measure has been in place since 2006. Military hostilities resulted in pausing maintenance grouting temporarily in 2014, and the high risk posed by the deteriorating foundation drove the Government of Iraq to secure funding loans for emergency grouting and repairs from the World Bank and the Italian Government. The United States (US) Government also allocated assistance funding for the project. In 2016, the Iraqi Government entered into a design-build contract with Trevi, an Italian grouting contractor, for the emergency work. At the same time, and due to a separate Government to Government Agreement between the US and Iraq, the United States Army Corp of Engineers (USACE) was appointed as the Engineer for the project. AECOM was subsequently contracted by the USACE to support the Task Force [1-3].
