The use of the DInSAR method in the monitoring of road damage caused by mining activities

Radosław Murdzek¹, Hubert Malik¹ and Andrzej Leśniak¹

Abstract. This paper reviews existing remote sensing methods of road damage detection and demonstrates the possibility of using DInSAR (Differential Interferometry SAR) method to identify endangered road sections. In this study two radar images collected by Sentinel-1 satellite have been used. Images were acquired with 24 days interval in 2015. The analysis allowed to estimate the scale of the post-mining deformation that occurred in Upper Silesia and to indicate areas where road infrastructure is particularly vulnerable to damage.

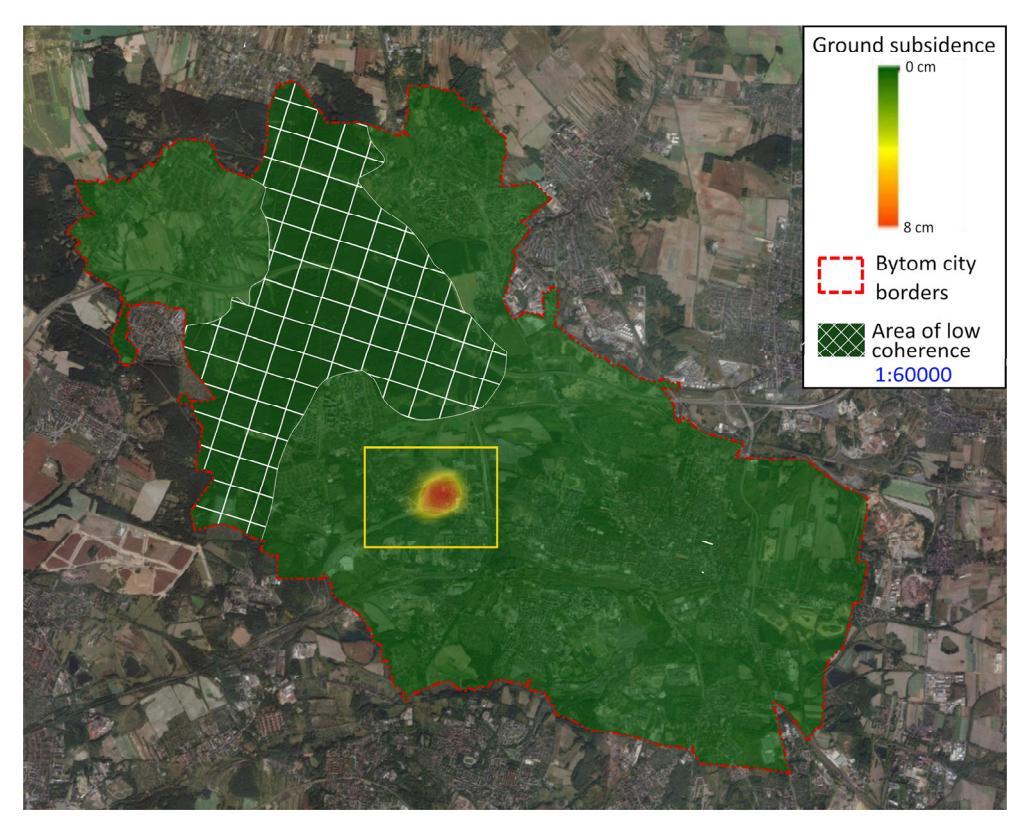
Then interferogram was converted to ground subsidence map (fig.1). One subsidence trough in the central part of Bytom was detected. Depth of this trough was about 6 cm. The centre of detected trough is localized at 18°52'10"E, 50°21'24"N.

Fig.1. Map of ground subsidence that occurred between 29.11.2015 - 23.12.2015. One subsidence trough was detected in the central part of Bytom city. Area marked in white is the area of low coherence and was not included in analysis.

4 Discussion

Area under DK94 route has collapsed on the section of about 1200 m, while under DK88 route on the section of about 1000 m. In both cases, the maximum subsidence exceeded 5 cm. It should be emphasized, that the detected terrain deformations occurred within only 24 days (between November 29, 2015 and December 23, 2015). Mining damage caused by mining operations conducted under the Karb district in Bytom has been registered for many years. Negative effects of coal mining have damaged, among others, water supply systems in the district, viaduct on Wrocławska street, or a nearby gas station [14]. In addition, in June 2016, the restaurant "McDonald's" located at Konstytucji street was closed. The reason for the decision was the poor technical condition of the building and high maintenance costs related to the growing costs of removing mining damage. Perhaps if the monitoring of the stability of this area was carried out earlier, the decision to build a restaurant in this place would not have been made and the DK88 and DK94 routes would be planned in a different way to avoid its destruction.
