Study on the Law of Surface Cracks While Coal Mining in the Thin Bedrock and Thick Unconsolidated Layer of Yu-Shen-Fu Mining Area

Abstract. The law of surface cracks caused by coal mining in thin bedrock and thick unconsolidated layer was studied in Yu-Shen-Fu mining area. The crack development in the overlying strata of the coal mining face was detected by drilling survey technology, the whole process of the ground surface crack dynamic evolution was carried out by similar material simulation, and the law of surface cracks evolution was verified by on-site tracking measurement. The study reached the regulation of the overlying strata failure and dynamic evolution of surface cracks caused by coal mining under thin bedrock and thick unconsolidated layer in Yu-Shen-Fu mining area, which can provide theoretical support for the ecological restoration of western mining area.

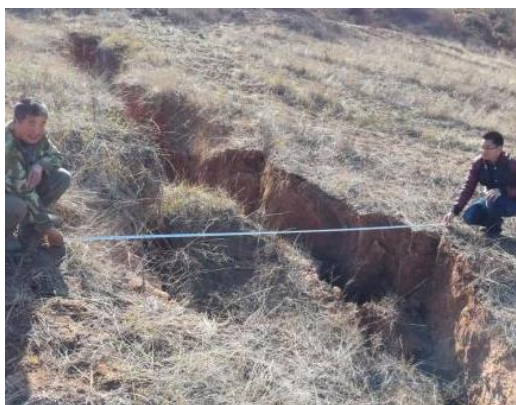
Figure 1. Disaster overview of surface cracks caused by mining

facilities such as roads, railways, pipelines and transmission lines within the influence of the goaf will undergo local strains such as stretching, compression and distortion under the influence of the goaf. When the deformation reaches a certain level, the traffic facilities will be partially damaged. (3) Soil erosion. While the coal resources are mined, the caving zone and the fracture zone of the goaf will develop into a loose aquifer, and the aquifer will be drained to form a precipitation funnel, resulting in a large loss of surface water. According to statistics, coal mining has formed more than 150 regional precipitation funnels in the country, with a total funnel area of 87,000 square kilometers. Soil erosion has caused more serious damage to the otherwise fragile ecological environment in western China. (4) Water and sand inrush of working face. Under the condition that the working face tends to be fully plucked in the width direction, the caving zone formed by the overlying strata in the goaf will rapidly develop into a loose aquifer with strong water-richness, and the loose sand body will flow into the working face through the falling crack under the action of self-weight stress and hydraulic force, causing water and sand inrush accident. The surface cracks obtained by a large number of on-site investigations is shown in Figure 1.

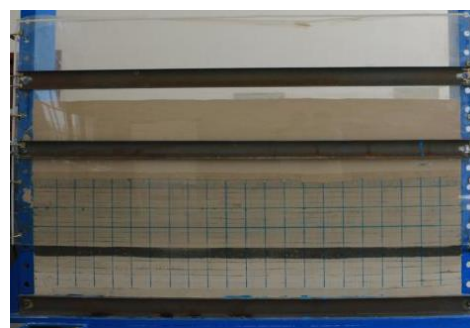
Figure 5. Initial state diagram of the model before coal mining

The similar material simulation model design had a bedrock thickness of 35m, a coal seam thickness of 5m, a unconsolidated layer thickness of 40m, a simulated mining coal seam length of 120cm, an open-off cut 50cm from the right side of the model, and a stopping line 50cm from the left side of the model. The mining depth is determined according to the thickness of the overlying strata and the thickness of the unconsolidated layer. The simulation of the unconsolidated layer used the acrylic transparent plate as the front limit of the section, and the quartz sand was used as the simulated material, which did not contain the cemented component. The simulated working face mining speed was 15m/day, referred to the time similarity coefficient, the model excavation speed was calculated as 10cm/h and the whole continuous excavation time of the designed coal seam in the model was 12h. The state of the experimental model before the excavation was first observed, and data was collected for each collapse occurred in the mining process. The state of the experimental model before the excavation was shown in Figure 5.

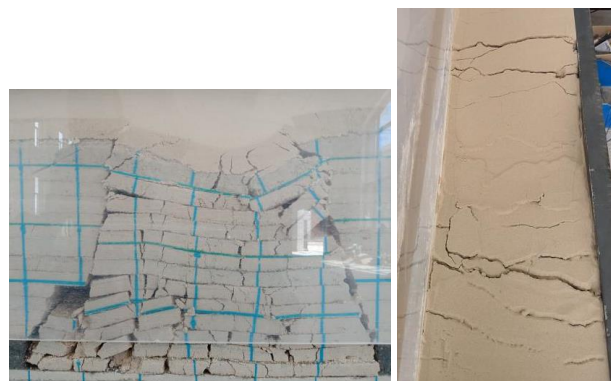
Figure 7. Deformation state and surface crack effect diagram when the overlying strata fell to the top of the bedrock

The whole simulated coal seam was carried out at a constant speed, and the overlying strata collapse was staged collapse with the advancement of the working face. The specific phenomenon was described as follows: when the simulated coal seam was mined to 28 m, the immediate roof of the goaf was initially collapsed; when the working face continued to advance to 39.8m, the immediate roof collapsed further along the direction of the working face, the fallen length increased to 36m, and the fallen rock layer developed upward to 9.8cm; when the working surface continued to advance to 46.2m, the fallen length of rock layer along the working surface increased to 46m, the vertical development increased to 15.5m; when the working surface continued to advance to 52m, two deformation processes appeared at the overlying strata in a short time. First, the fallen length of rock layer along the working surface increased to 52m, and the vertical development increased to 30m; then, the fallen rock layer directly developed to the top of the bedrock, a "sinking basin" appeared at the surface of the unconsolidated layer immediately, and cracks appeared at the edge area of the "sinking basin". The deformation state of the overlying strata at this time was shown in Figure 7; as the working face continued to advance, the overlying strata was degraded periodically, the average stepping distance was 19m. The surface cracks also showed periodic development.

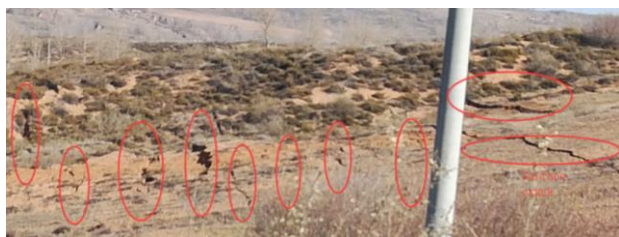
Figure 9. Field measurement overview of surface cracks

Through the actual observation of surface cracks in coal mining face and the comparison of similar material simulation experiments, it can be concluded that the surface cracks showed a dynamic process of "cracking-closing", the surface cracks, overlying strata slump and internal stress changes of rock mass showed the same spatial and time periodicity. The scene of the ground crack was shown in Figure 9.
