# Gravel and boulders mining from mountain stream beds

**Abstract.** Mountain stream gravel is very often legally and illegally mined and gravel is removed from river beds sometimes on the very large scale which is disastrous for fluvial situation of rivers, for river ecology and river engineering works done for flood protection such as river revetments, bridges and all hydraulic structures. This situation makes a big problem for all river managers. Thus gravel mining of the mountain streams in the Polish Carpathians is the subject of many scientific studies when we observe river problems, but also it has a place in Slovakia. This paper deals with such problems additionally showing examples of such bad practices.

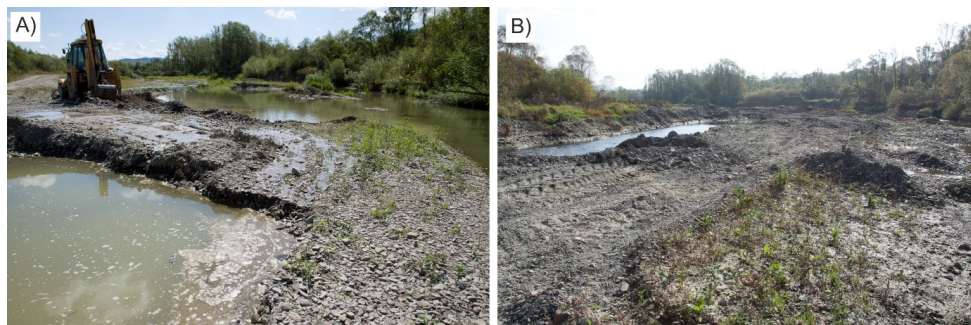
**Fig. 4.** Gravel mining on the Ondava River near the Breznica village (A) and channel destruction by mechanisms (B).

floodplain area. Nowadays gravel extraction (2002 – 2009) is concentrating to active channel area where the volume of gravel mining is permitted by the mining license up to 1000 m<sup>3</sup> per year for one company. This extracted sediment volume is aimed to restrict the sediment supply to the Domaša water reservoir. Channel bed is formed by gravel fraction (from 2 to 64 mm) with average proportion 84,1 % for the Topľa River and 81,8 % for the Ondava River. Average grain size D<sub>50</sub> is for the Topľa 33,09 mm (-5,02 Phi) and 35,23 mm (-5,08 Phi) for the Ondava. In addition to gravel extraction both rivers are lateral dynamic with intensive migration of channel. Erosion protection is ensured by channelization and artificial embankment in areas of settlements but in other section was channel modified and straighten to the original state, gravel materials are pre-load in the form of dikes near active channel without reinforcement (Fig. 3, 4).
