Coastal erosion risk assessment in the coastal area of Muara Asam Asam, Tanah Laut Regency

Rizki Adriadi Ghiffari^{1*} and Haryo Dwito Armono²

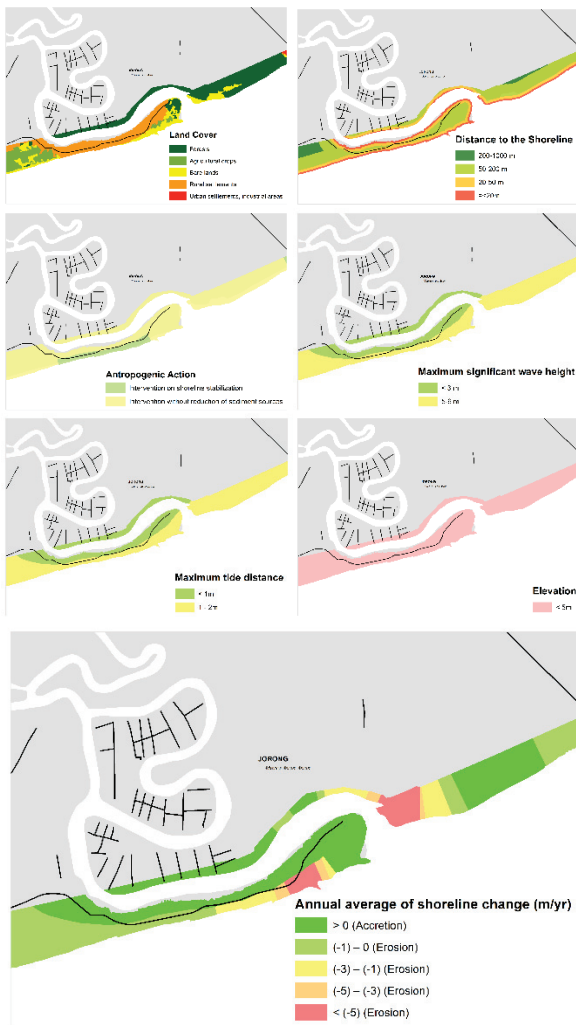
Fig. 2. Coastal erosion vulnerability assessment parameters

The results of the level of vulnerability analysis produced a map of the level of vulnerability to coastal erosion in Muara Asam Asam Village which can be seen in Figure 2.

Based on the results of field measurements, the highest tide distance of sea water on the coast of Muara Asam-Asam Village is a maximum of 2 meters from the coastline, this includes low classification in the level of vulnerability to coastal erosion. Parts of the river close to the estuary are also affected by tides, but only at a maximum level of 1 m or classified as very low in terms of coastal erosion vulnerability

The maximum wave height on the coast around Muara Asam-Asam Village is in the medium category, because it ranges from 5-6 m in bad weather conditions. This of course will greatly affect the level of vulnerability of community activity zones along the coastline, because the movement of wave energy is also sometimes followed by mass movements of ocean currents that can erode the shoreline or carry sediment in the form of sediment from the seabed.

Basically, the coastal area of Muara Asam Asam Village has similar topographic characteristics because it has a land elevation ranging from 1-4 m above sea level and with a gentle slope to flat (0-2%). This is because almost all of the land in this area is formed by sediment deposits from the sea and rivers, not through tectonic or denudational processes.

Based on the results of the shoreline change analysis through the DSAS software, it was found that along the shoreline of Muara Asam Asam Village, there were varied levels of erosion and accretion when viewed from the trend of shoreline changes between 1989-2017. The part with the highest level of erosion is around the center of the settlement of Muara Asam Asam Village, which is located some distance from the estuary, as well as the eastern part of the river estuary. This is an indication of the movement of the dominant ocean currents from the southwest to the northeast, thus diverting the river flow and forming an estuary on the east side. In fact, based on the identified trends, there is a tendency for river estuaries to move as far as 90 m to the east in a period of 28 years, which means that if this trend continues, new land will emerge on the eastern side of the
