Development of design solution for mine workings support repair and recovery in case of local massif deformations

Abstract. The article describes the causes of occurrence and forms of geomechanical processes manifestation in surrounding coal-rock massif of mine workings supported by anchor support. Based on long-term field observations, six forms of typical deformations of the surrounding massif have been established. Design solutions to strengthen the anchor support or complete reinforcement of damaged sections of mine workings during geomechanical processes of local felling have been developed. They include: installation scheme, substantiation of parameters and list of used reinforcement elements; technology of work, a list of equipment used.

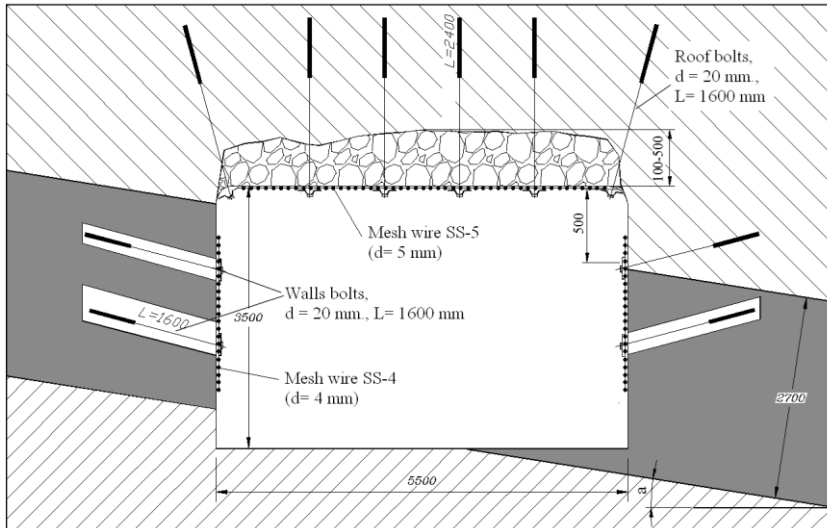
In case of *accumulation of exfoliated roof rocks on mesh wire without it deformation* (fig. 1), the boundary layers of the roof are gradually deformed, the process develops from bottom to top, deep into the roof rocks. With the stratification of rocks, the lower layers, losing their connection with the overlying ones, shift and fall on the lattice tie. The loading of mesh wire, bearing elements and bolts occurs. The height of the collapsed rocks mainly varies from 0.1 to 0.5 m. Depending on the thickness of the layer of exfoliated rocks, the state of mesh wire and bearing elements depends. When sagging, the load-bearing capacity of mesh wire is reduced. Thus, the actual load-bearing capacity of mesh wire is determined by the wire diameter, cell dimensions and the sagging boom. When the mesh wire SS-4, SS-5, SS-6 sags by 0.4 m, it is advisable to carry out repairs in such areas. The repair consists in the release of destroyed rocks in such an area, fixing the roof and filling the void after the release of rocks.

Fig. 1. The accumulation of exfoliated roof rocks on mesh wire without its deformation

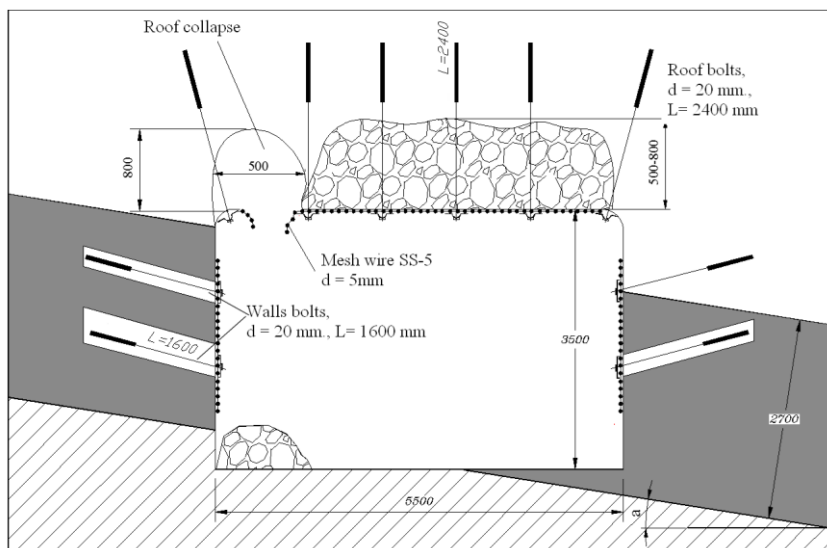
In case of *accumulation of exfoliated roof rocks with deformation of mesh wire and the formation of collapses and domes* in areas with a broken mesh wire, rock breakthroughs occur into the working. The formed collapses have different shapes and different parameters. The mesh wire fractures related to rock falls are most often observed in

local areas where the rocks are weakened, there is increased fracturing, high moisture content of the rocks, near zones with disjunctive disturbance. It has been established that ruptures of mesh wire occur with the accumulation of exfoliated rocks with a height of 0.5 m and more. Areas with a broken mesh wire and the presence of exfoliated rocks in the adjacent areas adjacent to the fall are subject to urgent repair. The repair consists in reinforcing the adjacent sections with supporting lining, releasing rocks near the fallout, securing the fallout with anchor support and filling the resulting void. Filling can be done with wood, foaming resins, foam concrete, followed by the construction of mesh wire puff. In case of ruptures of mesh wire in the areas where the processes of continuous bridging take place, the collapses further develop into long and high domes.

Fig. 2. The accumulation of exfoliated roof rocks with deformation of mesh wire and the formation of collapses and domes

When repairing sections of workings with accumulation of exfoliated roof rocks with mesh wire deformation and the formation of collapses and domes (fig. 2), the location of domes and collapses relative to the center of the excavation is determined by the formed stratification of rocks or natural layering and layer-by-layer cracks. The development of the domes along the height occurs along the normal to the layer-by-layer cracks and delamination cracks. When calculating the parameters of the roof bolting for fastening the local formation of collapses and domes formed during mechanical processes, it is recommended to use the following procedure (fig. 7):

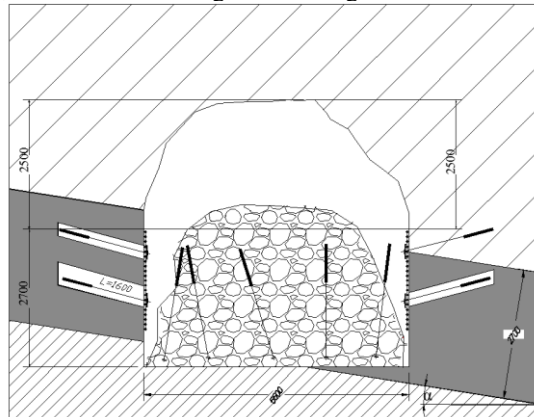
In case of *accumulation of collapsed rocks with deformation of mesh wire and the formation of a dome along the entire width of the mine* (fig. 3), the height of the domes, as a rule, is up to 2.5 - 3.0 m, the width is equal to the width of the working, and the length can reach 10 m. With this type of deformation of the rock mass in the emergency sections, a complete re-strengthening of the working is carried out. Re-fastening works are carried out from a special shelf. Collapsed rocks are released from under mesh wire into free area, the deformed parts of mesh wire are removed, then the walls and roof are trimmed. Either a new anchor support or a metal frame support is installed along the section of the mine working. The voids in the walls and roof are filled with either a wooden fire support or foam concrete.

Fig. 3. The accumulation of collapsed rocks with deformation of mesh wire and the formation of a dome along the entire width of the mine in conditions of seam 9 of «Raspidskaya» mine

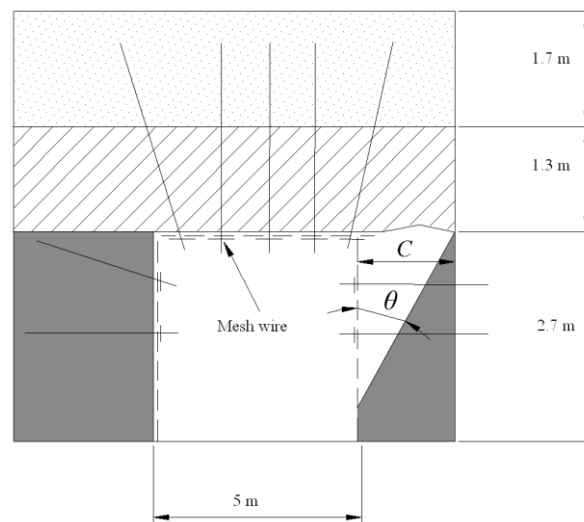
In case of *squeezing of rocks in the walls of workings in the form of a sliding prism* (fig. 4) the creep prism angles θ vary over a wide range, from 50° to 65° , and the creep prism width C is from 1.0 to 1.8 m. Pressing in the form of creep prisms causes significant outcrops of roof rocks and their collapses into the working. The width of the workings, as a result of this, increases sharply at the contact with the rocks. In the absence of rock falls from the roof in the sections of workings with squeezing the lining is reinforced based on the width of the sliding prism. Anchor support is used as a reinforcing lining. Initially, the mesh wire is applied, then the reinforcing roof bolting is installed.

Fig. 4. The squeezing of rocks in the walls of air roadway 4-9-25 of «Raspadskaya» mine in the form of a sliding prism

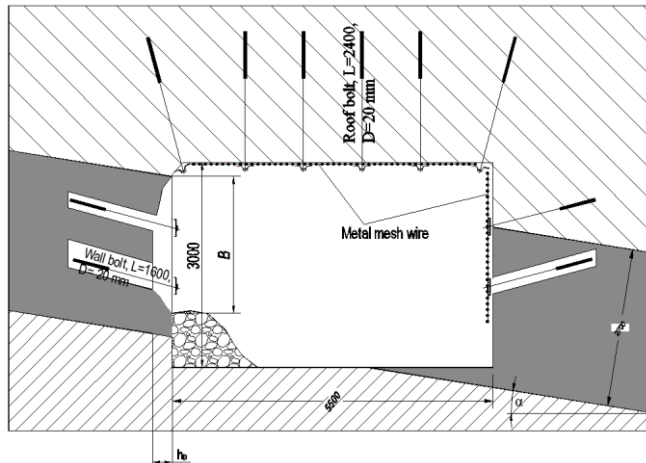
The squeezing of coal and rocks in the walls of workings in the form of dumps (fig. 5) is observed in areas where the roof is difficult to break. The depth of the extraction h_B reaches 1 m or more, the height B is different, sometimes it reaches the working height. Most often observed from lying wall side. In case of minor collapses in the walls, repair work is carried out by installing and securing a mesh wire or polymer mesh using one or two steel-polymer bolts. With deep and high falls, the site is re-strengthened. Exfoliated coal and rock are removed, the surface of the dump is leveled, mesh wire and bolts are installed. In some cases, the dumps are filled with bonding compounds such as Carbofil, Geofom, Tekfom.

Fig. 5. The squeezing of coal and rocks in the walls of workings in the form of dumps

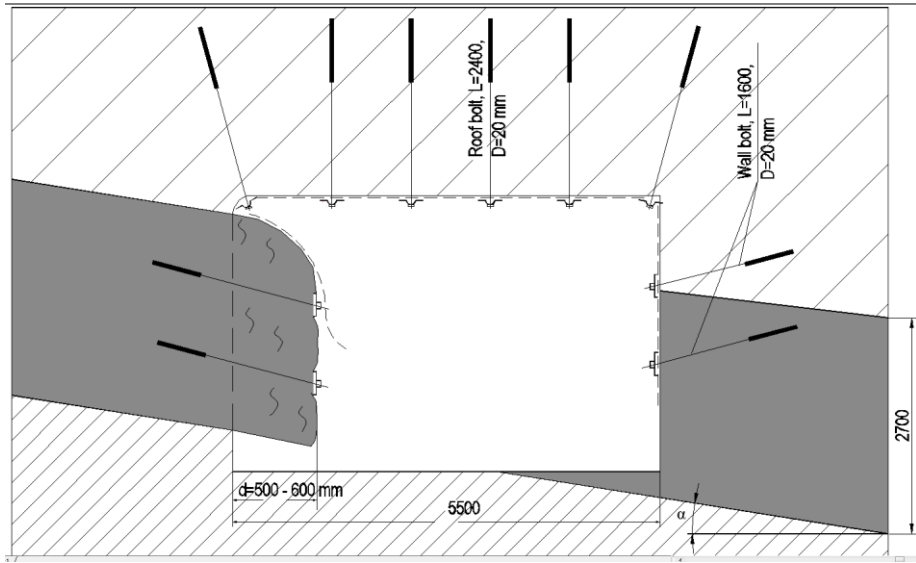
An episode of plastic extrusion of coal and rocks from the walls of workings (fig. 6) occurs in workings with a hard-to-break roof in areas with weakened strength properties of coal. Weakened coal layers at high horizontal stresses are squeezed out towards the workings. The squeezed out part of the coal into the working is destroyed, the fastening of the sides is broken. More often, coal squeezing is observed in the workings from the side of the hanging side. The amount of coal squeezing d into the working is 0.5 - 0.6 m, sometimes more. When coal is squeezed out, overhanging cornices are formed in the workings. At high yields, they are dangerous. Therefore, in such areas, the walls are reinforced. The destroyed coal collapses, the walls is leveled, overlapped with a mesh wire or polymer mesh, bolts installed into coal massif, sometimes the coal mass is strengthened with bonding chemical compounds.

Fig. 6. The plastic extrusion of coal and rocks from the wall of working

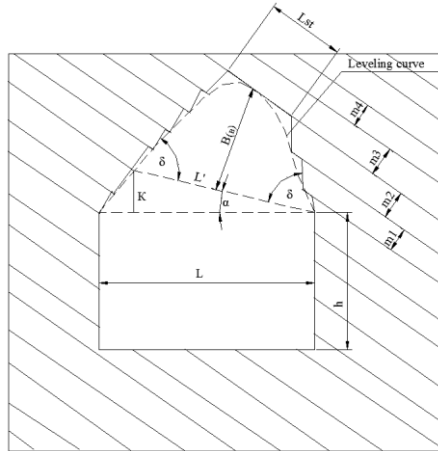
Fig. 7. Scheme for determining the main expected parameters of collapses during mechanical processes of local formation of collapses or domes

The main predictive parameters of collapses include:

B_B – the collapse height;

L_{ST} – the stable collapse span;

δ - the angle of inclination of the fracture line of the rock layers at the supports in walls.

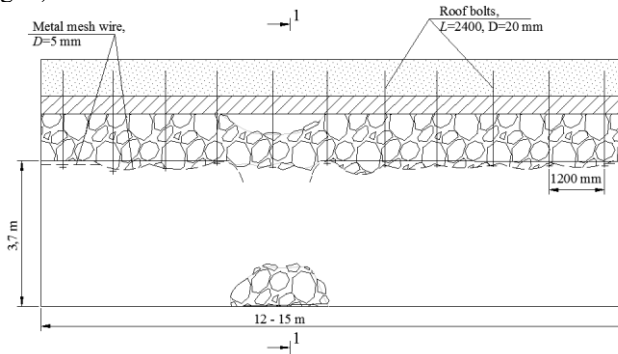
As an example of the implementation of design solutions for the repair and strengthening of the anchoring of mine workings, the section of the air roadway along seam 9 is presented in the conditions of "Raspadskaya" mine with exfoliated rocks, with a rupture of mesh wire (fig. 8).

Fig. 8. Exfoliation of roof rocks in roadway. Sagging of mesh wire with rupture (position before repair)

Repair work must be carried out using frame support - support frames and temporary support. The support frame is used to prevent deformation of mesh wire and the spread of its sagging to areas adjacent to the emergency one. The support frame is made of two ore racks with a diameter of at least 200 mm with the installation of racks under a wooden plank. A carriage is used as a top stand (timber, a block can be used). The support frame is installed in the spaces between the anchor rows in front of the emergency section. Temporary support serves to fasten the part of the site where the rock is released from the roof and mesh wire will be replaced. The temporary support consists of two VK-7 (VK-8) racks, which are installed under a wooden plank (timber, block). From under the protection of temporary lining, work is carried out directly on the release of destroyed rocks and replacing the mesh wire and strengthening the roof bolting.

Roadway repair works are carried out in the following sequence. Elements of the support frame and temporary support frame and other materials are delivered to the working area - reinforcing support anchors with washers and nuts, lattice lagging, block (bar or carriage), portable shelves, equipment and tools for performing work, one or two wooden ladders, metal peaks at least 3 m long. The base frame is initially installed. The frame is installed with a spacer, wooden wedges are used. After that, it is carried out with the help of metal peak frills of the roof and walls from the hanging pieces of rock and coal. The temporary support frame is installed directly in front of the front boundary of the site where repair work is to be carried out. With scissors for metal, the bars of mesh wire are cut, the deformable tightening section is thrown out, a new lattice tie is installed, fixed on the roadway support bolts. From under the protection of temporary lining, boreholes are drilled in the area where the rocks are released, then reinforcing lining bolts are installed and fastened in the boreholes.

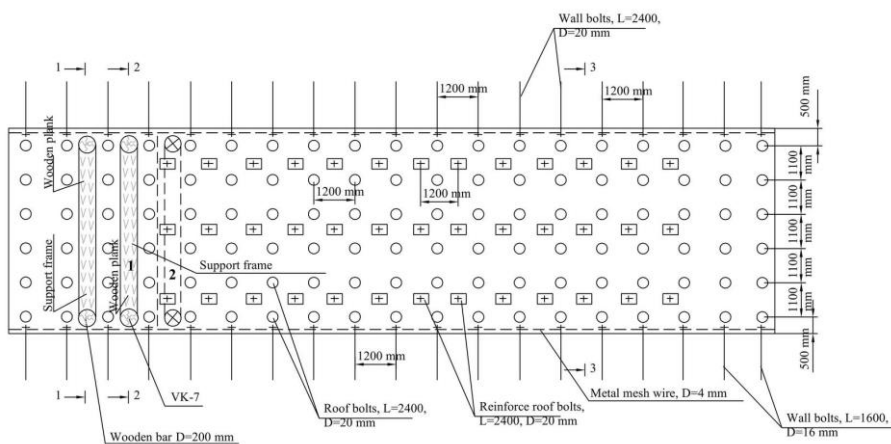
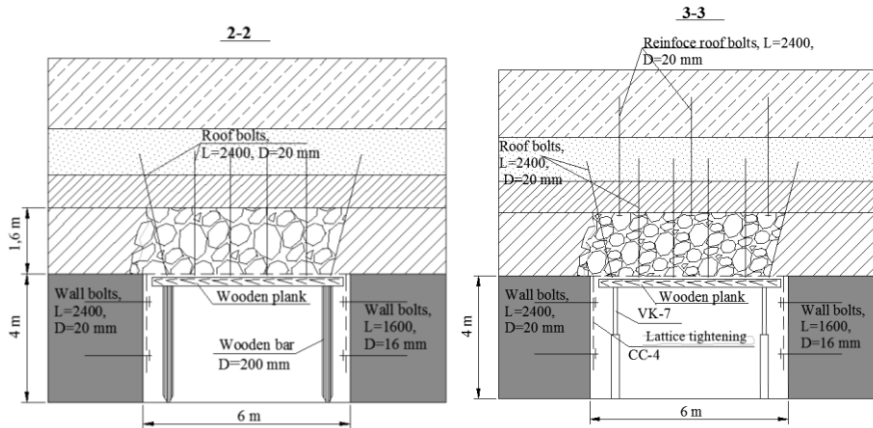
The parameters of the reinforcing lining anchors are calculated according to the regulatory method in force in Russia, according to the weighted average resistance of the rocks within the limits of the thickness equal to the width of the working. In this case, the length of the reinforcing anchors in roadway is taken as 2.4 m, the type of anchor is AVR-20 (A20V), fastening in the holes using resin capsules, the length of fastening in the holes is at least 1 m. Installation of anchors is carried out for individual grips in the form of supporting spherical washers with dimensions of 300x300 mm or flat grips with dimensions of 300x300 mm. Density of installation of anchors is not less than 0.5 bolts/m². Thus, repair work is carried out along the length of the section. In this case, the step of releasing rocks and strengthening the lining during repairs is taken no more than 1 - 1.2 m (fig. 9).

Fig. 9. Condition in the roadway before the start of repair work and after the completion of repair work

An increase in the height of the working after the release of destroyed rock in the repaired section causes a decrease in the resistance of coal in the sides of the drift, increases the relative tension in the sides [8-10]. It is recommended that the increased part of the height of the sides in the workings after the release of the destroyed roof rocks be fixed with anchor support. In this case, one additional anchor is installed in the sides. Installation of anchors is carried out during the period of strengthening the roof lining. After installing reinforcing anchors along the entire length of the cleaning section of the support frame and the temporary support frame, the resulting void is filled with light foam concrete.
