Organization of restoration and repair works

Abstract. Housing stock and the objects of industrial production of our country are represented by constructions, which were erected in the XX century, XIX century and pre-revolutionary time. Among them there are constructions built with using of natural stone and brick. The service time of this constructions is several decades or hundreds of years. Considerable amount of this value are constructions of the first industrial generation and objects of cultural heritage under the state protection. Nowadays, because of untimely overhaul and restoration, it is very complicated to bring masonry cultural heritage objects in normal technical state, accounting the negative effect of natural climatic factors. Monitoring of technical state of this objects is quite important for timely carrying out the overhaul, restoration and reconstruction. This government-controlled task has actual significance. Preservation of this objects in good technical state is important in general for the Russian Federation. Domestic researchers developed effective method for the monitoring of technical state of masonry architecture structures. It takes to the account th

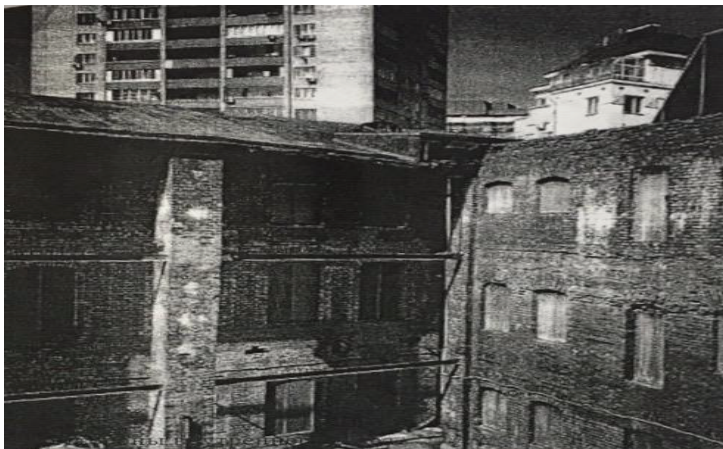
Fig. 1. General view of the brickwork of the external walls.

There wasn't necessity of top coating removing in southern and eastern parts of the building, because brickwork there was in open form (fig. 1). The condition of walls in southern, northern and eastern parts of the building varied so it was important to assess the level of walls deterioration.

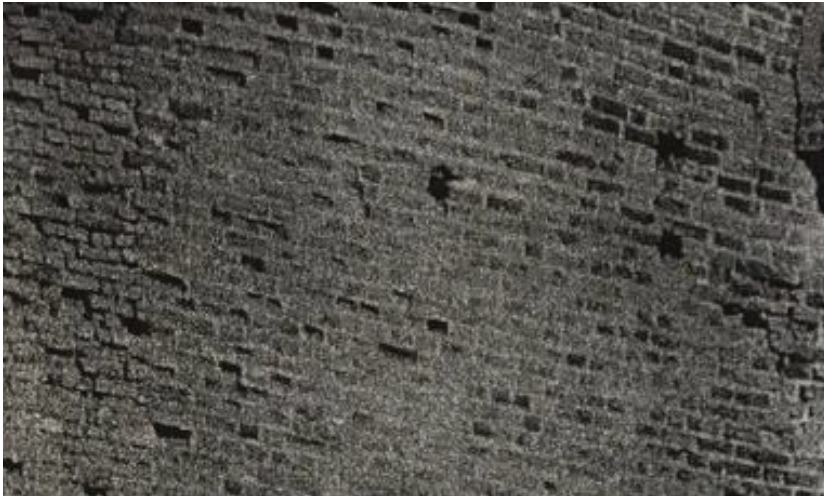
Low deterioration (less 15%) is caused by the defrosting, weathering and fire damages of walls material to depth no more than 5 mm, vertical and oblique cracks, crossing no more than two masonry rows.

Fig. 3. Example of masonry destruction.

The walls were fully cleared from the old covering, bricks, which were weakly connected – are fixed by the way of pouring the solution in cracks. Highly damaged elements were extracted using the hammer and chisel and replaced using the solution to new one, which are similar in color and texture. Replacement of dropped out and weakened stones were held from top to bottom direction. The disordered stones in old brickwork were extracted and replaced to new ones, the solution was removed about 0,5 in depth by the chisel and angle grinder, the cracks were occluded by the troweling.
